USDA-FOREST SERVICE

RIVER COMPLEX FIRE BURNED-AREA REPORT
(Reference FSH 2509.13)

PART II - BURNED-AREA DESCRIPTIONA. Fire Name: River Complex FireB. Fire Number: CA-SHF-002066C. State: CAD. County: TrinityE. Region: 5F. Forest: Shasta-TrinityG. Districts: Trinity River Management UnitH. Fire Incident Job Code: P5J0HRI. Date Fire Started: July 31, 2015J. Date Fire Contained: September ??, 2015K. Suppression Cost: \$30?? million

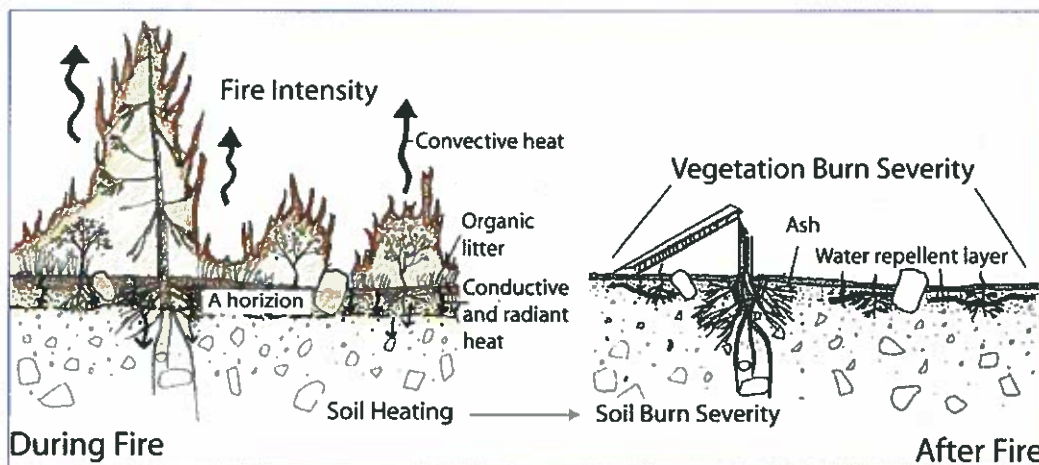
Figure 2 Illustrates the effect of fire intensity on above-ground vegetation and below-ground soil properties (Graphics by Mike Hankinson, National Park Service)
