Subject: Blue Cut Fire BAER Initial 2500-8 Request

Date of Report: 9/6/2016 Initial Request

Blue Cut Fire – San Bernardino National Forest, Front Country Ranger District

BURNED-AREA REPORT
(Reference FSH 2509.13)

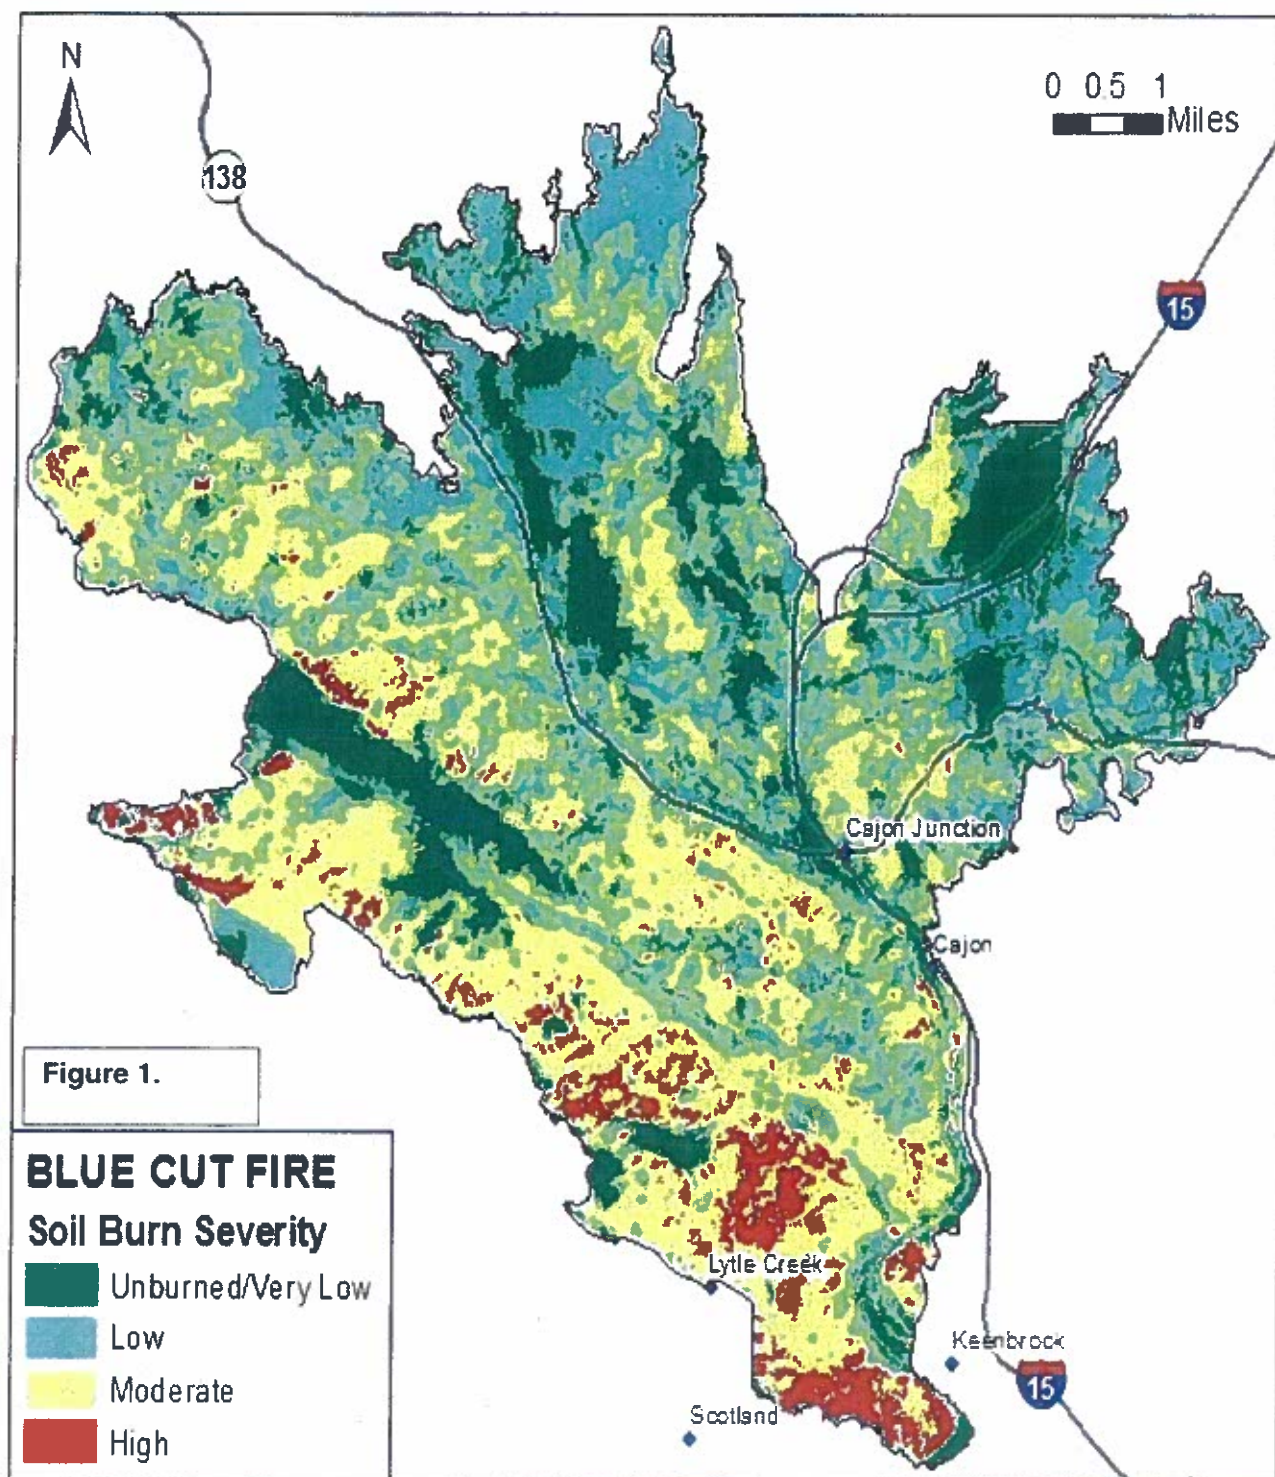
- Railroad tracks: The Union Pacific railroad track within the fire area is along the foot and toe of slopes that burned with high and moderate severity, especially in western portions of the fire, between milepost 64 and 68, and the narrow portion of the track in the Keenbrook area by milepost 67. The risk of rockfall and slope wash (dry ravel) in this section of the tracks as a result of the fire is considered **Very High**.
- PCT: various sections of the PCT through steep slopes, especially between Lone Pine Canyon and Lytle Canyon. PCT use through this section is generally highest in late spring, rocks and debris actually impacting hikers as they traverse by is possible, especially during storm events. Rock and debris are expected on the trail potentially impacting tread. This risk can be considered **High** as a result of the fire.

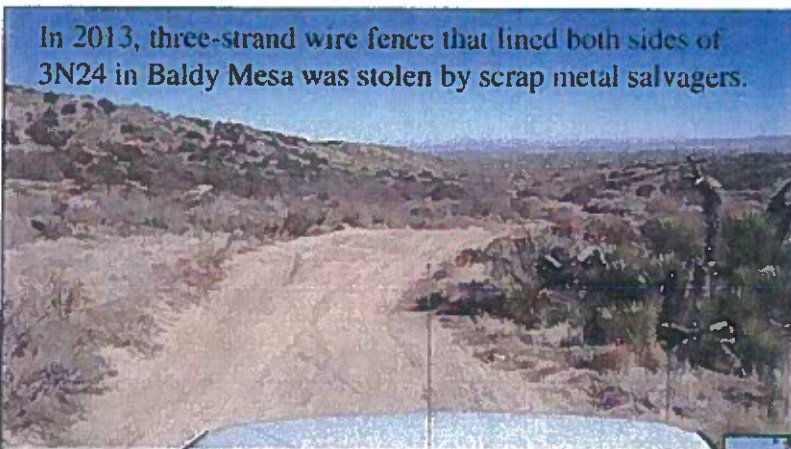
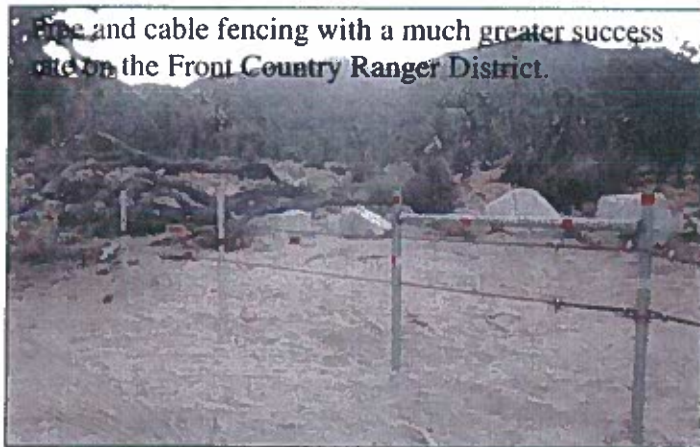
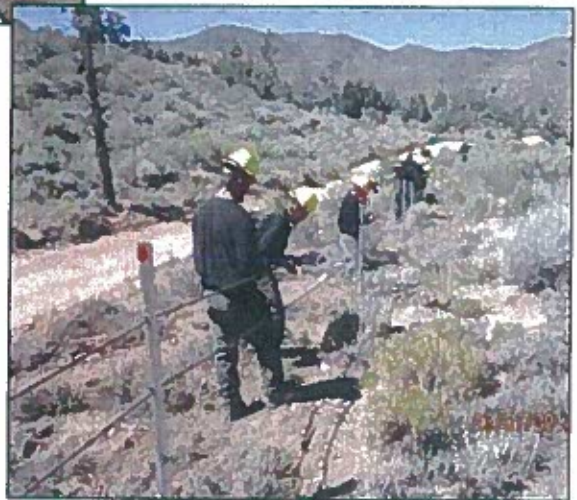
Traditional barbed/smooth wire fencing is often ineffective and/or stolen (for scrap metal recycling profit). Previous wildfires and ecological restoration activities within the Blue Cut Fire Area have provided the Forest numerous opportunities to determine treatment methods with the highest rate of success. After the Hill Fire (2011), the Forest attempted to conduct a closure using 3-strand smooth wire and 6-foot T-posts at the Forest boundary. Materials and installation in 2011 was \$13,000 per mile. After installation, these fences were cut and the T-posts stolen. For a closure to succeed, a heavier duty fence and gate system is required (as occurred as a BAER treatment in the adjacent 2015 North Fire). As such, the District has found that pipe and cable fences, vegetation barriers, "chunking", and boulder placement to be the only reliable and effective treatment method in many of the higher-use areas.

A majority of the Blue Cut fire area proposed for BAER land treatment is within the Baldy Mesa OHV Trail/Staging Area and Restoration Project Area. The SBNF and our partner, the Southern California Mountains Foundation (SCMF) acquired state OHV funds to construct OHV trail, improve the trailhead, and restore 55 miles of unauthorized routes within the project area over the next 2 years. OHV project implementation began 2 weeks prior to the Blue Cut Fire and eighty percent of the project area is within the fire area. As a result of the existing grant and partnership, the Forest and SCMF can provide several crucial items for the OHV Resource Protection Treatment proposals to enhance BAER treatment success. Contributed items are
