Date of Report: 06/29/2022**BURNED AREA REPORT**

PART II - BURNED-AREA DESCRIPTION**A. Fire Name:** Sheep**B. Fire Number:** CA-ANF-0174**C. State:** CA**D. County:** Los Angeles**E. Region:** 05**F. Forest:** Angeles**G. District:** San Gabriel Mountains National Monument**H. Fire Incident Job Code:** P5PP6U22**I. Date Fire Started:** 06/11/2022 @ 1836 hrs**J. Date Fire Contained:** 100% as of 06.19.2022**K. Suppression Cost:** \$8 M

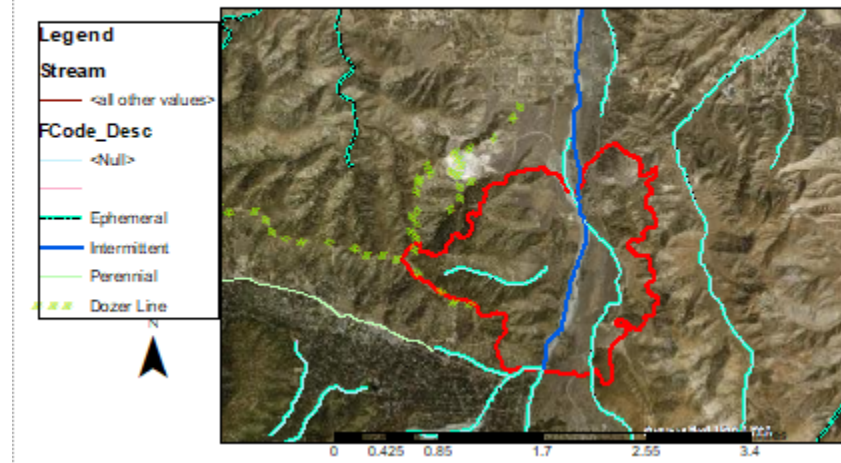
Figure 3 Sheep Creek is an intermittent stream. Other drainages feeding into Sheep Creek are typed as ephemeral.

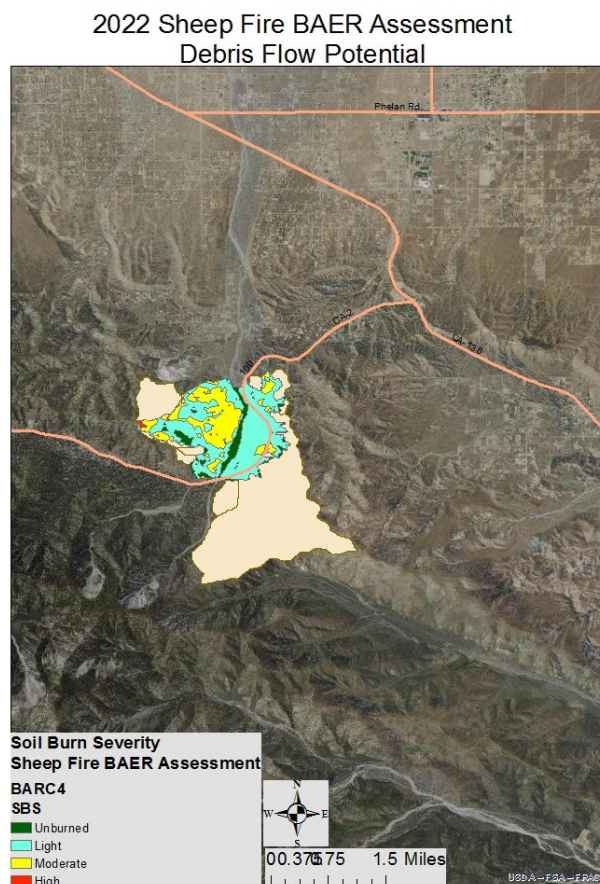
USGS models estimate a low level of debris-flow hazard for most of the area burned by the Sheep fire. Most stream reaches and drainage basins have a less than 20% likelihood of debris-flow occurrence at the modeled rainfall intensity. A few small drainages have a higher level of debris-flow hazard, with a 40-60% likelihood of debris-flow occurrence. These higher hazard areas occur in the northern portion of the burn area along some sections of Sheep Creek. Most of the assessed burn area requires rainfall rates greater than 44 mm/h (1.73 in/h) to exceed a 50% likelihood of debris-flow occurrence. Higher hazard areas require much more modest rainfall rates between 20 and 28 mm/h (0.79 in/h and 1.1 in/h) to exceed a 50% likelihood of debris flow occurrence. Most modeled watersheds have the potential to produce sediment volumes less than 10,000 m³ (13,079 cy), resulting in low to moderate combined hazard for most of the burn area.

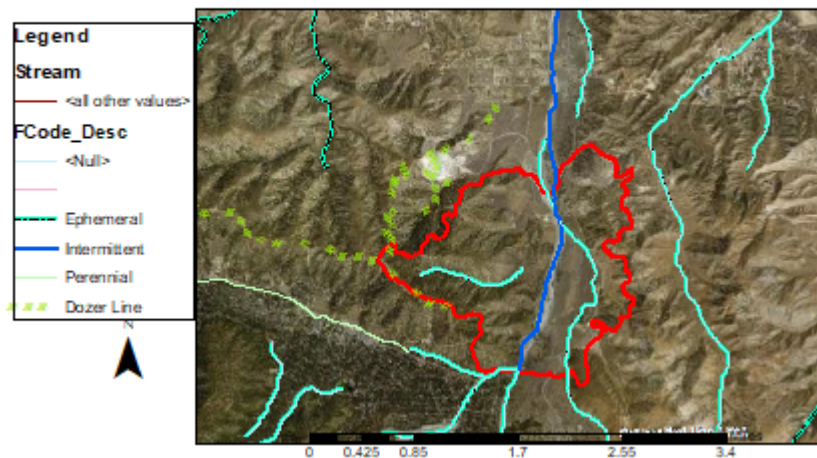
Based on the potential for visitor falls, the BAER team identified a serious risk to public, employees, and cooperator staff in the Sheep Fire area. The dozer lines now connect the mountain bike trail from Table Mountain (4N21) through to the Desert Front Country Road. These dozer lines now surround a deep pit quarry which would be a very high risk. There is also Quarry Road which goes to the quarry. Mountain bikers and hikers frequent these trails and now that they are open, there is a need to ensure access is limited.

A critical value is the safety risks due to access into fire footprint, flooding and debris flows in floodplain during and post-storm events, and access onto dozer lines past quarry.

Probability: Possible

Magnitude: Major

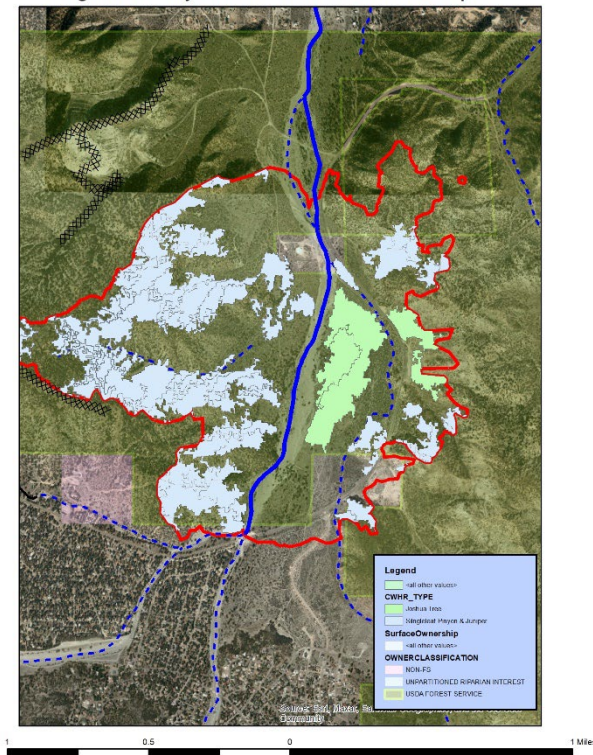
Sheep Fire with Joshua Tree Woodland and
Singleleaf Pinyon Pine and Western Juniper

Due to the slow nature of Joshua Tree, Pinyon Pine and Juniper recovery, it's important to address invasive plants such as cheat grass, Russian thistle and mustards. All three are noted in the ANF invasive weed database. In addition, observations of intact ecosystem next to the burned area noted scattered individuals of these species. Also, observations were made of Russian thistle in the suppression piles of pushed vegetation and in flumes draining Hwy 2. (Appendix A) These are highly flammable and quick to spread flames. If a fire occurs in the Sheep Fire area within the next 20 to 30 years, the area will be permanently type converted and we will lose these important cornerstone species.

An emergency exists to address the threat of post-fire weed incursion within the fire perimeter and in areas where fire suppression activities occurred. The incursion and dispersal of invasive weeds into areas disturbed by fire suppression and rehabilitation has the potential to establish large and persistent weed populations. In addition, it is highly likely that existent weed infestations along
