**IRON - ALPS COMPLEX BURNED AREA REPORT**  
(Reference FSH 2509.13)

Granite Fire in Trinity Alps part of the Iron-Alps Complex

- A. Fire Name: Iron-Alps Complex
- B. Fire Number: CA-SHF-001057
- C. State: CA
- D. County: Trinity
- E. Region: 5
- F. Forest: Shasta-Trinity
- G. District: Trinity River Management Unit
- H. Fire Incident Job Code: P5D8HV
- I. Date Fire Started: 6/20/2008
- J. Date Fire Contained: 9/05/08
- K. Suppression Cost: 72 million
- L. Fire Suppression Damages Repaired with Suppression Funds
1. Fireline (miles): 352
  2. Fireline waterbarred and seeded (miles):
  3. Other (identify):
- M. Watershed Number: 26539846 - Trinity River
- N. Total Acres Burned: 105,367
- NFS Acres( 101,000)    Other Federal (1,386 )    State ( 10)    Private ( 3,180)

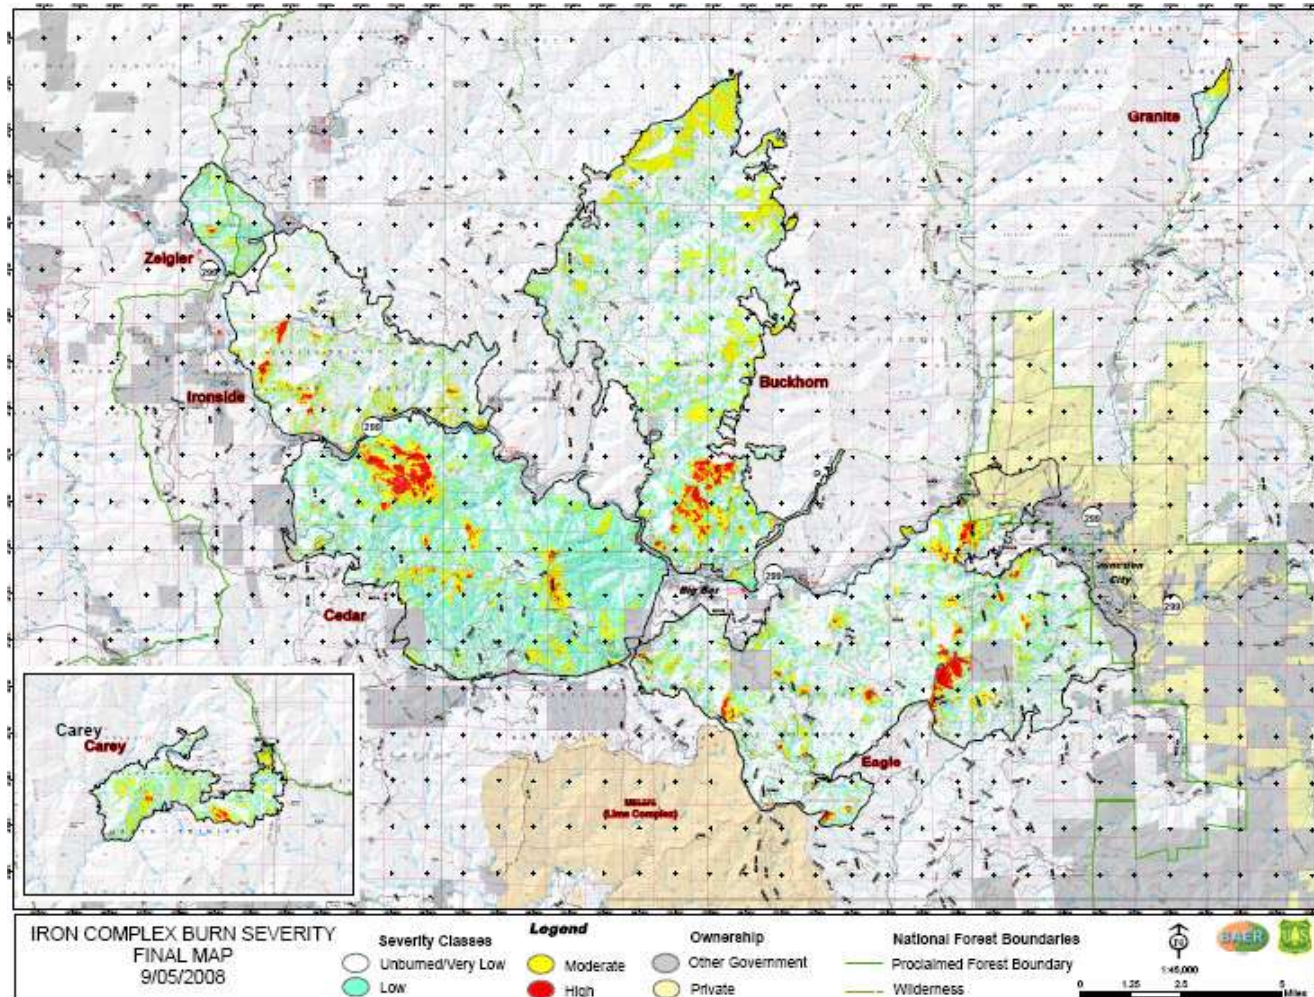
#### **IRON-ALPS SOIL BURN SEVERITY**

A. Burn Severity by total and FS (acres): 88,503 (v. low & low) 15,805 (moderate) 2,107 (high)

B. Water-Repellent Soil by total and FS (acres): Water repellency is present in the high soil burn severity class, approx. 2,200 acres. Repellent layer is from 4 to 8 inches thick, moderate to severe, and continuous.

Approximately 17% burned at high and moderate soil burn severity (see soil burn severity map below). The rest of the fires were either low or very low soil burn severity. General trends are forested areas that were north or east-facing slopes were nice mosaic under-burns. Forested areas that were south or west-facing slopes burned hotter and had tree mortality of 30-60% with ridges burning hotter (see pics below).
