FORENSIC ANALYSIS OF FAILED SURGE ARRESTORS

Gujarat Energy Transmission Corporation Limited

28th April 2016

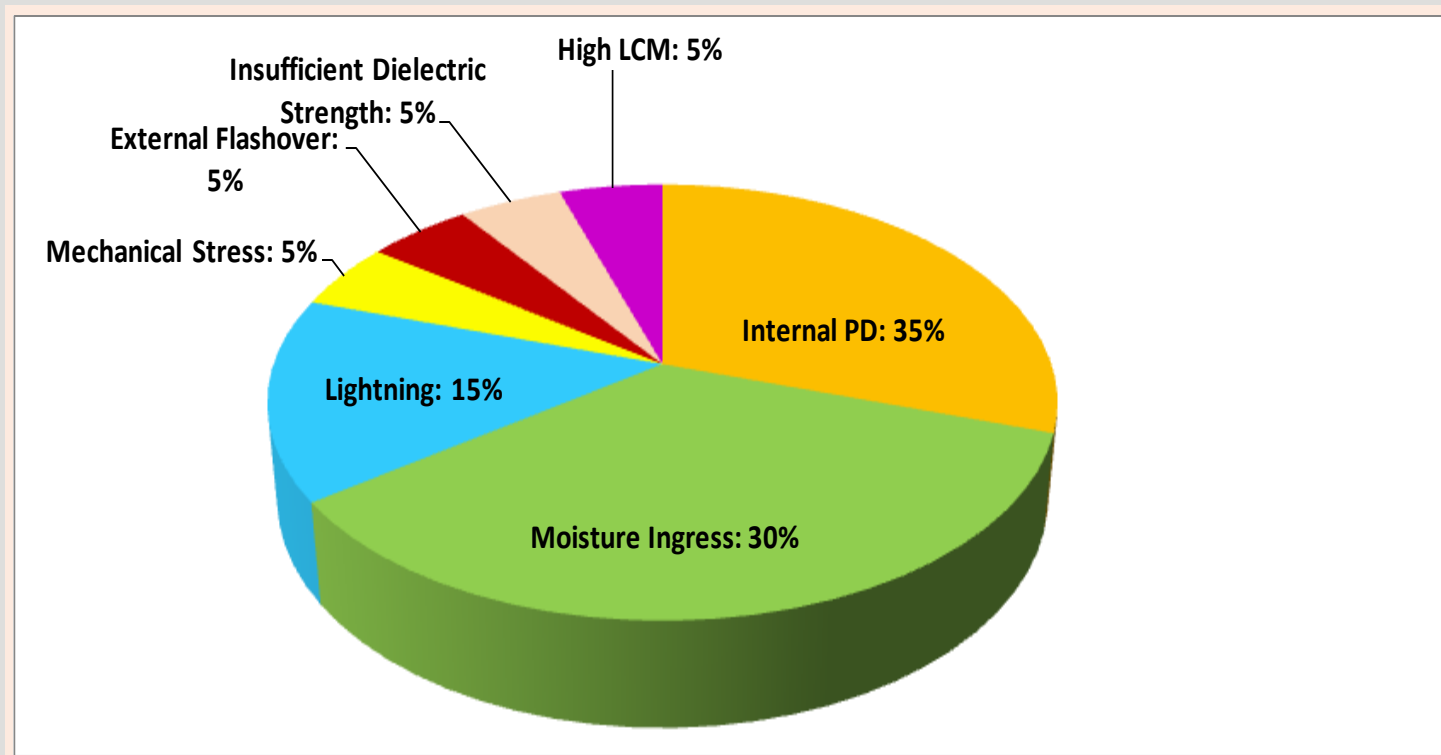
Analysis

After matching the conditions of failed SA with indicators or symptoms given in the matrix, the potential root causes of 20 nos. of Surge Arrestors are concluded as follows:
