BOEING COMMERCIAL AIRPLANES

FLIGHT OPERATIONS TECHNICAL BULLETIN

NUMBER: 737-12-2
747-400-64
747-8-4
757-84
767-86
777-36
787-8

SUBJECT: Upset Recovery

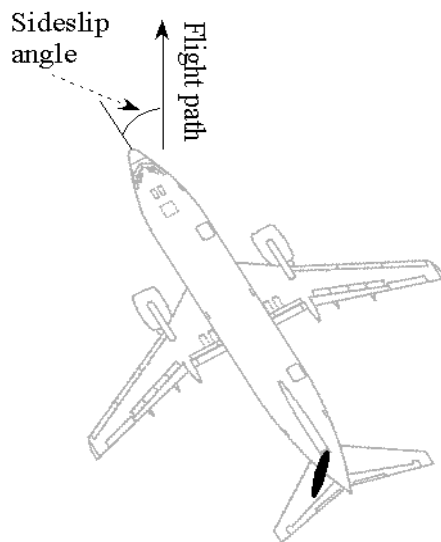
Figure 1 Rudder Induced Sideslip

Maneuvering an airplane using the rudder will result in a yaw and roll response. The roll response is the result of sideslip. For example, if the pilot applies left rudder the nose will yaw left (Figure 1). This yawing response to the left will generate a sideslip (right wing forward). The resulting sideslip will cause the airplane to roll to the left (i.e., roll due to sideslip). The actual force on the vertical tail due to the rudder deflection tends to roll the airplane right, but as the sideslip moves the right wing forward, the net airplane roll rate is to the left.

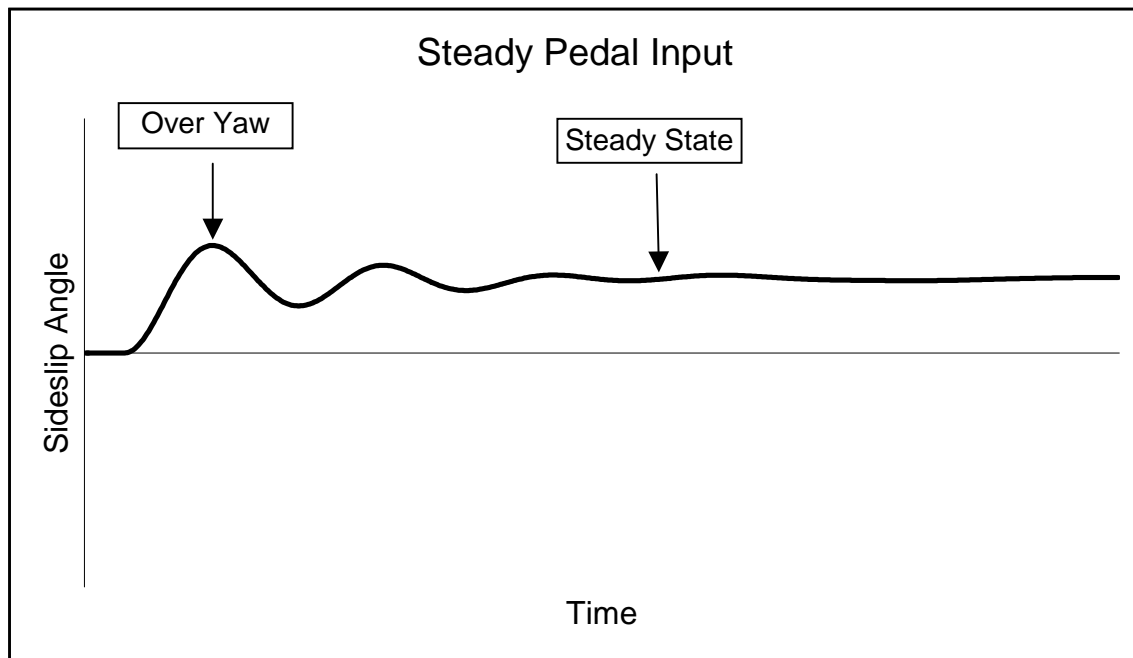
Figure 2 “Sideslip Response to Abrupt Steady Rudder Input”

sideslip. As the pilot applies more rudder, more sideslip is generated and a greater roll response will result. Large, abrupt rudder inputs can generate very large sideslip angles, much larger than encountered in a steady state sideslip (that which is reached with a slow pedal input and held for a period of time). This is due to the dynamic response characteristics of the airplane (Figure 2). This “over yaw” can amplify the roll rate. It is important to use the rudder carefully so that unintended large sideslip angles and resulting roll rate do not develop. The amount of roll rate that is generated by using the rudder is typically proportional to the amount of sideslip, NOT the amount of rudder deflection.

The sideslip angle that is momentarily reached with such “sequential over yaw” can be much larger than the over yaw associated with a single, abrupt rudder input (See Figure 2 & 3). When the rudder is reversed at this sequential over yaw/sideslip angle, the rudder induced fin force is added to the sideslip induced fin force (See Figure 4 & 5). The resulting structural loads can exceed the limit loads and possibly the ultimate loads, which can result in structural damage.

Precise roll control using rudder is difficult and therefore not recommended. Because sideslip must build up to generate the roll, there is a time lag between the pilot making a rudder input and the pilot perceiving a roll rate. This lag has caused some pilots to be surprised by the abrupt roll onset and in some cases to interpret the rapid onset of roll as being caused by an outside element not related to their rudder pedal input. If the pilot reacts to this abrupt roll onset with another large rudder input in the opposite direction, large amplitude oscillations in roll and yaw can result. Cyclic rudder pedal inputs can result in very large amplitude sideslip oscillations (See Figure 3).

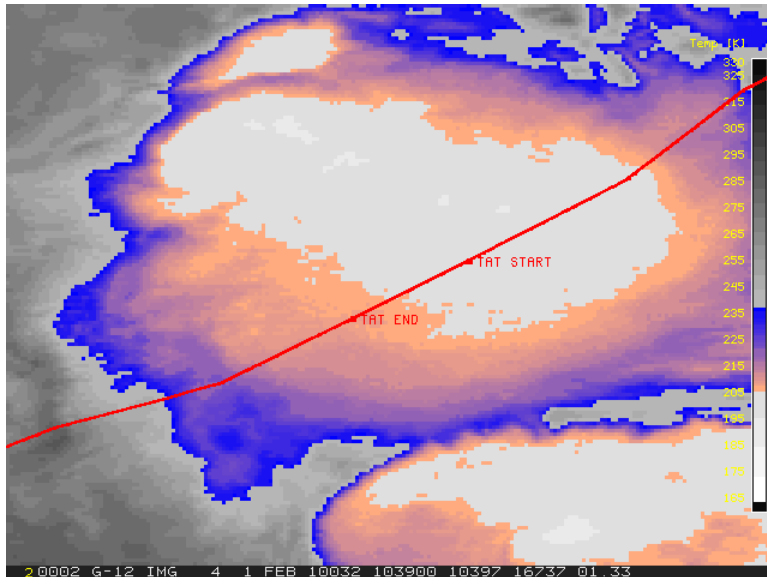
Figure A: Enhanced infra-red satellite image showing clouds at or above the tropopause in grey and white colors. The airplane track is shown in red. An engine damage event occurred during a TAT anomaly, noted by TAT start and TAT end notations. In the flight deck, the flight crew observed an auto-throttle disconnect associated with the TAT anomaly.

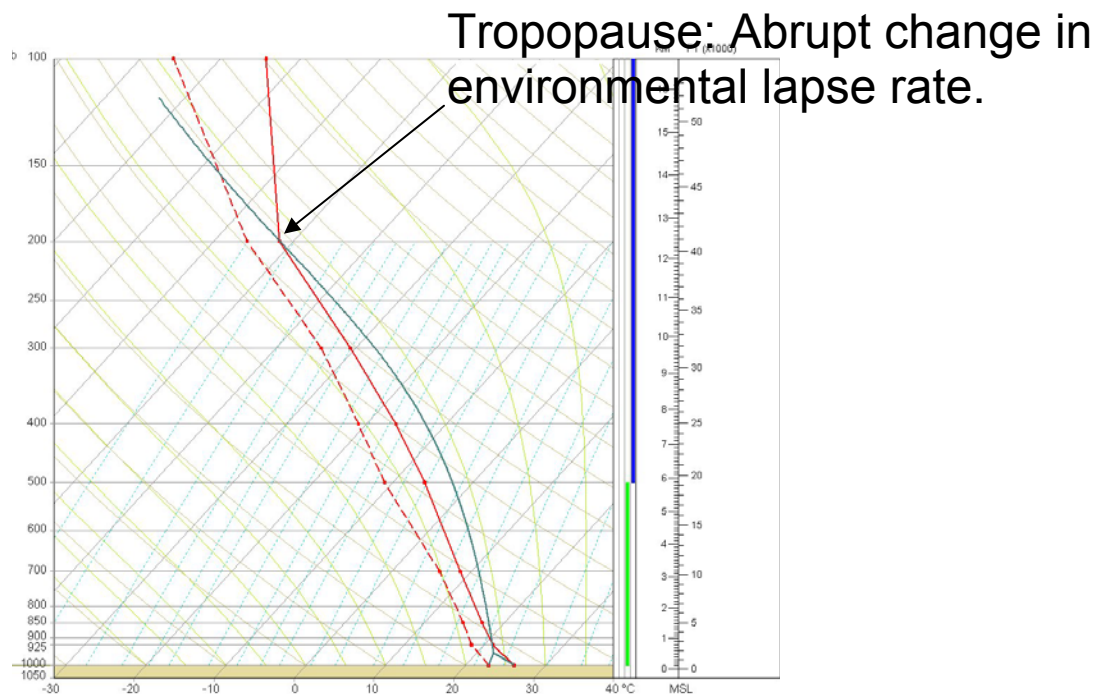
Figure B: An average sounding compiled from engine power loss and damage events up through 2009
