## Case Study: “V” Flow Lines

- Color ink screen printed on lamp panels to change the color of the EL light (“overprint”)
- Some panels get a defect in a “V” pattern that is usually not a functional defect, ***but customers do not like it***
- Panels with the V defect must be reworked by removing ink with solvent – time consuming and unsafe

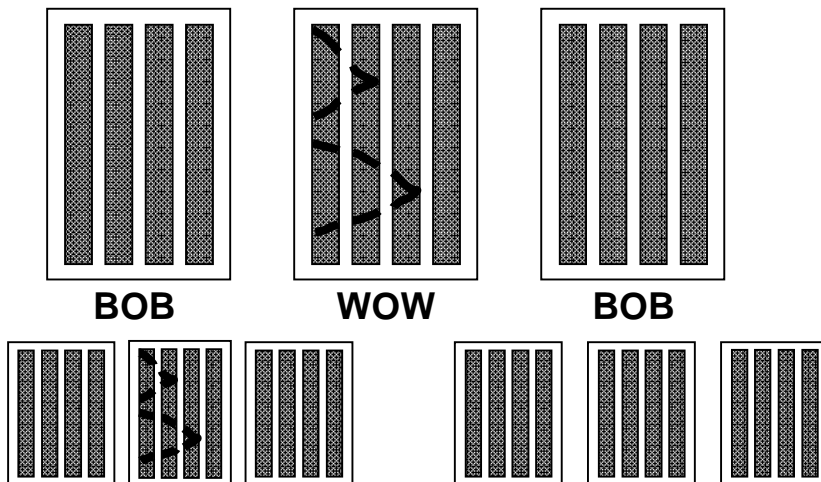
**Some contrast:** some runs have up to 25% defects (can be reworked). WOW runs mostly with “large” artwork.

WOW  
25% Rework

BOB  
1% Rework
