Rail Accident Report

Train/vehicle collision on the Leighton Buzzard Narrow Gauge Railway 25 March 2007

Train/vehicle collision on the Leighton Buzzard Narrow Gauge Railway, 25 March 2007

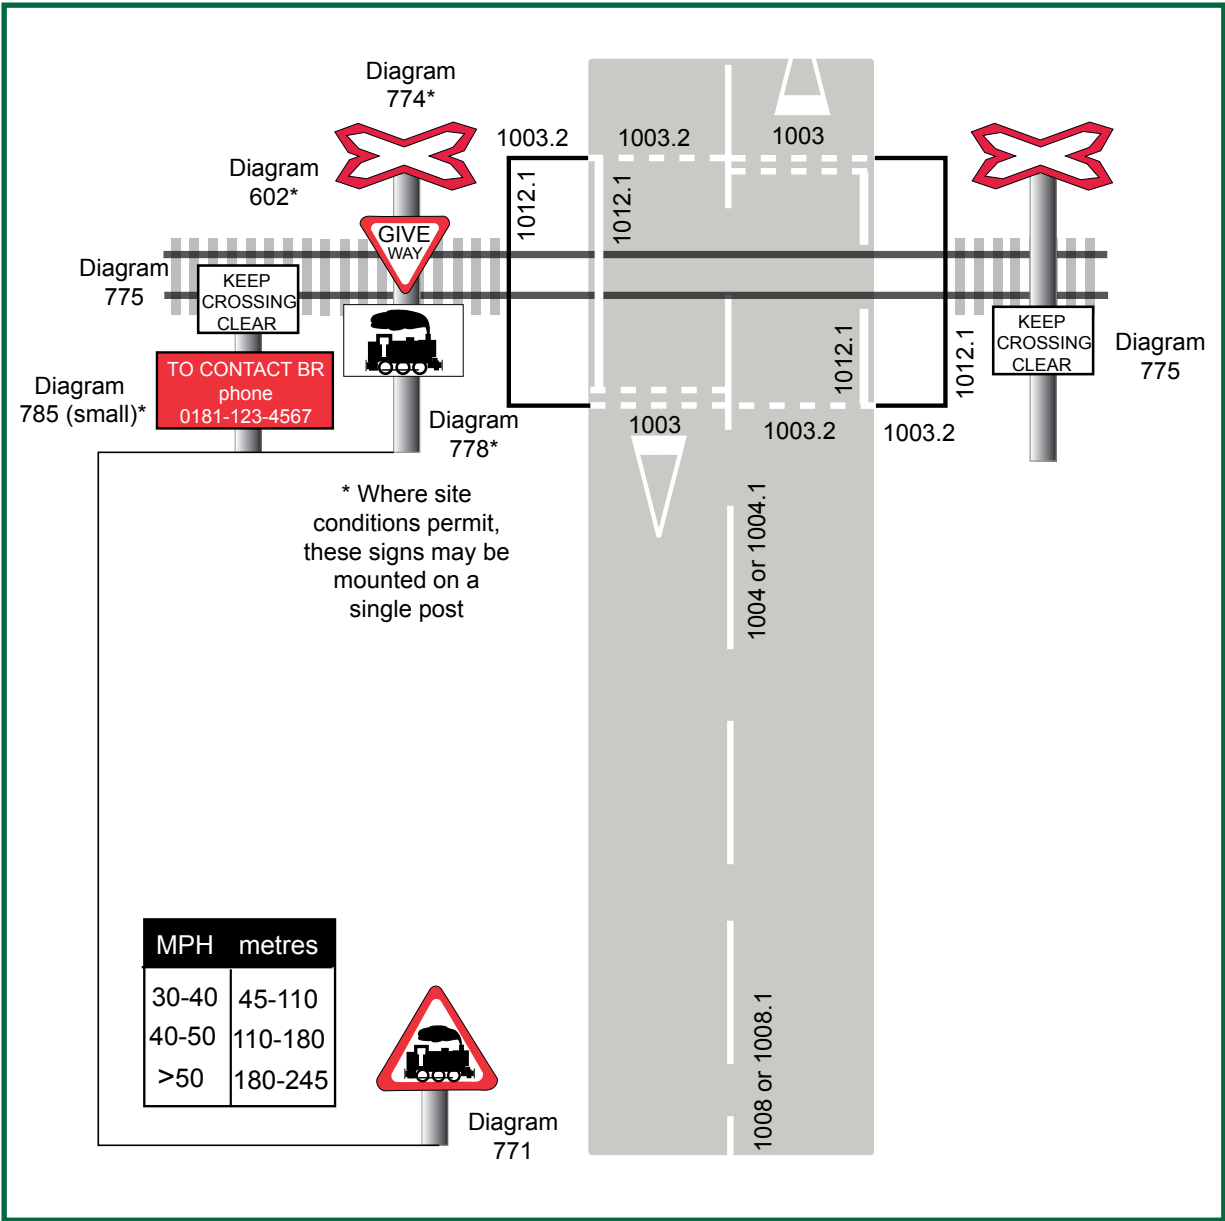
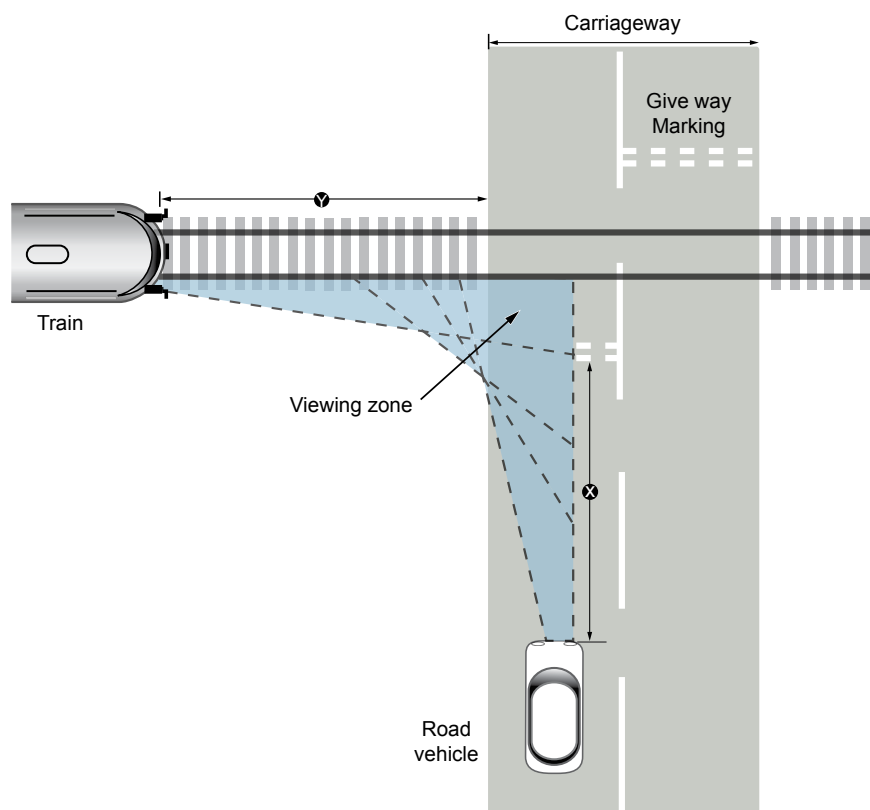
1. The viewing zone (as shown in the shaded area) is defined by lines connecting points 'X' and 'Y' given in Table 13

2. Distance 'X' is the distance of road vehicle users from the 'give way' line on the approach. Distance 'Y' is the distance of an approaching train from the crossing. A crossing which crosses the railway at right angles over a single line is normally considered as 7 m long, but at longer crossings it should be possible to see trains earlier. Where road gradients are steep, distances 'X' should be varied accordingly. Where the 85%ile road speed is less than 25 km/h (15 m/h), the maximum value of 'X' may be 20 m.
