Rail Accident Investigation Branch

Rail Accident Report

Runaway of a road-rail vehicle at Glen Garry 5 December 2007

5 December 2007

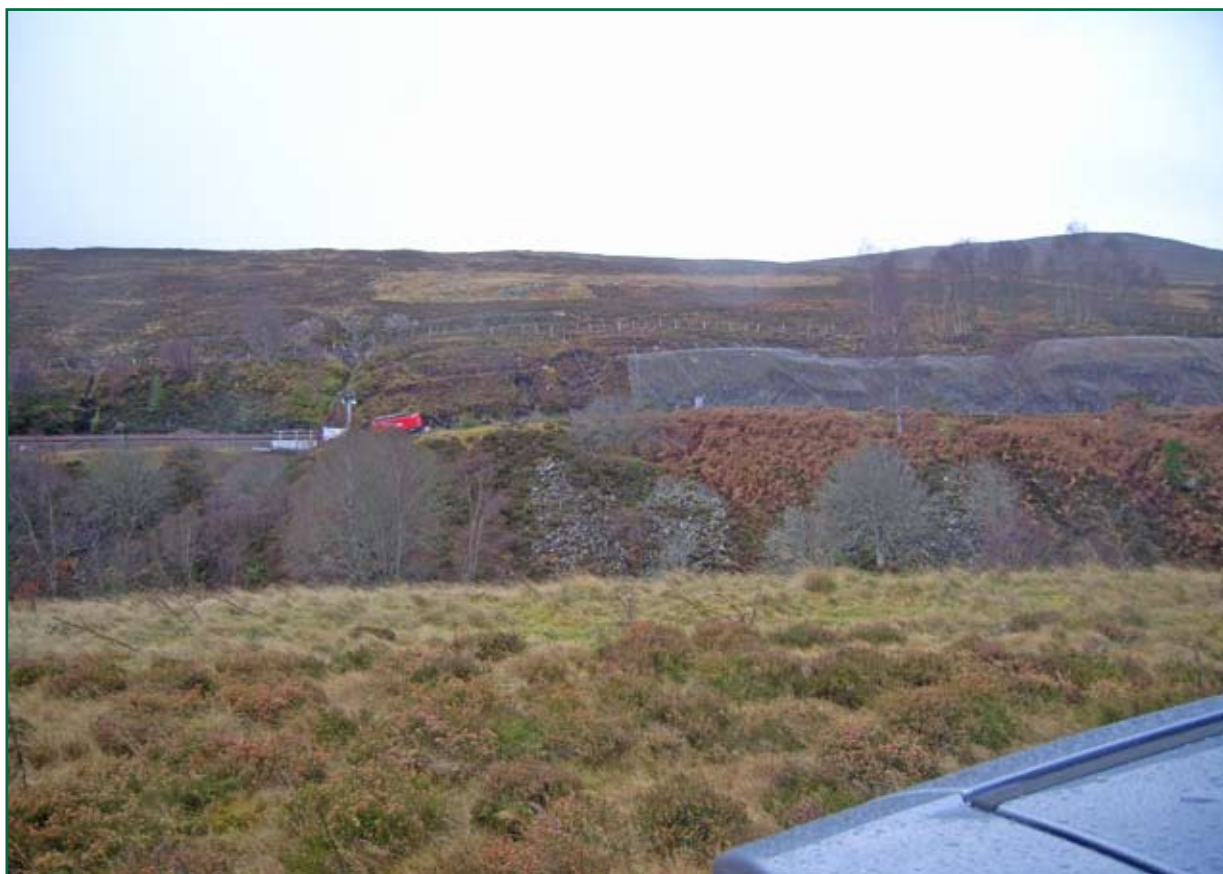
Figure 4: Incident site viewed from the opposite side of the glen

- 30 The site of the incident was in Glen Garry, 46 miles 1080 yards (74.58 km) from Perth, between Blair Atholl and Dalwhinnie stations.
- 31 The line at the incident site is on the west side of the river valley. There is no road access to this side of the valley and the nearest road-rail access point is at Red Van road rail access point, which is 2.4 miles (3.8 km) further up the valley to the north.
- 32 The site compound and messing facilities for the repair works were situated on the east side of the river and pedestrian access to the track was provided by a footbridge over the river. All plant and materials for the repair works were brought to site by rail using RRVs.

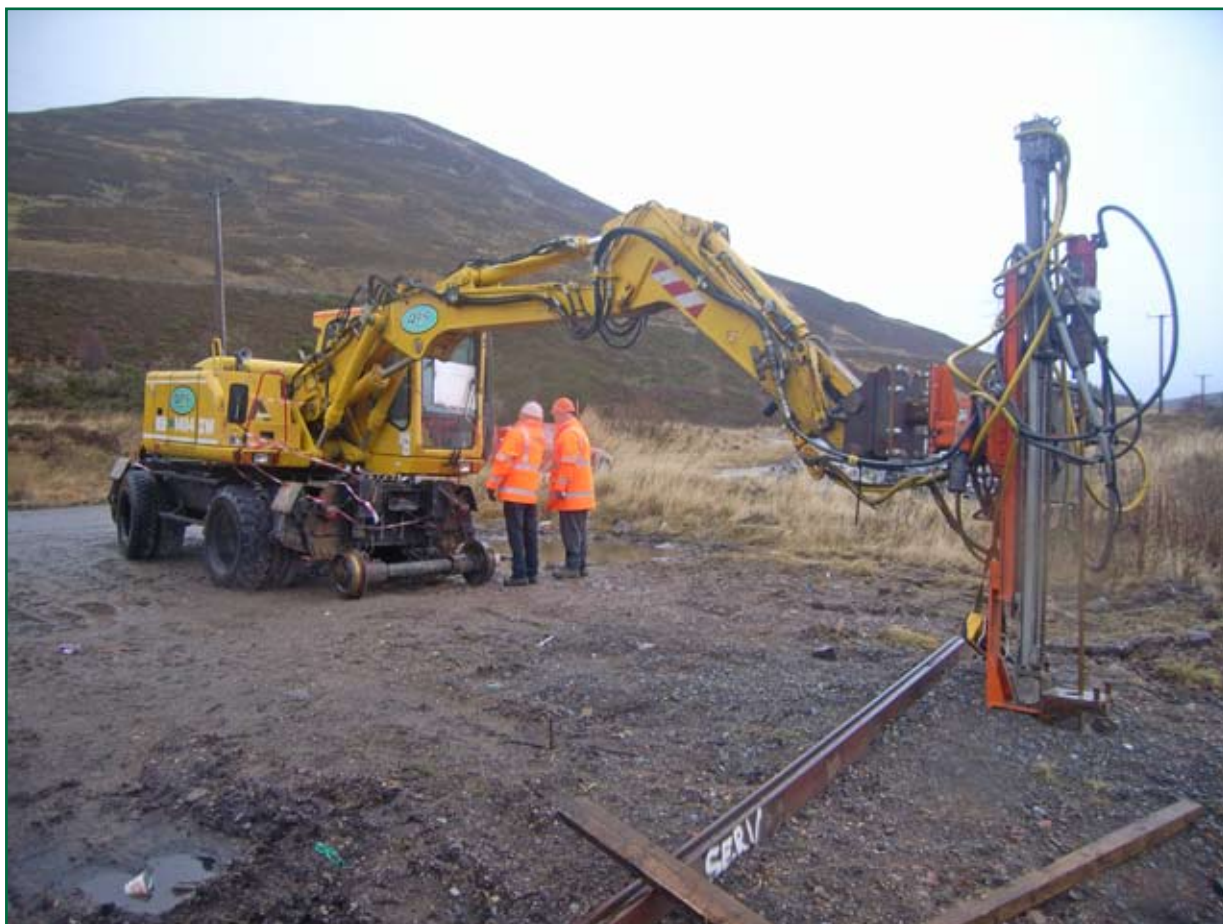
Figure 6: Atlas 1404 RRV

- 35 The stationary RRV was a '*low ride*' 360 degree wheeled excavator manufactured by Atlas (type 1404). The machine was fitted with a drilling mast and rock drill. Figure 6 shows the RRV parked at Red Van road rail access point.

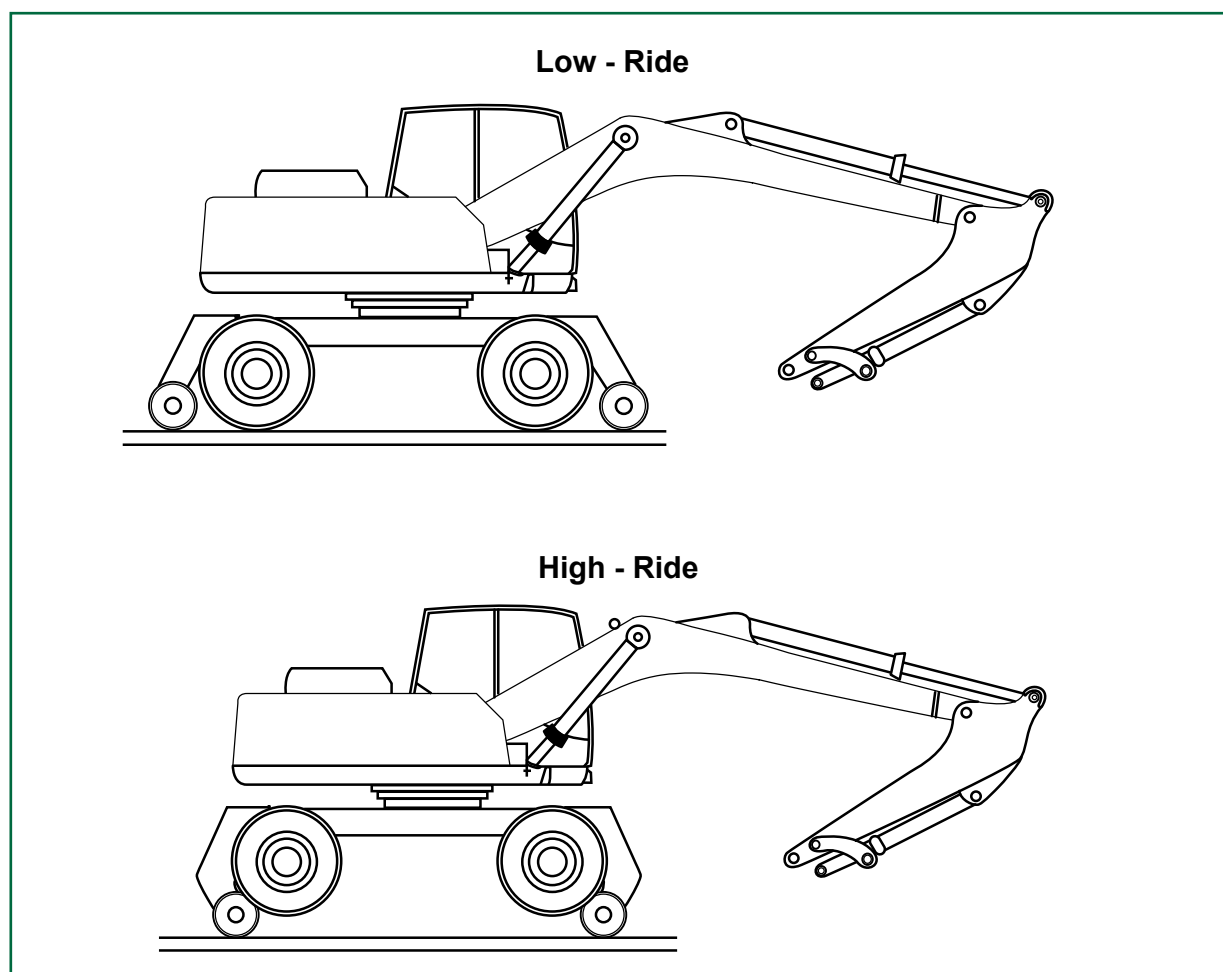
Figure 8: High ride and low ride RRV's

- 70 Prior to 1990 the most common types of RRV used were road lorries fitted with specialist rail gear for use in derailment recovery. The rail wheels fitted to these vehicles were directly powered and braked by *hydrostatic drive units*. There were also a few shunting tractors in use in sidings. These relied on friction between their rubber tyres and the rail for traction and braking and used rail wheels for guidance. Vehicles which have their rubber tyres in contact with the rails to provide traction and braking are referred to as low ride machines. The Atlas RRV involved in the Glen Garry incident was a low ride machine.

- 71 After railway privatisation, the use of RRVs expanded substantially as contractors new to the rail industry started to use them for infrastructure work. These machines were mostly converted from existing road-based machines by adding rail wheel running gear. Some of these new machines were of the low ride design but most were of the high ride type. The high ride design involves the use of idler rail wheels which are driven by friction from the road tyres. The road wheels are lifted completely clear of the rails and all traction and braking effort is transmitted by friction from the rubber tyre to the steel rail wheel, then by friction between the steel rail wheel and the rail. The Colmar RRV involved in the Glen Garry incident was a high ride machine. Figure 8 shows the principle of operation of high ride and low ride RRVs.
