Rail Accident Investigation Branch

# Rail Accident Report

**Derailment of a freight train near Moor Street  
station, Birmingham  
25 March 2008**

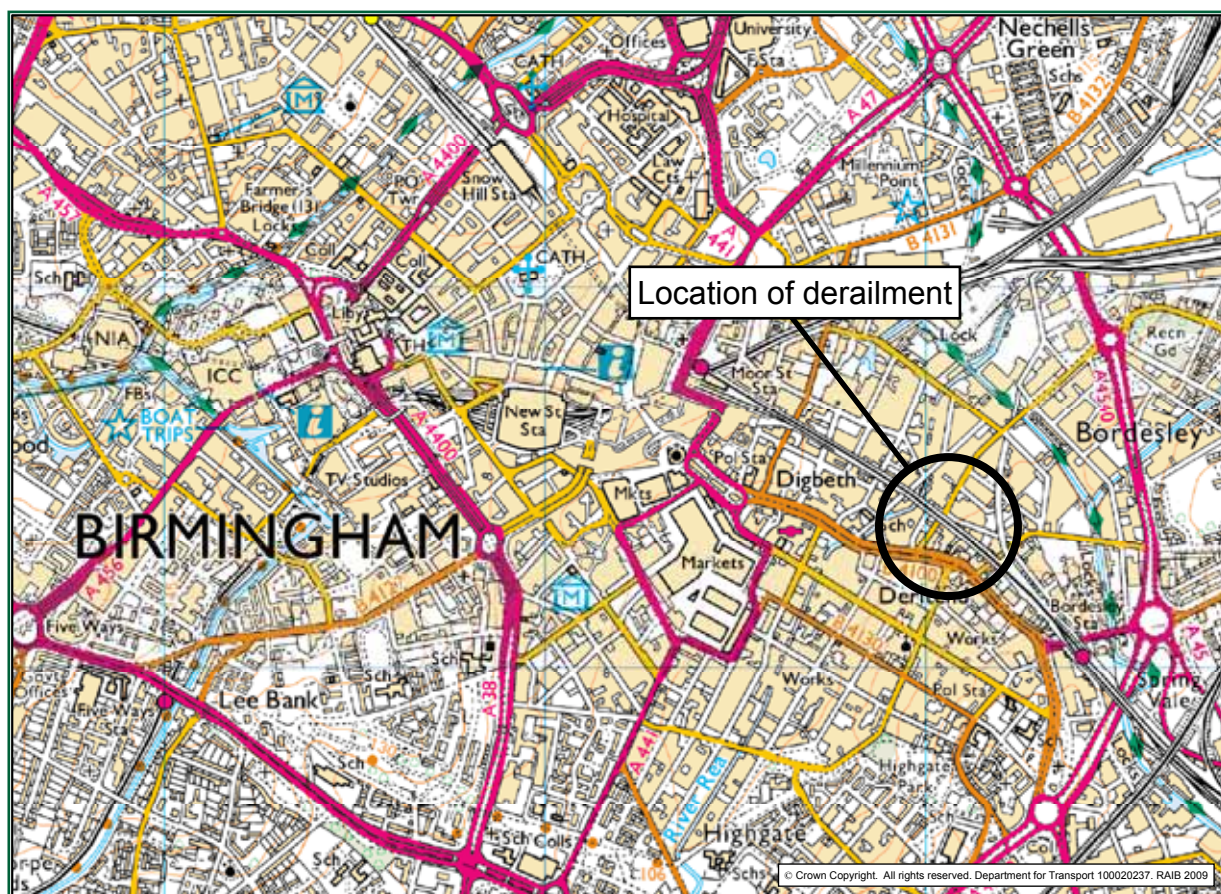
Figure 1: Location of the derailment

- 6 At 06:37 hrs on 25 March 2008 train 6M15 became derailed on *plain line* on the *up* and *down* goods line on the approach to Moor Street South junction (Figure 1). The train, the 01:46 hrs Aldwarke to Handsworth, consisted of a class 66 locomotive and 30 empty SSA four-wheel box wagons, and was travelling at 15 mph (24 km/h) at the time of the derailment.

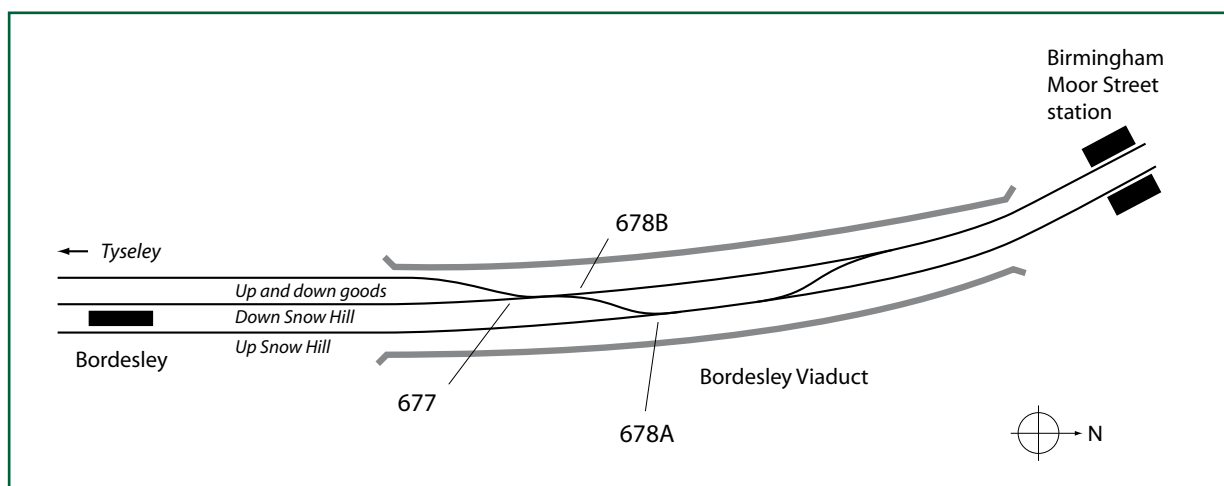
Figure 2: The track layout at Moor Street South junction

- 7 Following the initial derailment the train travelled a further 90 metres before being brought to a stand following an automatic brake application. At this point, the locomotive and leading wagons were standing on the down Snow Hill line; the wagons at the rear of the train remained on the up and down goods line. A diagram of the track layout is shown in Figure 2.
- 8 The 15<sup>th</sup> and 16<sup>th</sup> wagons were completely derailed to the left and turned onto their sides. The 14<sup>th</sup> and 17<sup>th</sup> wagons were partially derailed. All four of the derailed wagons had run derailed through 677 *points*. The 14<sup>th</sup> wagon ran with its *trailing* wheels derailed through 678B *facing points*.

- 9 There was significant damage to 677 points and some damage to 678B points, the operating equipment and *sleepers*, *baseplates* and *timbers* along the route of derailed running. A section of the adjacent viaduct *parapet* was demolished.
- 10 The 16<sup>th</sup> wagon suffered significant damage to its leading left-hand suspension assembly; the three other derailed wagons suffered less severe damage.
- 11 Rail traffic was initially stopped on all lines. The up Snow Hill line was released for *single line working* at 07:57 hrs. Repairs to the points equipment and track components were completed and normal operations recommenced on the down Snow Hill line and up Snow Hill line at 01:55 hrs on 26 March 2008.

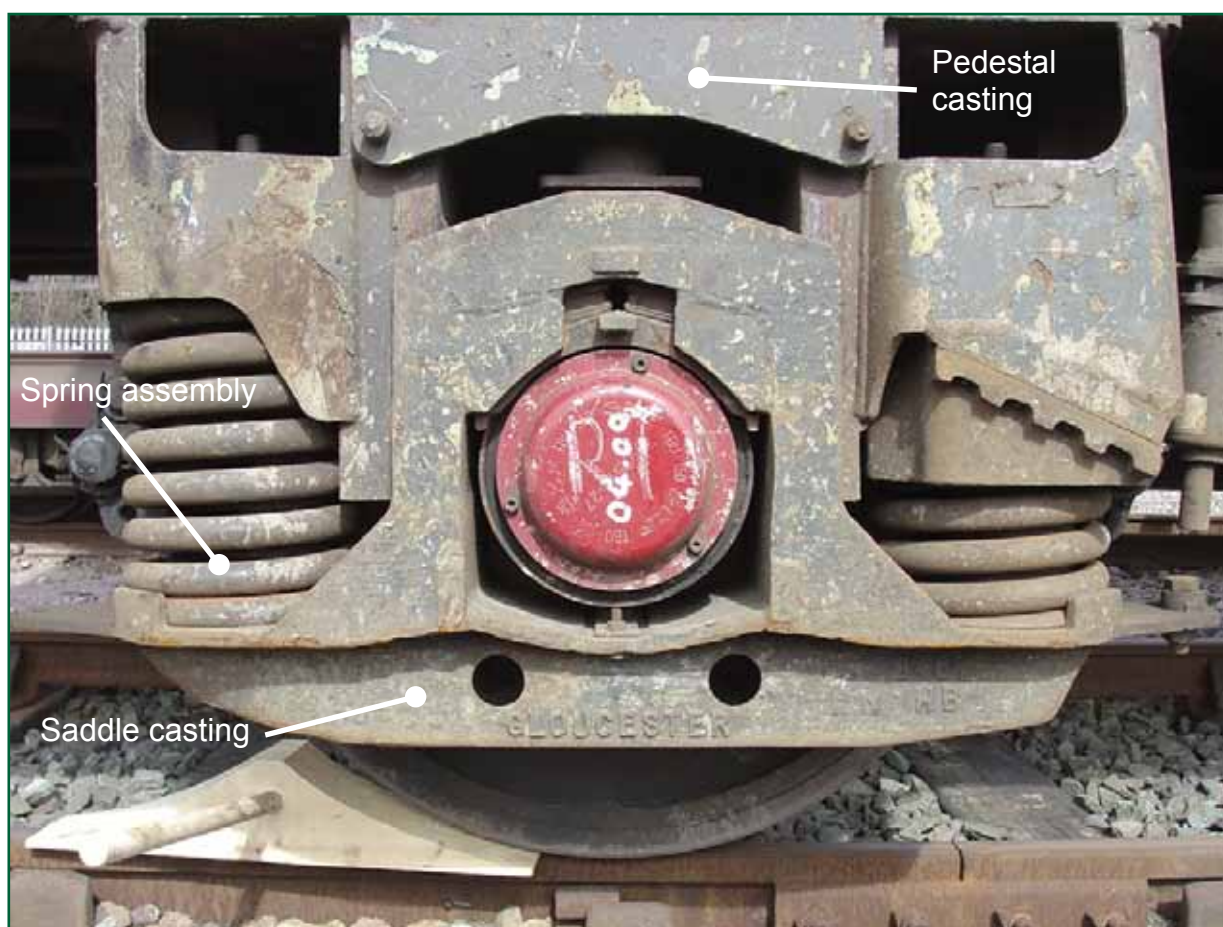
Figure 5: SSA pedestal suspension as fitted to wagon 470152

- 19 The train was formed of class 66 locomotive, 66093, and 30 empty SSA scrap carrying wagons. SSA wagons were constructed by reusing chassis from redundant hopper wagons, and attaching purpose-built box bodies. Approximately 80 such wagons are currently in service. SSA wagons operate in *block trains* delivering scrap materials from collection points to steel terminals and returning empty. A typical SSA wagon is shown in Figure 4.
- 20 The nominal *tare* weight of an SSA wagon is 15.0 or 15.5 tonnes; there are some minor construction variations. The suspension is a *pedestal* system using multiple coil springs and friction damping. The arrangement is shown in Figure 5.
