Rail Accident Report

**Derailment near Exhibition Centre station,
Glasgow
3 September 2007**

Derailment near Exhibition Centre station, Glasgow, 3 September 2007

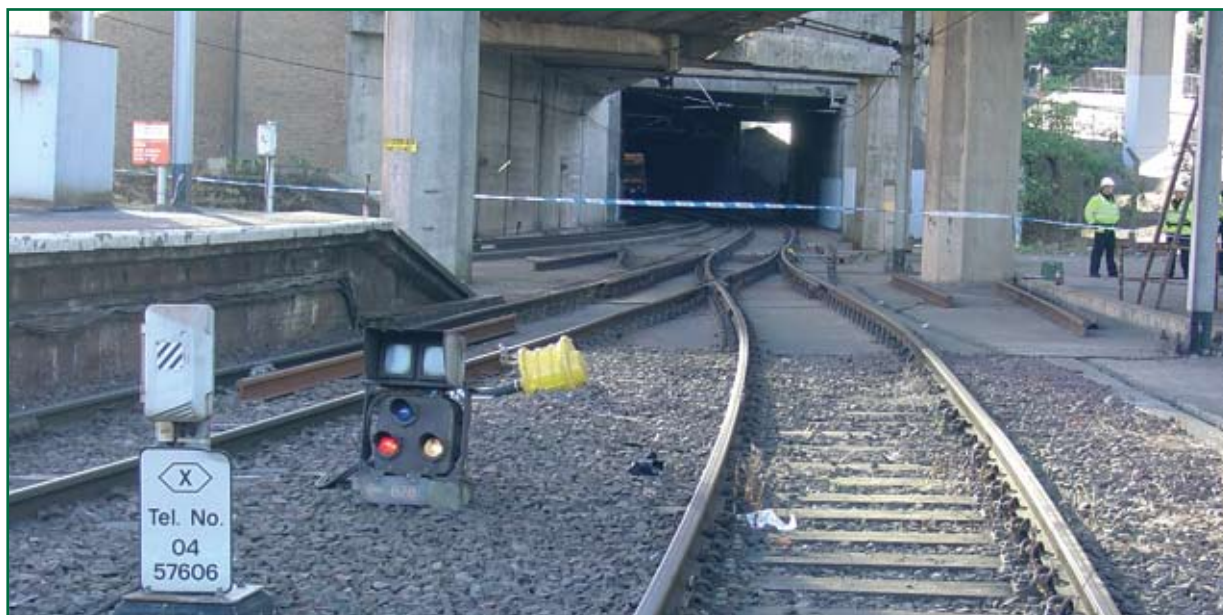
Figure 4: Photograph of the start of the slab track section at Exhibition Centre station, looking towards Anderston and the western portal of Stobcross Tunnel. This is shown as location 4 on Figure 3

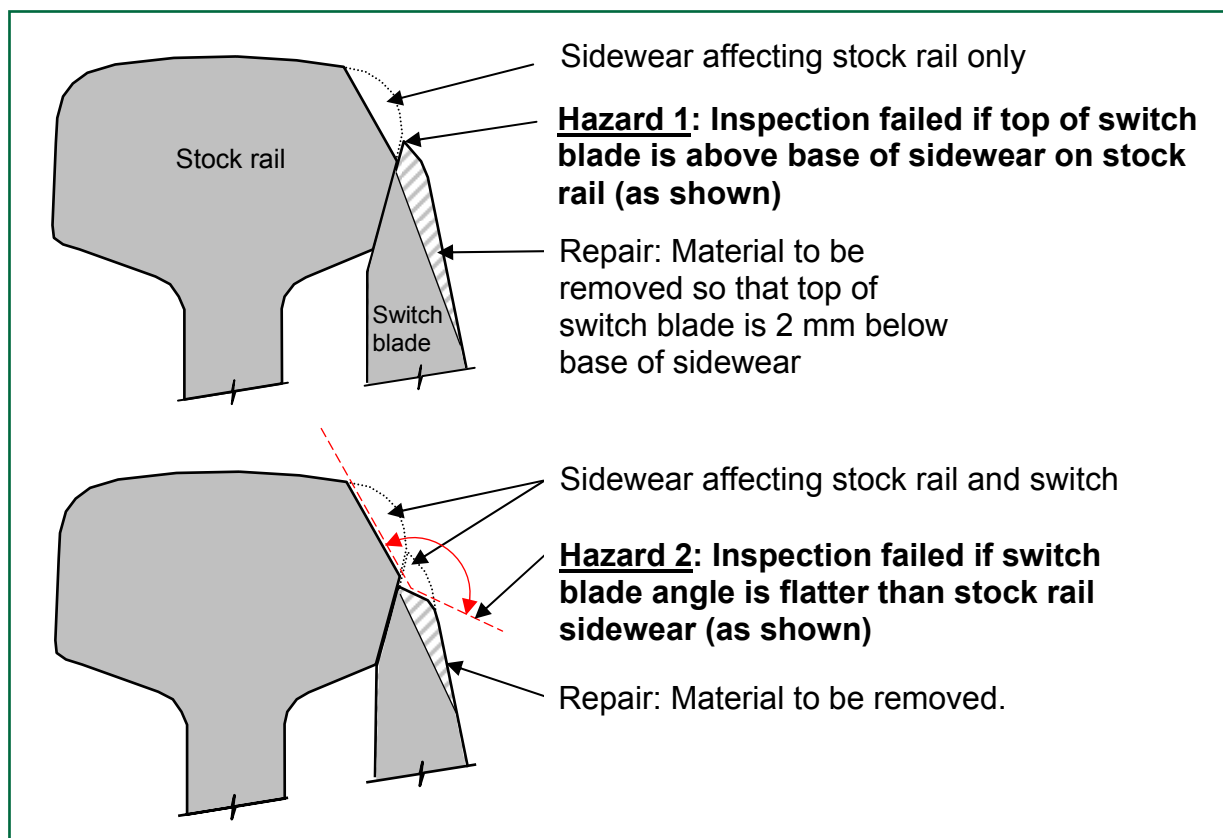
- 78 Following the visual identification of a possible hazard, or as part of a detailed inspection, the assessment of derailment hazards 1 and 2 (Appendix D) is undertaken by visually comparing the height and profile of a switch blade relative to its stock rail; hazard 1 exists if the top of the switch blade is above the base of any sidewear visible on the stock rail, and hazard 2 exists if the angle of the switch blade face is shallower than the sidewear on the adjacent stock rail and less than 60° to the horizontal following reprofiling (Figure 8). A derailment hazard is avoided if the contact point between the flange of the wheel and the rail does not present a ramp for a wheel flange to climb.

Figure 8: Illustration of derailment hazards 1 and 2 as defined by standard NR/SP/TRK/053 (issue 3)

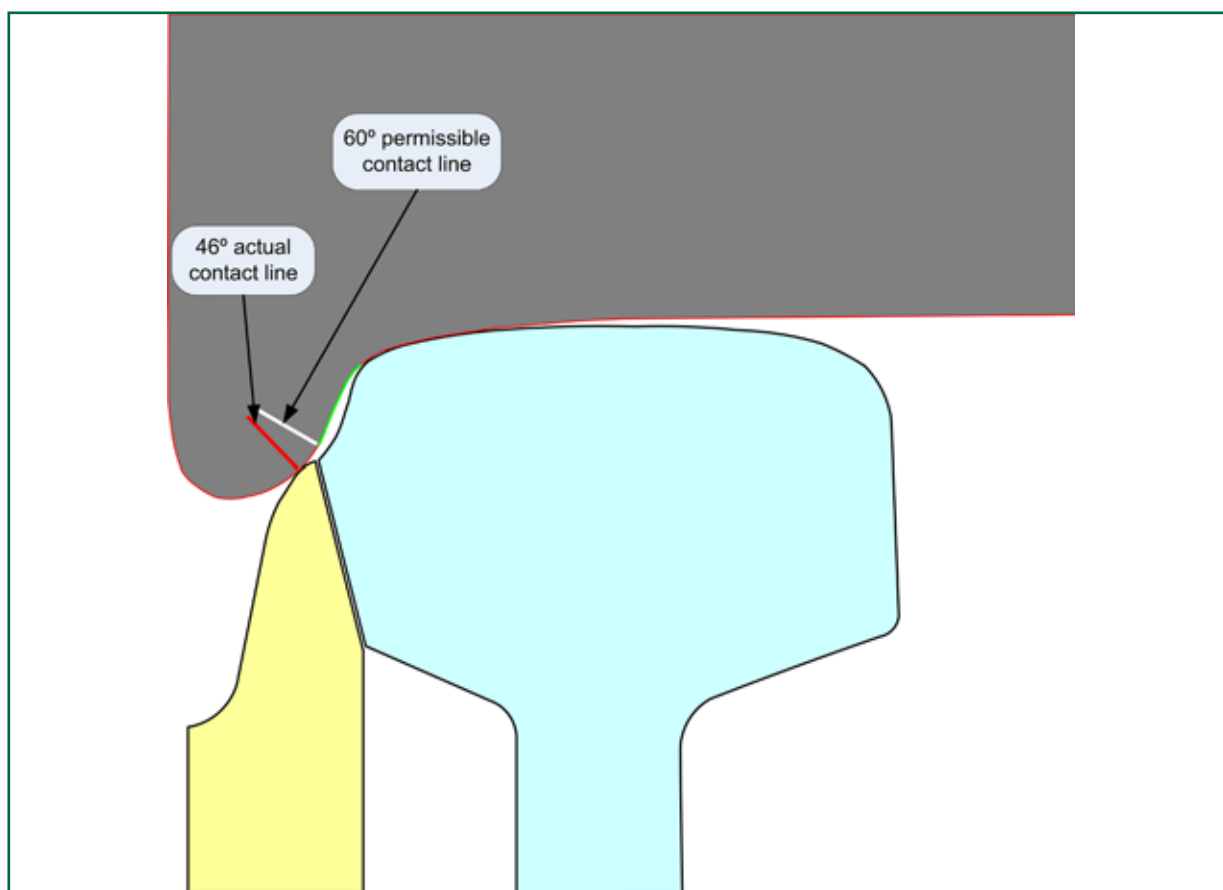
- 91 Although the training was delivered the inspectors later misinterpreted how the TGP8 gauge should be used (paragraph 95).
- 92 The national introduction date for the TGP8 gauges was in the spring of 2006; its use was made mandatory by Letter of Instruction NR/BS/LI/063 from 20 December 2006. It reached the Area Track Engineer – Scotland West on 21 December 2006 and was briefed out on 26 January 2007.

Figure 13: Diagram showing the correct use of the TGP8 gauge (not to scale)

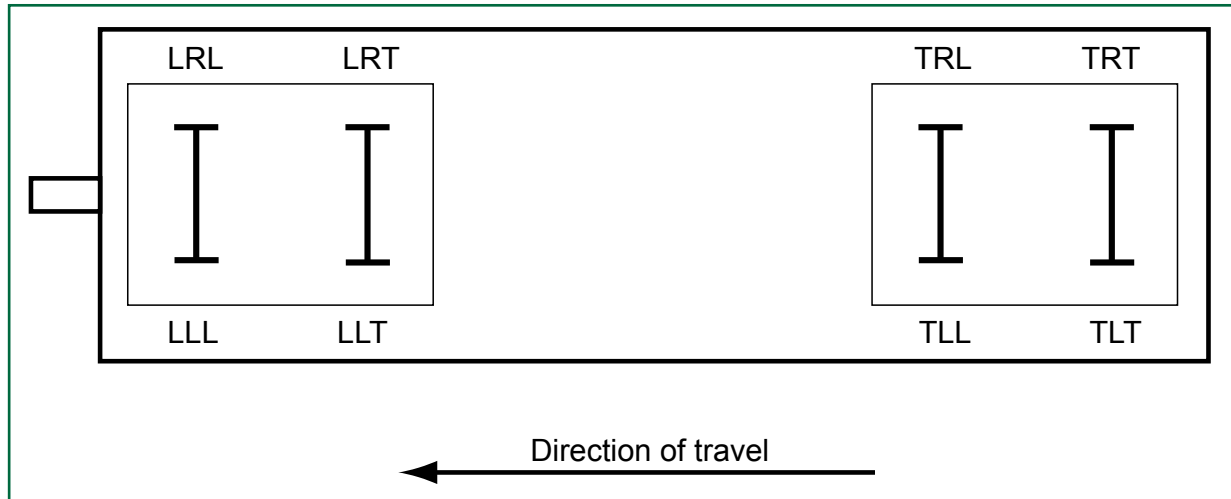
- 103 There was some damage sustained by all the wheels as a result of the derailment.
- 104 Certain wheel profiles on coach 77244 showed flange face wear and a discontinuity where the thinning of the flange met the normal profile of the flange tip. Figure 16 shows the nomenclature used for wheelset identification. The discontinuities were found on the wheels in positions LRL, LLL, LRT, LLT and TRT wheels.

Figure 16: Nomenclature used in describing the bogies and wheelsets of vehicle 77244 (example: LRT is Leaming bogie, Right-hand side Trailing wheel)
