Rail Accident Report

**Signal passed at danger and subsequent
near miss at Didcot North junction
22 August 2007**

Signal passed at danger and subsequent near miss at Didcot North junction, 22 August 2007

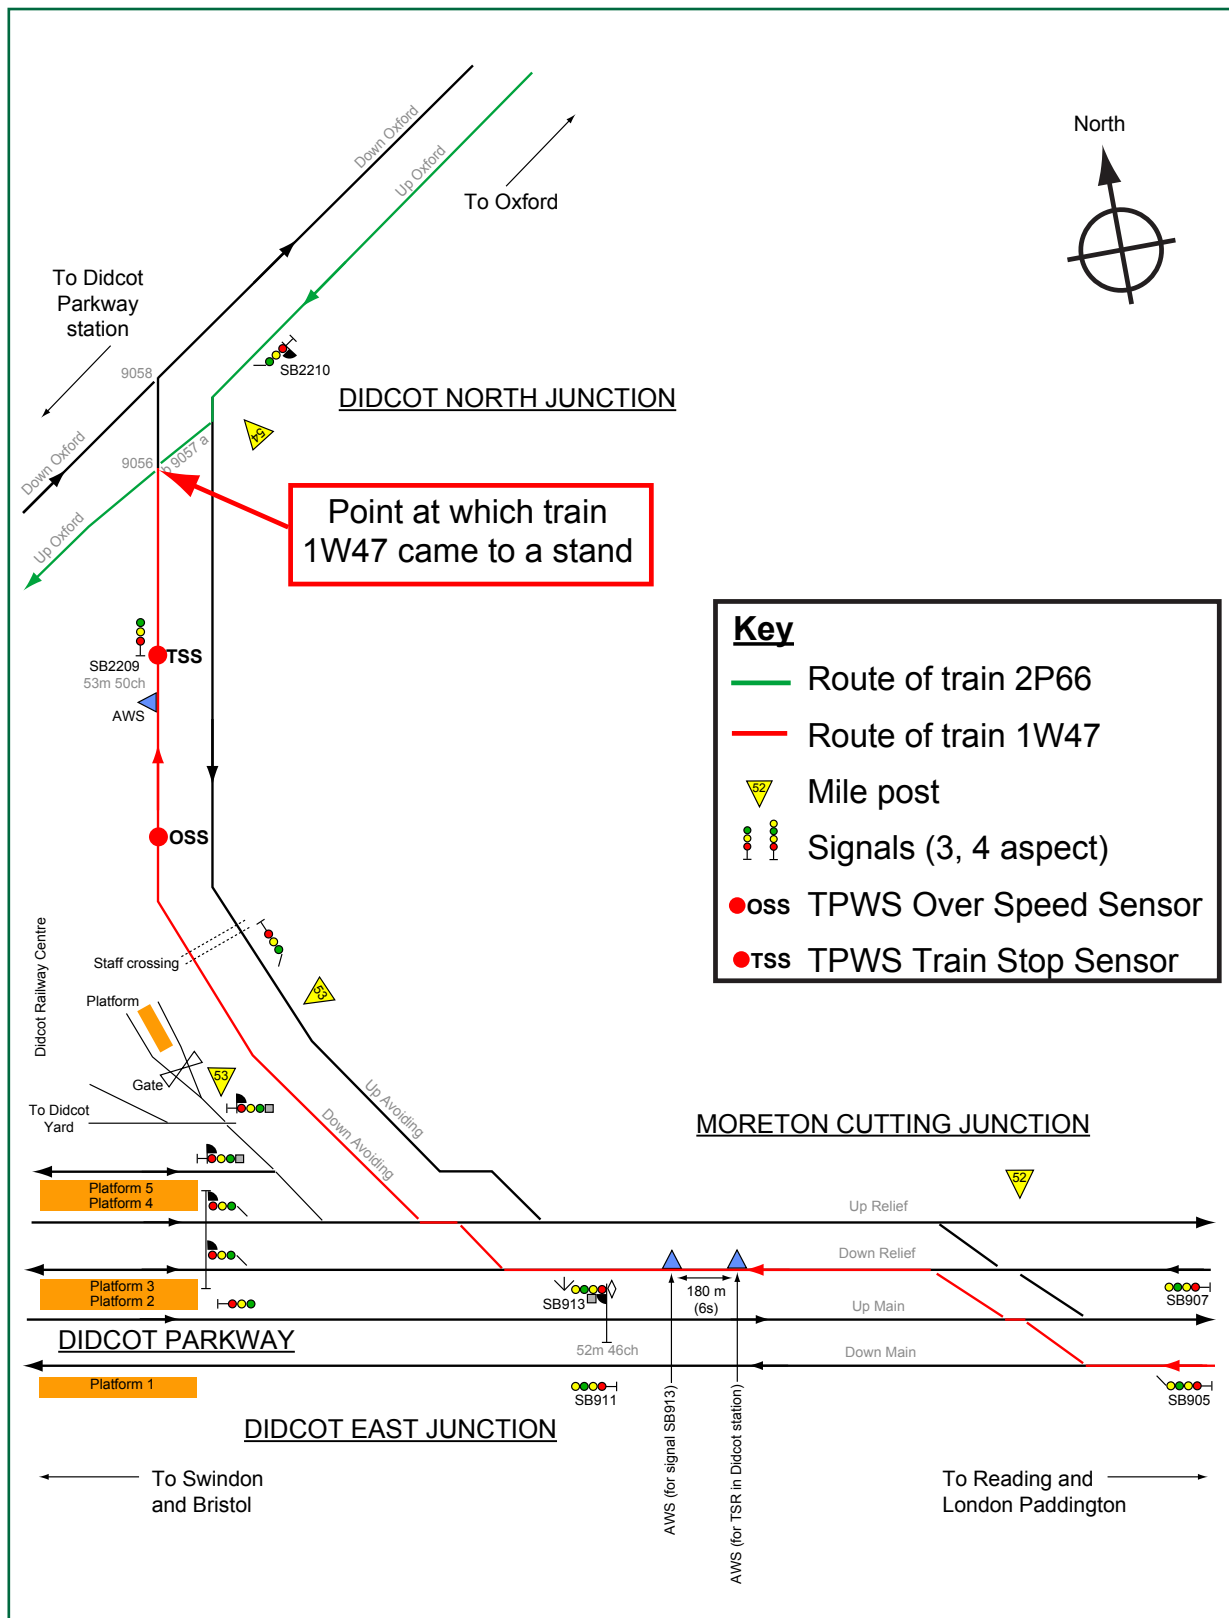
Figure 5: Layout of track and signalling equipment, and the routing of the trains involved in the incident

- 27 The lines in and around Didcot Parkway station are signalled using track circuits and conventional line side signalling. Running signals on the main and relief lines east of Didcot are of the *four aspect* type. The remainder of the signals, including those on the Avoiding and Oxford lines, are of the *three aspect* type. The key characteristics of the signals involved in this incident are shown in Table 1.

- 28 These signals are controlled from the Swindon Signalling Control Centre. All of the route setting involved in the incident was commanded by the *Automatic Route Setting* system located at the Signalling Control Centre.

- Signal SB2209 becomes visible to the driver at a distance of about 400 m. This equates to 13 seconds at 70 mph (113 km/h).
- The track layout at Didcot North junction creates a potential for a head-on collision between northbound trains and those southbound trains that are being routed across the junction towards the Up Oxford line (Figure 5). There is also the potential for a collision to occur between passenger and freight trains. Conflicting freight train movements include loaded coal trains bound for Didcot power station and elsewhere.
- The *overlap* of signal SB2209 is 185 m in length (although compliant with the standards that applied at the time of installation, recent schemes have tended to adopt a longer dimension of 225 m). The fouling point is located only 16 m beyond the end of the overlap giving a total safe overrun distance of 201 m.

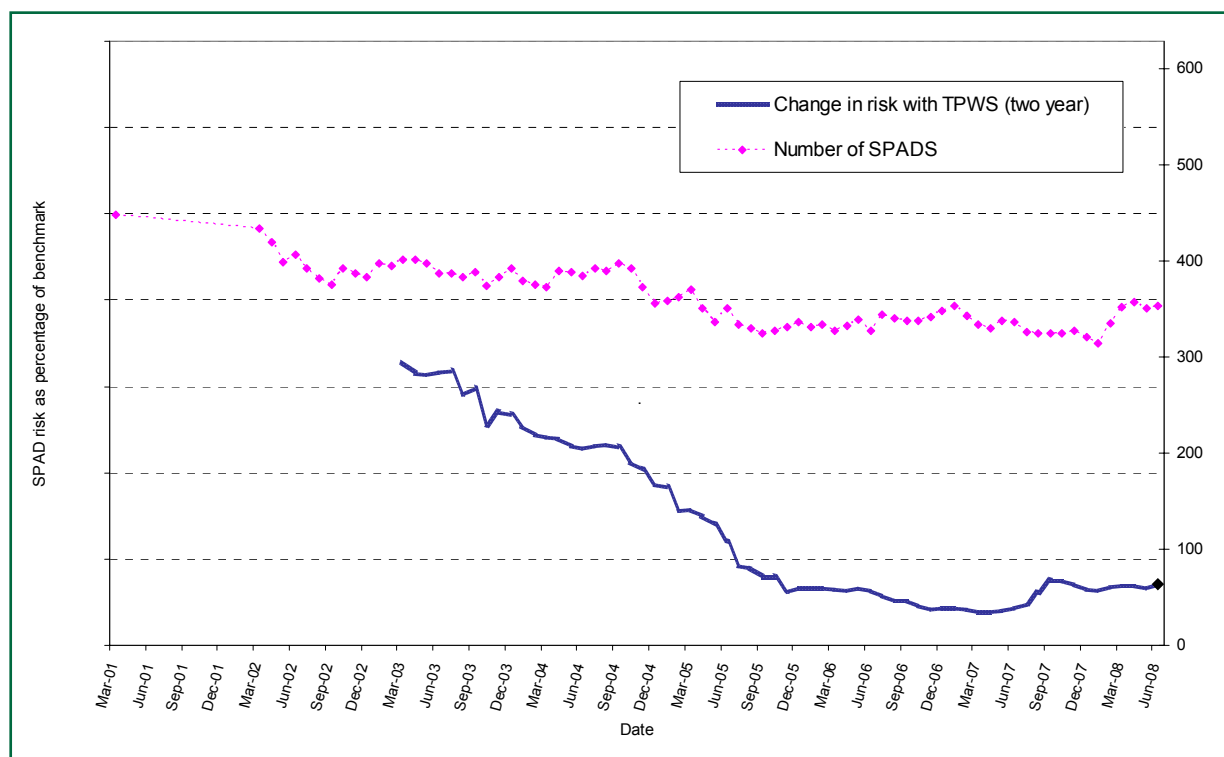
Figure 7: Change in SPAD risk over time

- 84 By the time of the collision at Ladbroke Grove, detailed development and testing of a new system, TPWS, was already ongoing, although the extent of its installation had still to be decided.
- 85 Full-scale installation of TPWS at numerous junctions and high risk locations commenced in 2001 and was completed in the early part of 2004. Since the installation of TPWS there has been a 22 % reduction in the number of SPADs and an estimated 86 % reduction in the overall risk (see Figure 7). This reduction is due in large part to the installation of TPWS but also reflects factors such as driver management, improved train performance and crashworthiness.
