# Rail Accident Report

## **Derailment of a freight train at Carrbridge, Badenoch and Strathspey 4 January 2010**

# **Derailment of a freight train at Carrbridge, Badenoch and Strathspey, 4 January 2010**

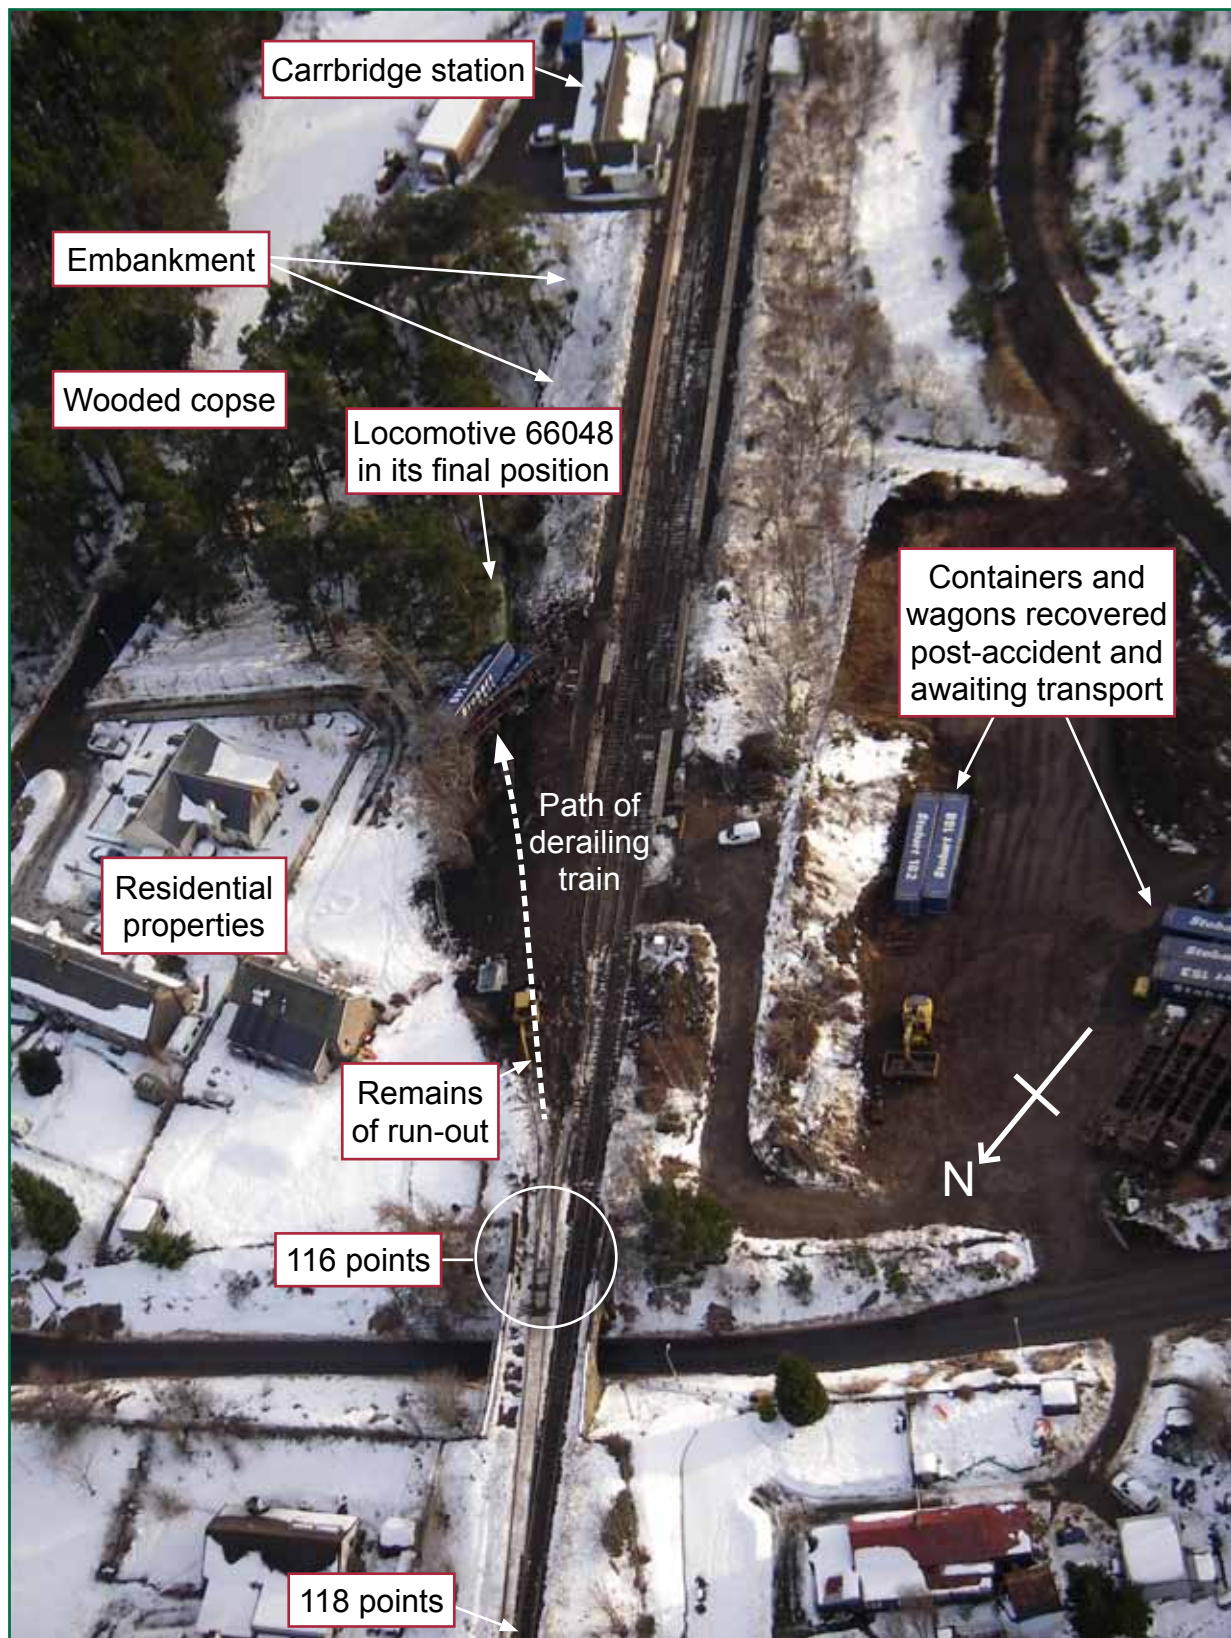
- 6 The train came to rest amongst trees on an embankment east of the railway, close to some houses (see figure 2). The locomotive and the front six 'twin' wagons (each wagon consisting of two element vehicles) derailed and they, and their container loads, came to rest in a number of locations including in the gardens of the houses and foul of the running lines through Carrbridge station. The rear four wagons (eight elements) did not derail or lose their containers.
- 7 The driver and technician onboard the train suffered minor injuries. Damage was caused to private property, the station platform, the *permanent way*, signalling equipment and the locomotive, wagons and containers which derailed.

Figure 2: Aerial view of Carrbridge from the north during post-accident recovery operations (image courtesy of the Ministry of Defence)

- 190 Four houses are located east of the loop at Carrbridge station (see figure 2). Three of these houses were formerly railway properties built around the time of the construction and opening of the railway in 1898. A fourth house was built in the early 2000's<sup>42</sup>. Some of these houses lie close to the potential path of a train derailing from the run-out at Carrbridge. Derailed wagons and containers from 4N47 came to rest within the gardens of two of them, including the newest property, on 4 January 2010.

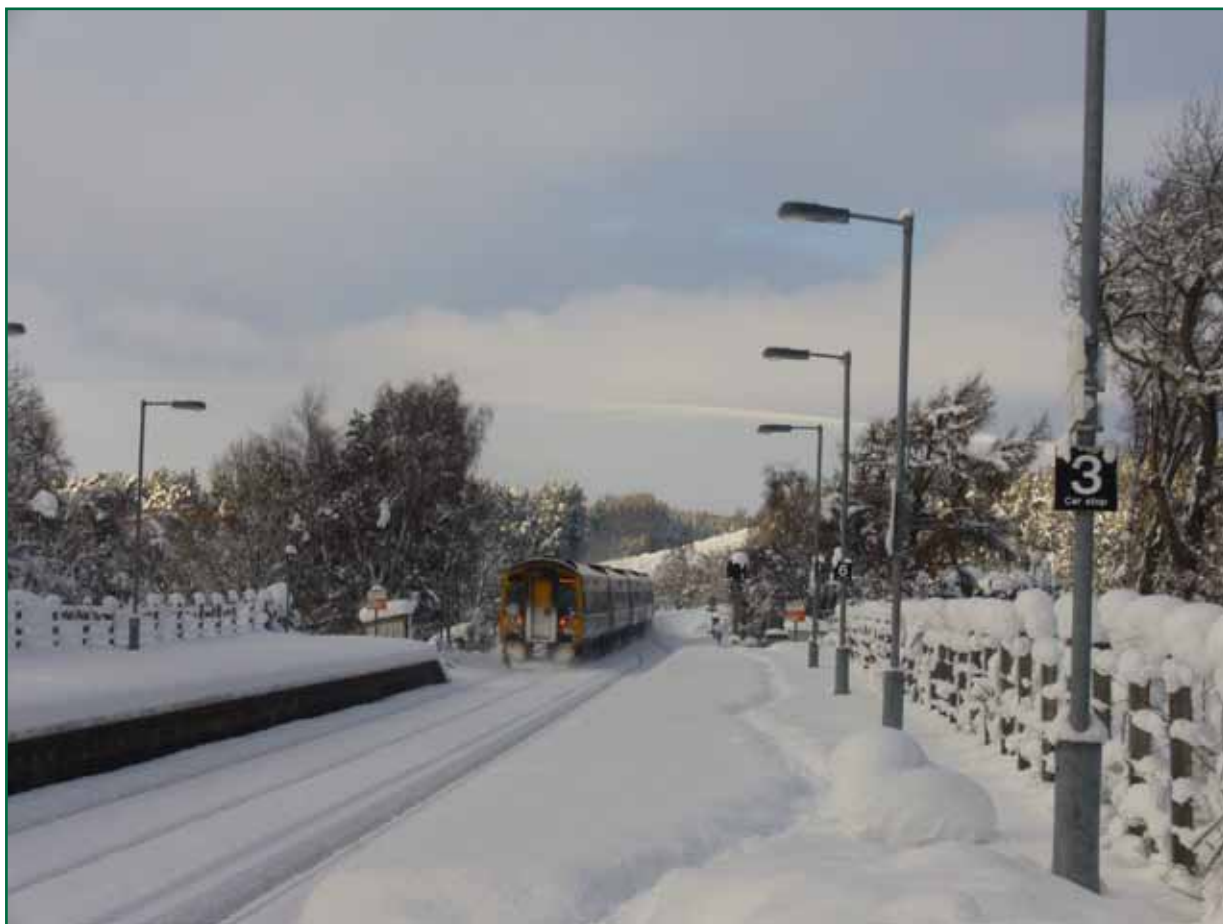
- 16 Lying snow had been present in the area of the journey since mid-December 2009 (see figure 3). By 4 January 2010 the depth of lying snow<sup>3</sup> on the line from Inverness to Carrbridge was between 300-400 mm, around 150-250 mm above rail height<sup>4</sup>.

Figure 3: View towards the north end of Carrbridge station on 2 January 2010 (image courtesy of Roy Brown)

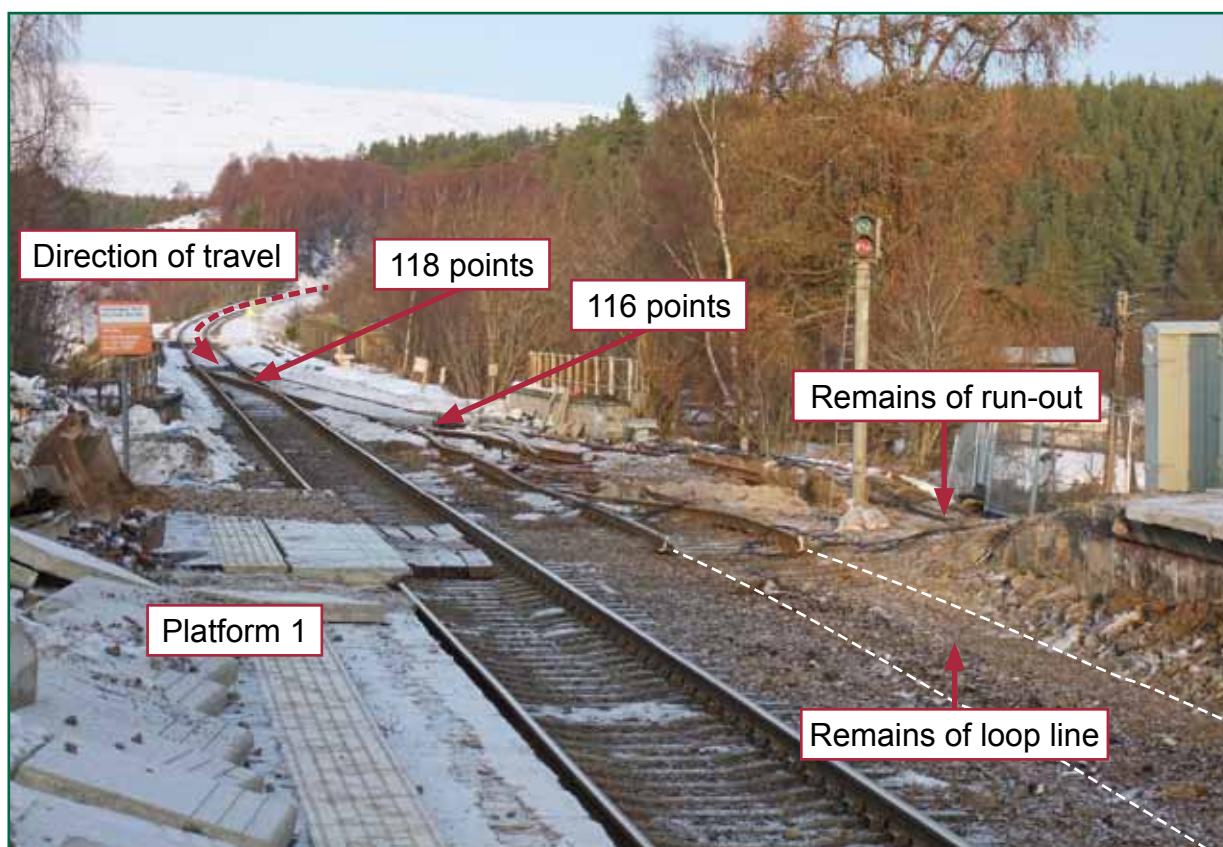
Figure 7: View of the north of Carrbridge station taken whilst post-accident repair work was ongoing (image courtesy of Trevor Roots).

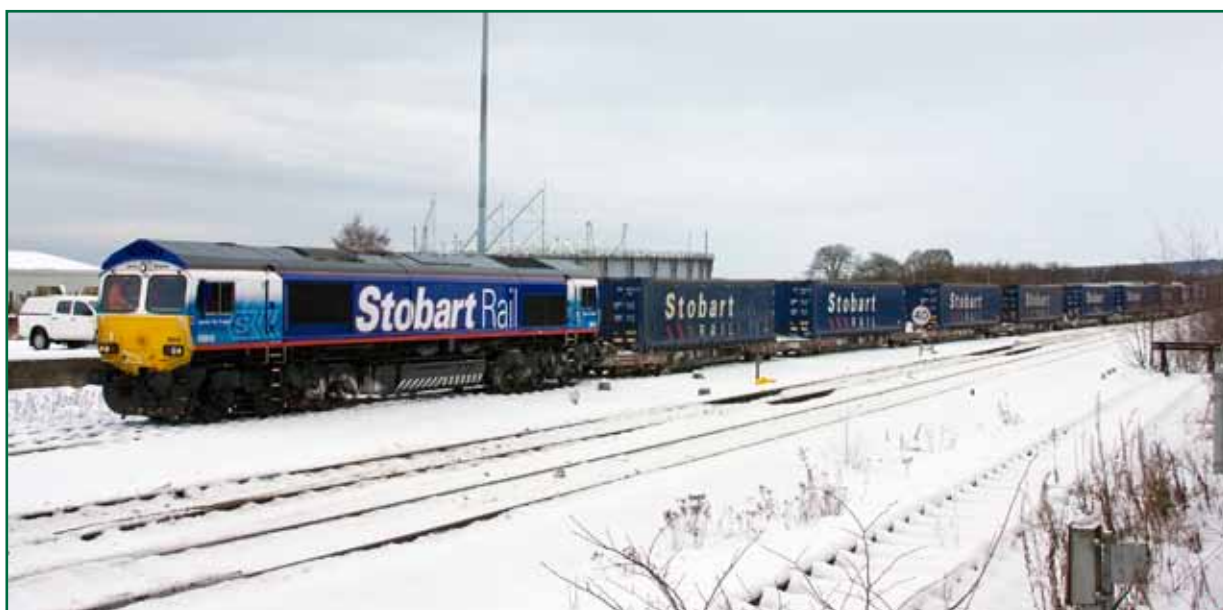
- 42 At 11:00 hrs train 4H47 arrived at Inverness Millburn Yard, 82 minutes late (see figure 8). On arrival the train crew did not report any problems relating to the train's braking during the journey. The train was split into two portions and shunted in order to allow loaded containers to be exchanged with empty ones. These portions were then reformed to make train 4N47. Staff working in the yard scraped ice from the *solebar* and *spigots* of some of the wagons. No ice or snow was reported as being in the brake rigging, wheels or brake blocks, although almost all of the brake rigging on an FKA wagon is hidden when the wagon is viewed from a standing position. While shunting was underway a new driver arrived to take over the train. He booked on, checked for *engineering notices* and then completed the shunting. It was this driver, along with the existing technical rider, who would form the crew of train 4N47.

Figure 8: Train 4H47 on arrival at Inverness Millburn Yard on 4 January 2010 (image courtesy of Steven Robertson)

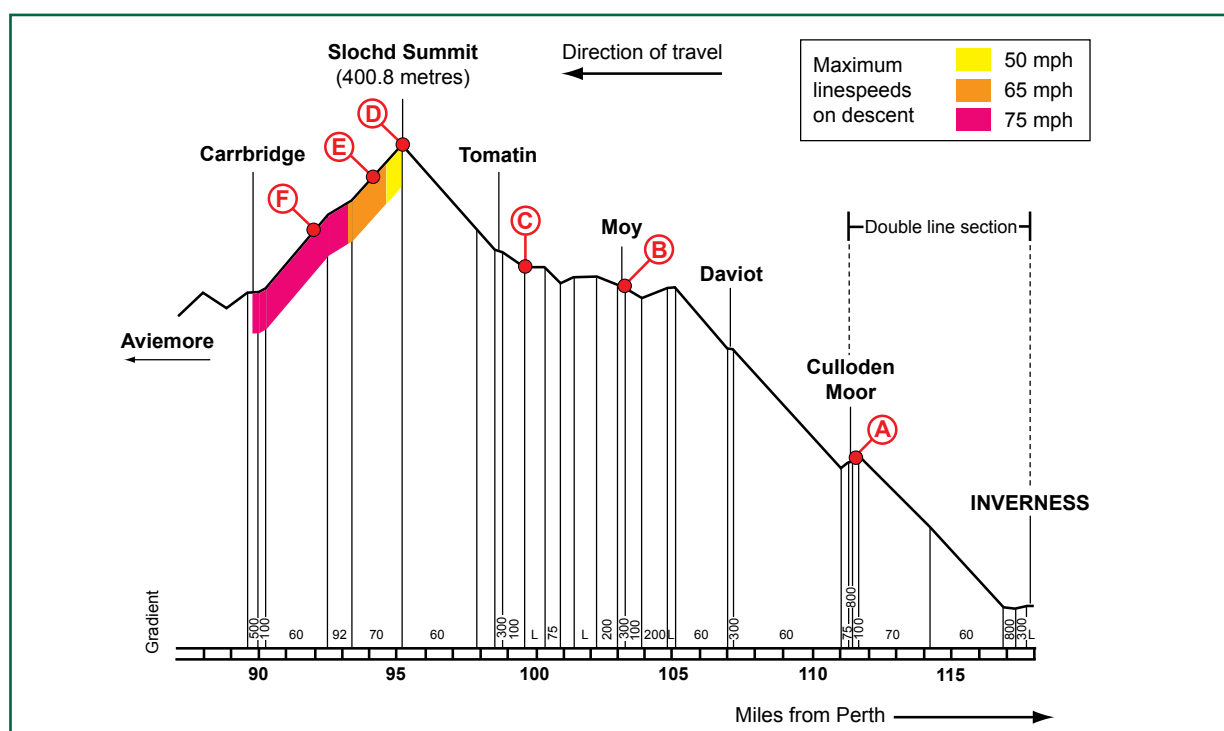
- 49 At 15:45 hrs, train 4N47 passed through Moy at 50 mph (80 km/h) (Point B on figure 10). The driver made an *initial application* of the automatic brake lasting 10 seconds with the locomotive's throttle at its maximum setting of 8. There was no reduction in train speed during this brake application. It had been 28 minutes since the train's brakes had previously been operated.

- 50 At 15:49 hrs, train 4N47 was continuing to climb towards the summit at 51 mph (82 km/h). Prior to passing through Tomatin (Point C on figure 10), the driver made another initial application of the automatic brake of 10 seconds duration, again with the throttle set at 8. There was no reduction in train speed during this brake application, which came four minutes after the previous one and which was the last undertaken on the ascent. The driver's later recollection was that he had made a brake application on or near the summit in order to slow the train down for the approaching PSR and that the brakes had functioned correctly. The OTDR recorded no brake application being made at or near the approach to the summit.

- 53 At 15:59 hrs the train was descending towards Carrbridge at 44 mph (Point E on figure 10) when the driver shut-off the throttle and made an initial application of the automatic brake which lasted 21 seconds. Train speed increased slightly during this brake application, which came 10 minutes after the final one made during the ascent.

Figure 10: Key events during passage of 4N47 between Inverness and Carrbridge on 4 January 2010

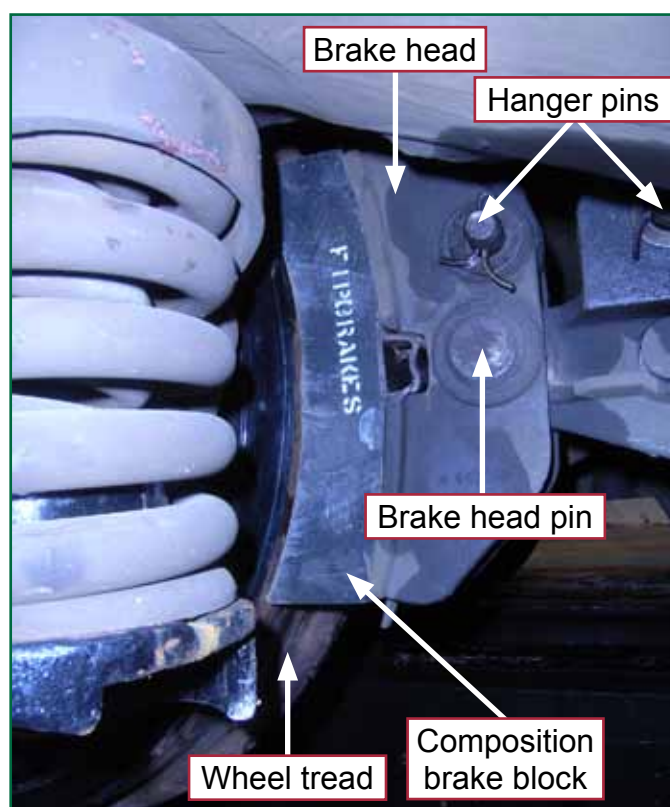
- 90 Snow and ice ingress between the brake block and the wheel tread can reduce the effective coefficient of friction for the portion of the block affected when it is applied to the wheel tread. This would in turn reduce the total braking force being generated to retard the wheel.
- 91 Photographs of the train taken in the hours following the derailment show that, on some of the wagons which did not derail, the brake blocks, brake heads, suspension springs and underframe were coated in a layer of snow, ice and slush. In some cases a thin layer of ice and snow could also be seen between the lower portion of the brake block and the wheel tread (see figures 13, 14 and 15).

Figure 13: Photograph of the brake block, brake head, suspension springs and underframe of an FKA wagon without a coating of ice or snow

- 93 The brake heads (which hold the brake blocks) on FKA wagons are connected to the brake beam via a mounting pin (see figure 13). This arrangement gives the brake block a limited ability to pivot so that it can apply a uniform contact to the face of the wheel tread during normal braking applications<sup>19</sup>. Analysis undertaken by the RAIB has showed that, if the lower portion of the brake block is prevented from moving towards the wheel tread by an obstruction (such as a significant build up of ice or snow), then the block will pivot to apply the upper edge of the brake block face to the wheel tread<sup>20</sup>.
