Rail Accident Investigation Branch

# Rail Accident Report

## Track worker fatality at Ruscombe Junction 29 April 2007

## 29 April 2007

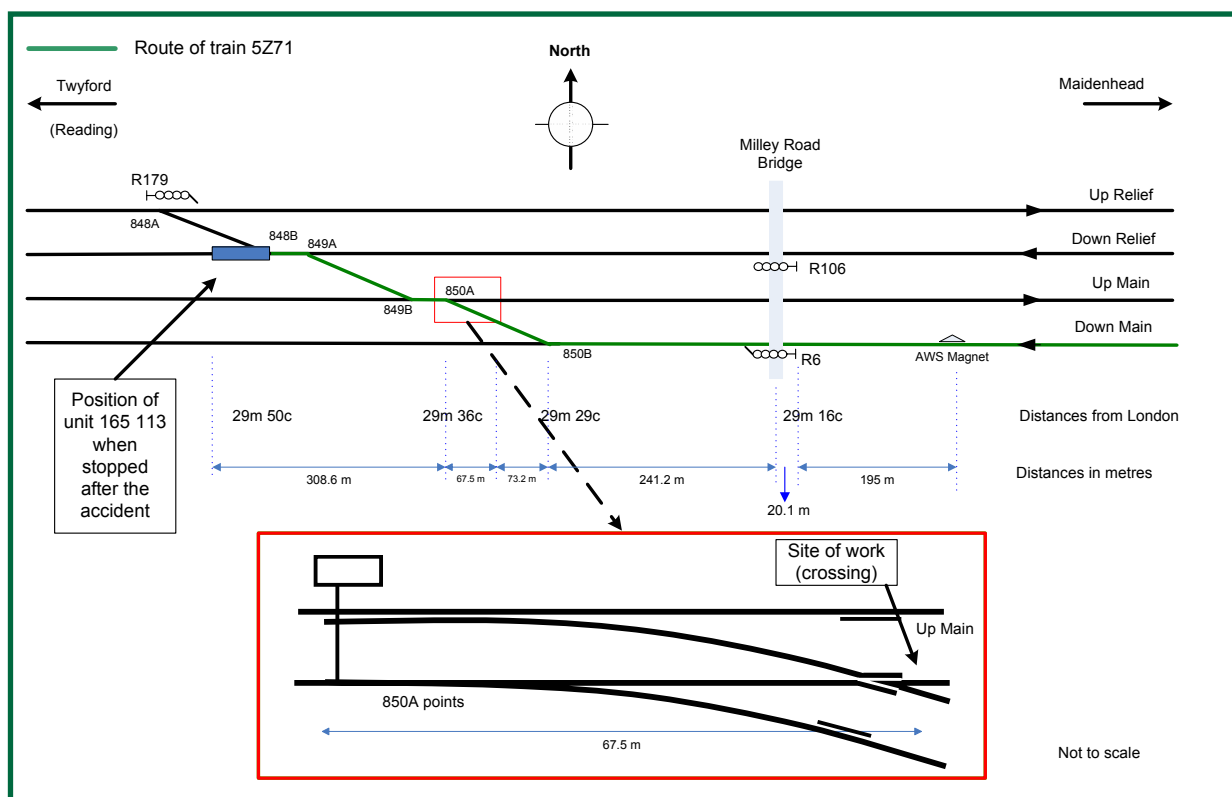
Figure 2: General layout of Ruscombe Junction, showing route of train 5Z71 in green

- 24 The highest permitted speed on the main lines is 125 mph (200 km/h).
- 25 The highest permitted speed on the relief lines is 75 mph (120 km/h).
- 26 The four lines are connected at Ruscombe Junction by three high speed crossovers. Each crossover is formed by a pair of points and a short interconnecting section of track such that trains are able to transfer from one track to another (Figures 2 and 3).

- 131 As the driver passed over the *Automatic Warning System* (AWS) magnet at signal R6, (195 metres on the approach to signal R6 - Figure 2), he applied the brake in order to slow his train to the authorised speed for the junction of 70 mph (112 km/h). While the train was braking he noticed some track maintenance staff working on the track ahead. The train had decelerated to a speed of 68 mph (109 km/h). He noticed that one of the group was welding.

- 170 The Air Ambulance helicopter was deployed by the South Central Ambulance Service, NHS Berkshire Division, as part of the emergency response to the accident. The helicopter arrived at Ruscombe Junction at approximately 11:35 hrs and landed approximately 100 m from the site of the accident, (between Milley Bridge and 850B points) across the down and up main railway lines (Figure 2).

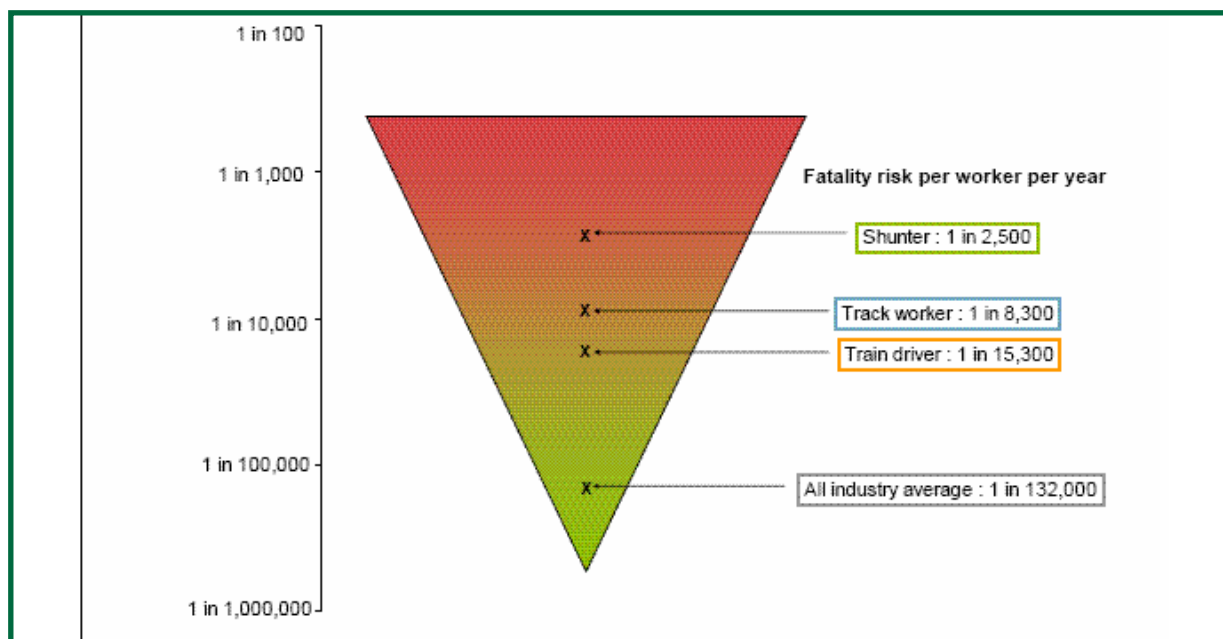
- 68 Track workers are subject to levels of risk well in excess of the average for all workers in the railway industry. The RSSB Annual Safety Performance Report (provisional) for 2006 concludes that the risk of fatality per track worker per year is 1 in 8,300 (Figure 4). This compares to 1 in 15,300 for train drivers and 1 in 132,000 average for all workers in the industry.

Figure 4: Levels of individual risk (extract from the RSSB Annual Safety Performance report)

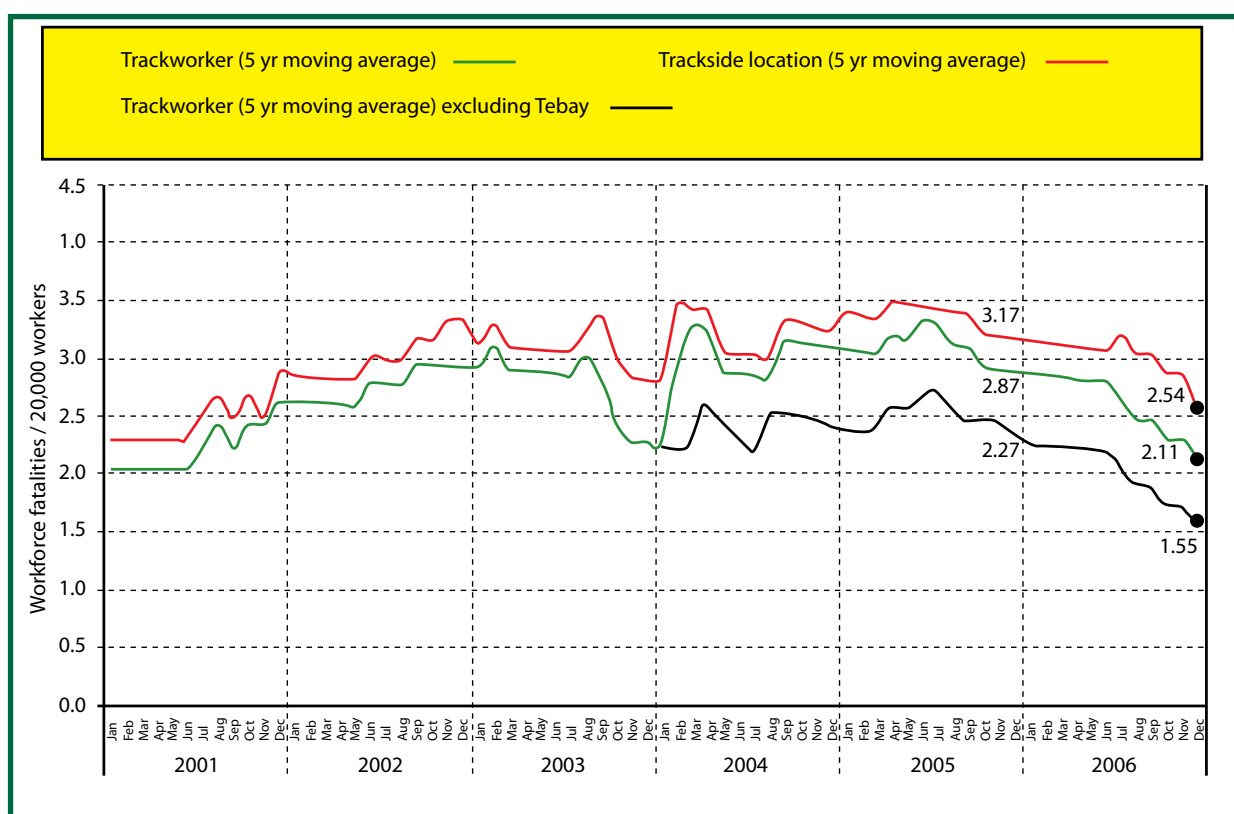
- 69 Statistics provided by the RSSB show that the 5-year moving average track worker fatality rate (normalised by staff numbers) for 2006 was roughly similar to that in 2001 (Figure 5). However, this average was influenced by the four fatalities that occurred in 2004 as a direct consequence of a criminal act at Tebay. If the impact of this single event is excluded from the data, the track worker fatality rate is calculated to have fallen by 25 per cent between 2001 and 2006.

Figure 5: Track worker fatality rates normalised by staff numbers (data provided by RSSB)
