Rail Accident Report

Signal passed at danger at Stafford
26 April 2012

Report 16/2013
September 2013

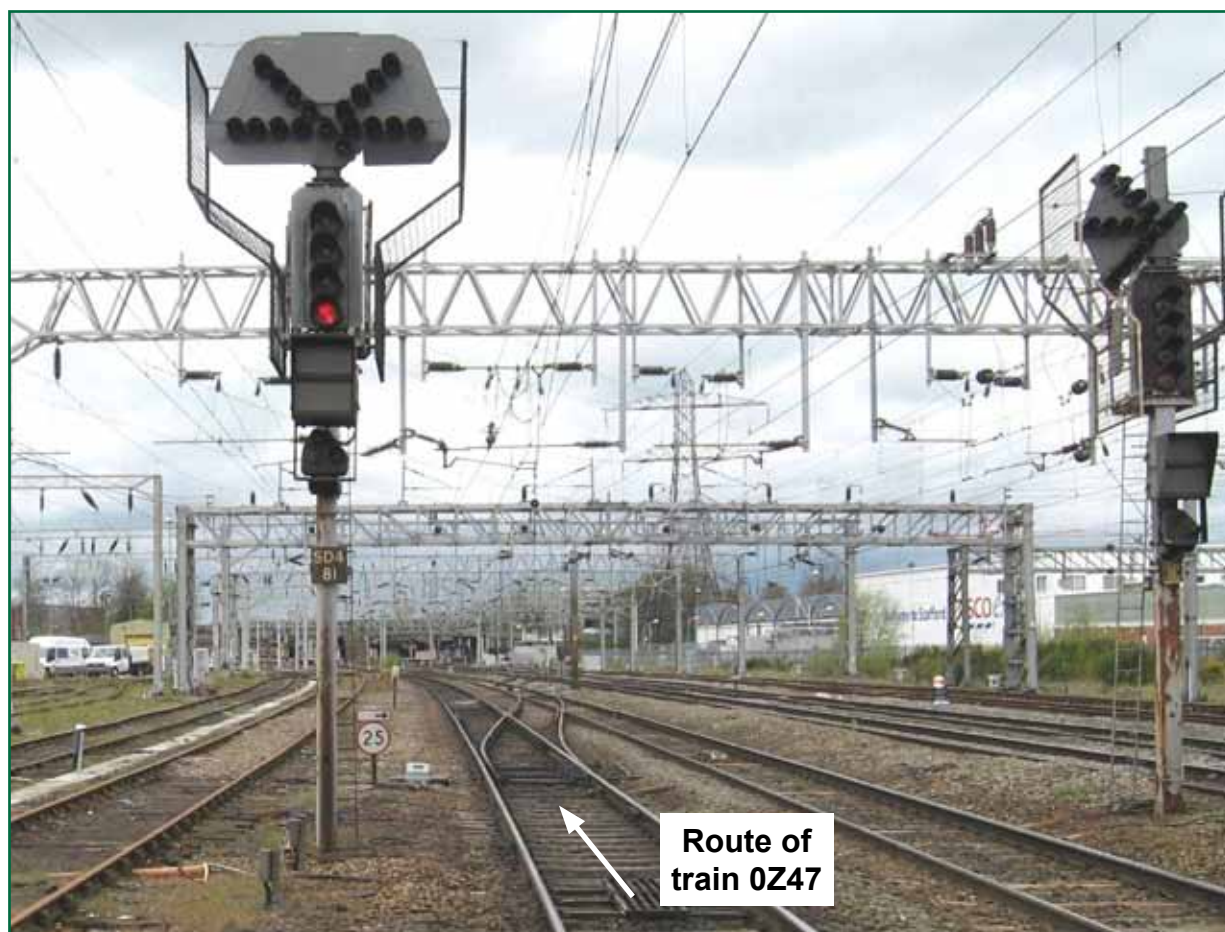
Figure 2: Signal SD4-81

- 7 Signal SD4-81 is classified as a *multi-SPAD signal*, situated on the approach to Stafford station on the *Down Slow* line of the West Coast Main Line, figure 2. The *permissible speed* at this location is 60 mph (97 km/h). Signalling in the area is controlled from Stafford No. 4 signal box.
- 8 The locomotive approached Stafford on the Bushbury to Stafford (Grand Junction) line¹, before joining the West Coast Main Line at Trent Valley Junction No. 1, figure 3. The permissible speed on the Down Birmingham line² reduces from 90 to 60 mph (145 to 97 km/h) shortly before the junction.

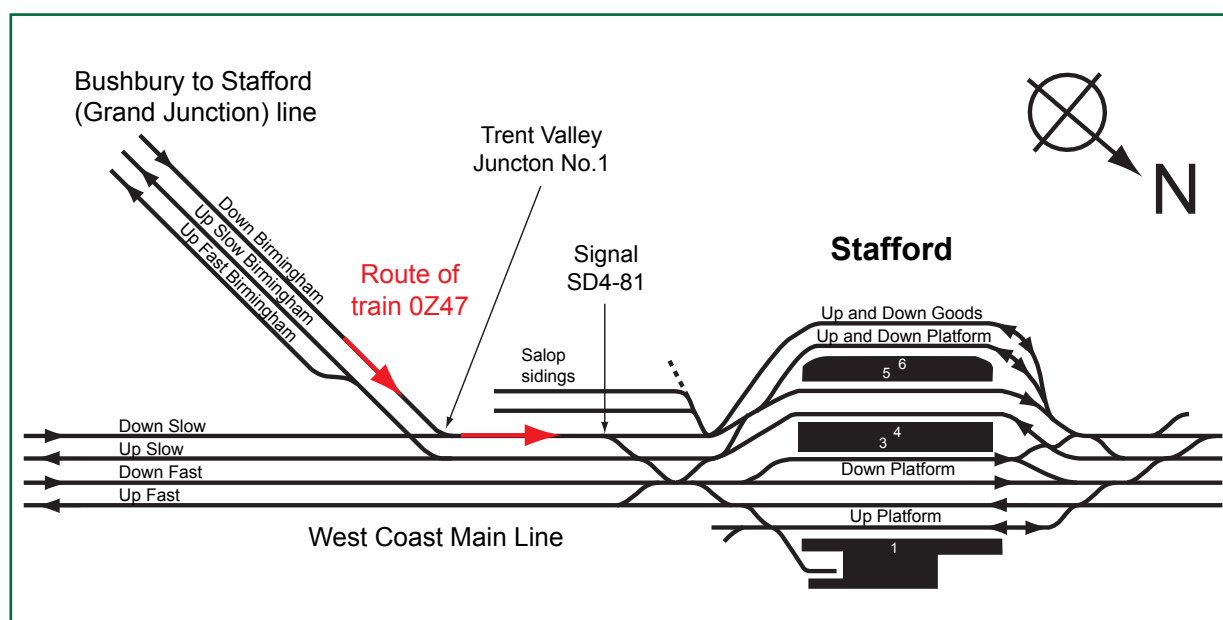
Figure 3: Track layout

- 30 The driver and technician state that DCR management initially instructed them to continue their journey to Crewe. However, they alleged that the brakes on the locomotive were defective, and the technician contacted an independent engineer from URS⁶; arrangements were then made for him to come to Stafford to examine the locomotive. Locomotive 47843 was then moved into platform 6 at Stafford station, and was later stabled nearby in the Salop sidings (figure 3).

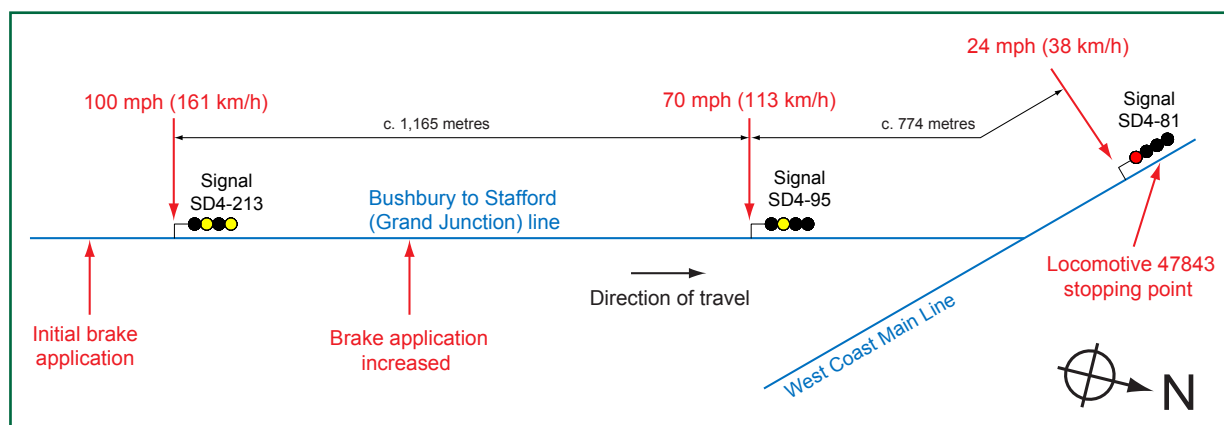
Figure 6: Diagram showing the approach of locomotive 47843 to Stafford

- 28 The driver made a partial brake application as the locomotive approached signal SD4-213, which was displaying a double yellow (*'preliminary caution'*) aspect, (figure 6); the brake application was increased 16 seconds later. The locomotive subsequently passed signal SD4-95, which was displaying a single yellow (*'caution'*) aspect, at approximately 70 mph (113 km/h) and signal SD4-81, which was displaying a red (*'danger'*) aspect at approximately 24 mph (38 km/h).
