Rail Accident Investigation Branch

Rail Accident Report

**Dangerous occurrence at Lindridge Farm user
worked crossing, near Bagworth, Leicestershire
22 March 2012**

Report 11/2013
July 2013

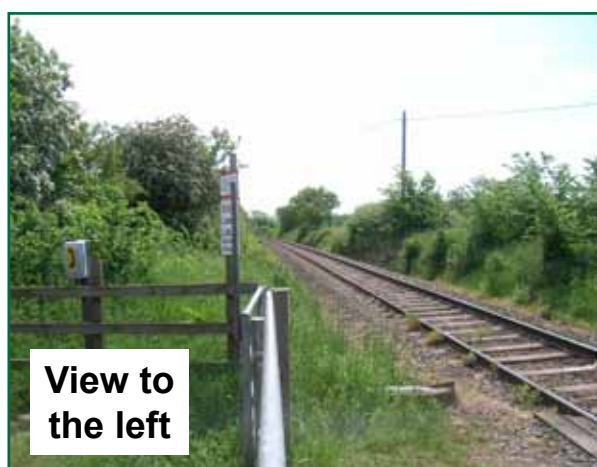
Figure 5: The view of approaching trains in both directions from the gate on the side of the crossing that the motorist approached

- 18 The crossing is located on a curve in the railway (figure 5). The motorist approached from the inside of the curve. From the gate on this side, in clear conditions and in daylight, trains approaching from the right (from the Bagworth Junction direction) can be seen about 250 metres from the crossing, while trains approaching from the left (from the Knighton Junction direction) can be seen from about 230 metres away.

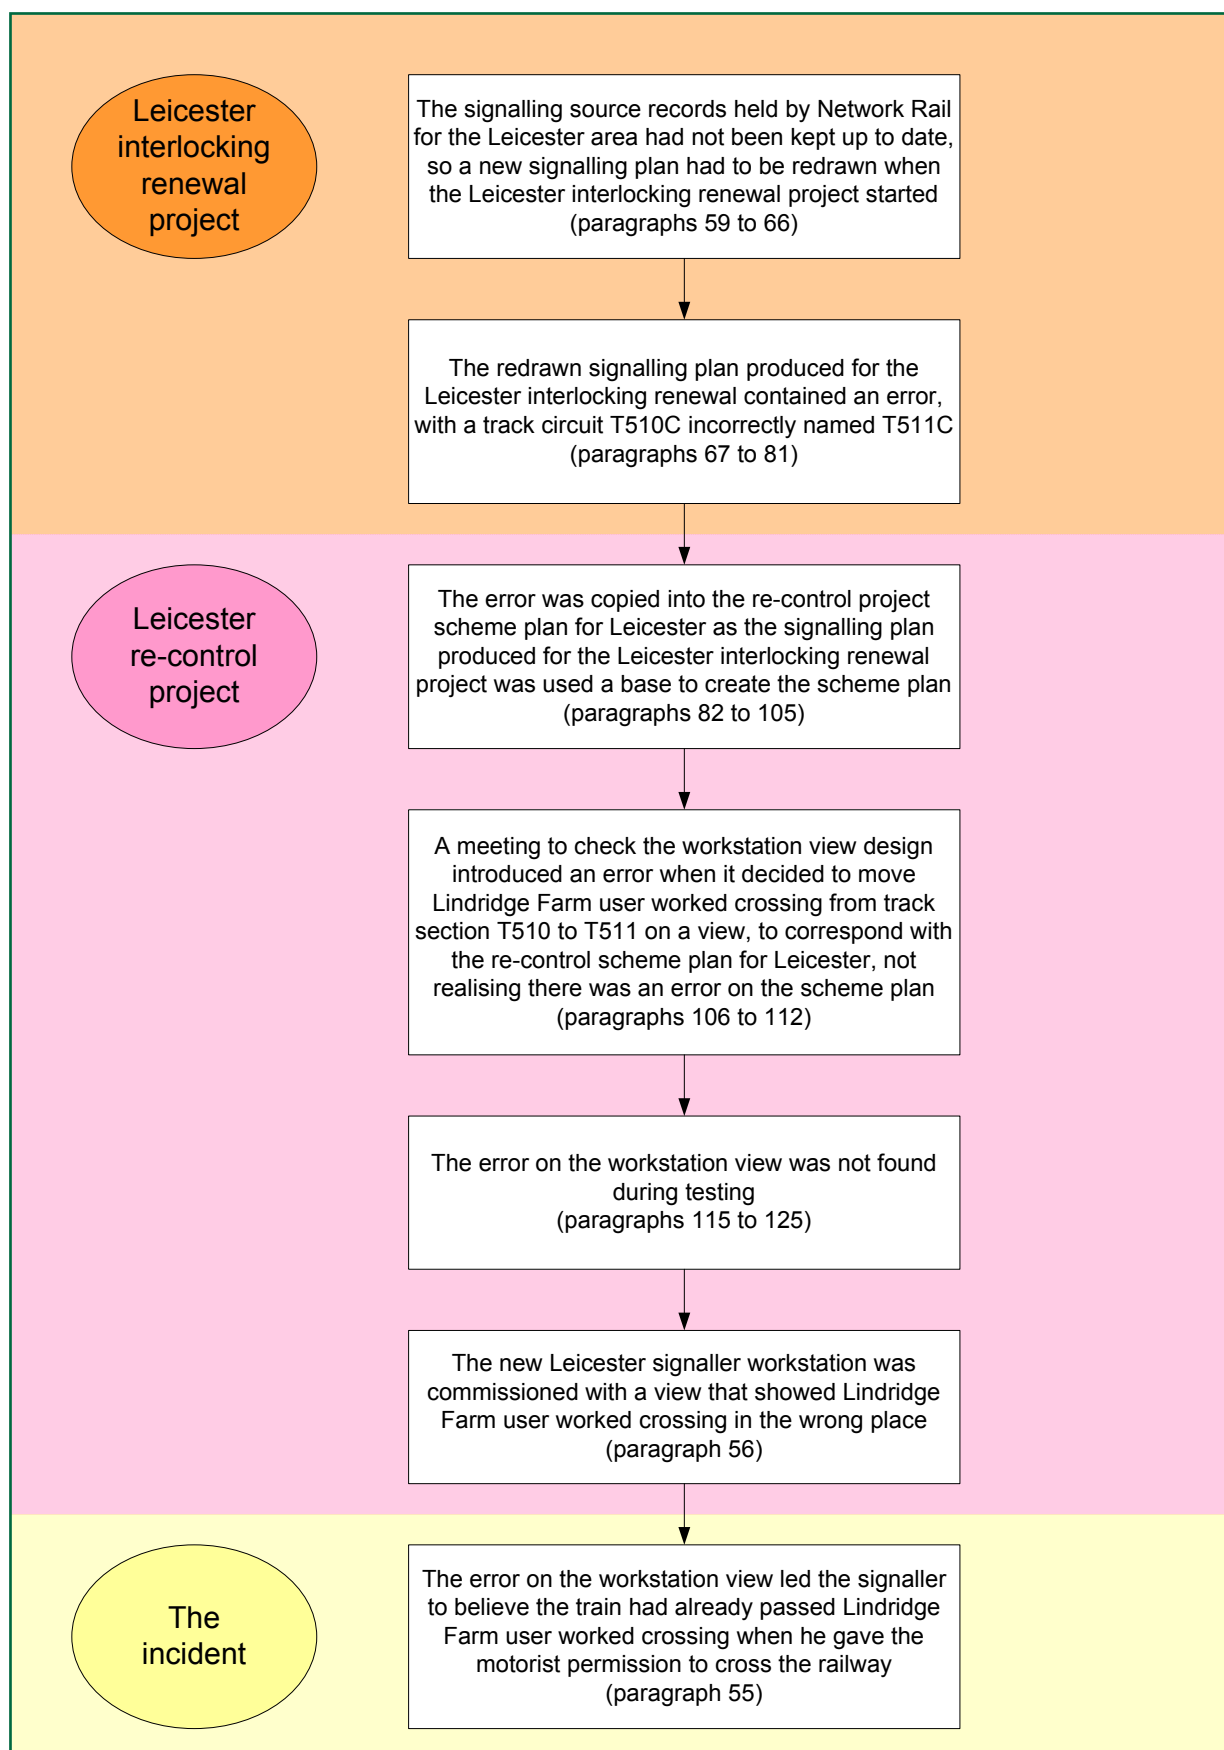
Figure 11: Diagram showing the sequence of events

- 57 The error on the Leicester workstation view was introduced during the process for designing and reviewing the views and was not identified when the workstation was tested before it was commissioned.
- 58 The sequence of events that led to the incident occurring is shown in figure 11. Each of these events and the factors associated with them are now considered in turn.

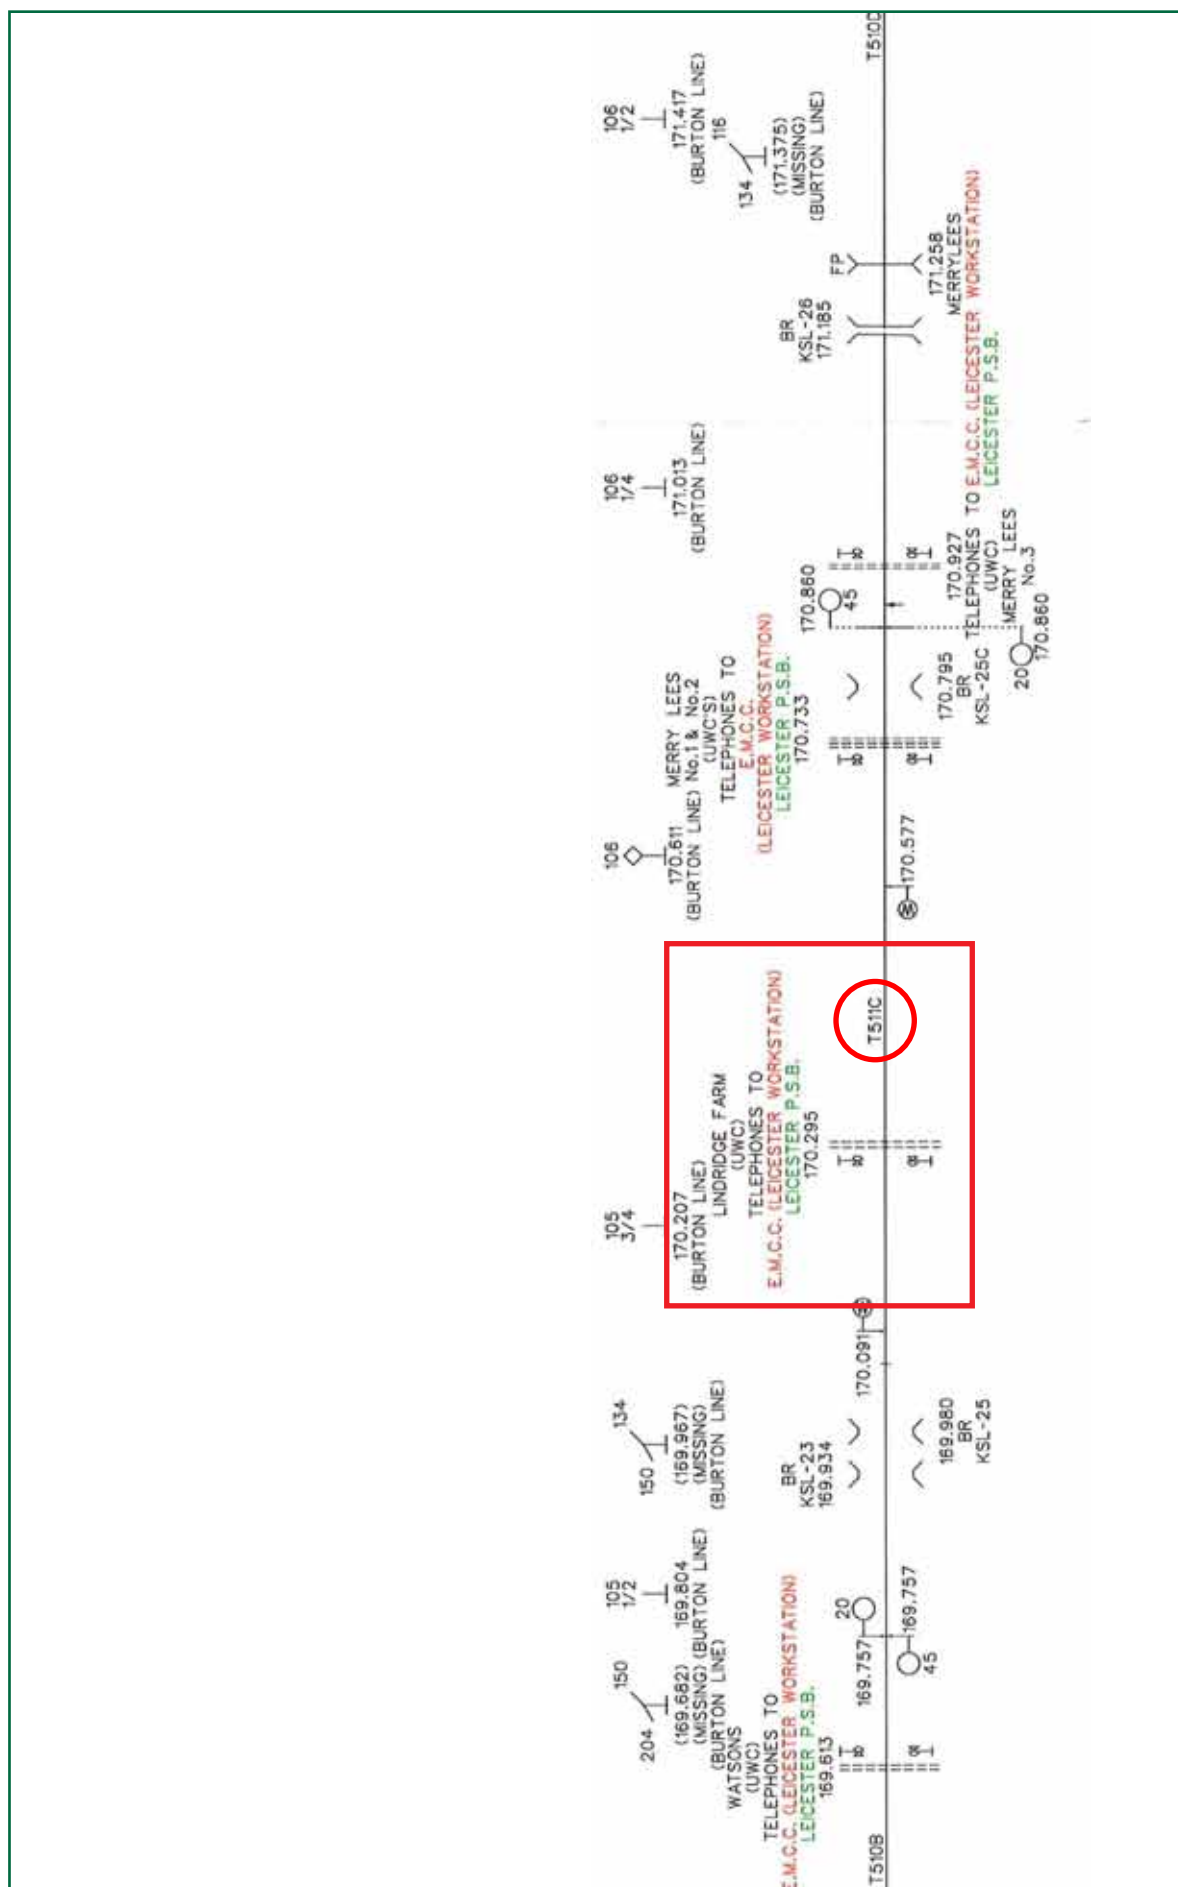
112 Afterwards, no one from Network Rail's operations was consulted about moving Lindridge Farm user worked crossing to track section T511 on the view. Another meeting was already arranged for 20 October at which the final versions of the views were to be reviewed by staff from Network Rail operations. However, by the time this meeting took place, the view had not been updated to include this change. Instead, the action to make this change was transferred from the 12 August meeting minutes to the 20 October meeting minutes without any discussion or further review. Invensys Rail then made the change to the workstation view to close out this action, which introduced an error as Lindridge Farm user worked crossing was now shown on the wrong track section.

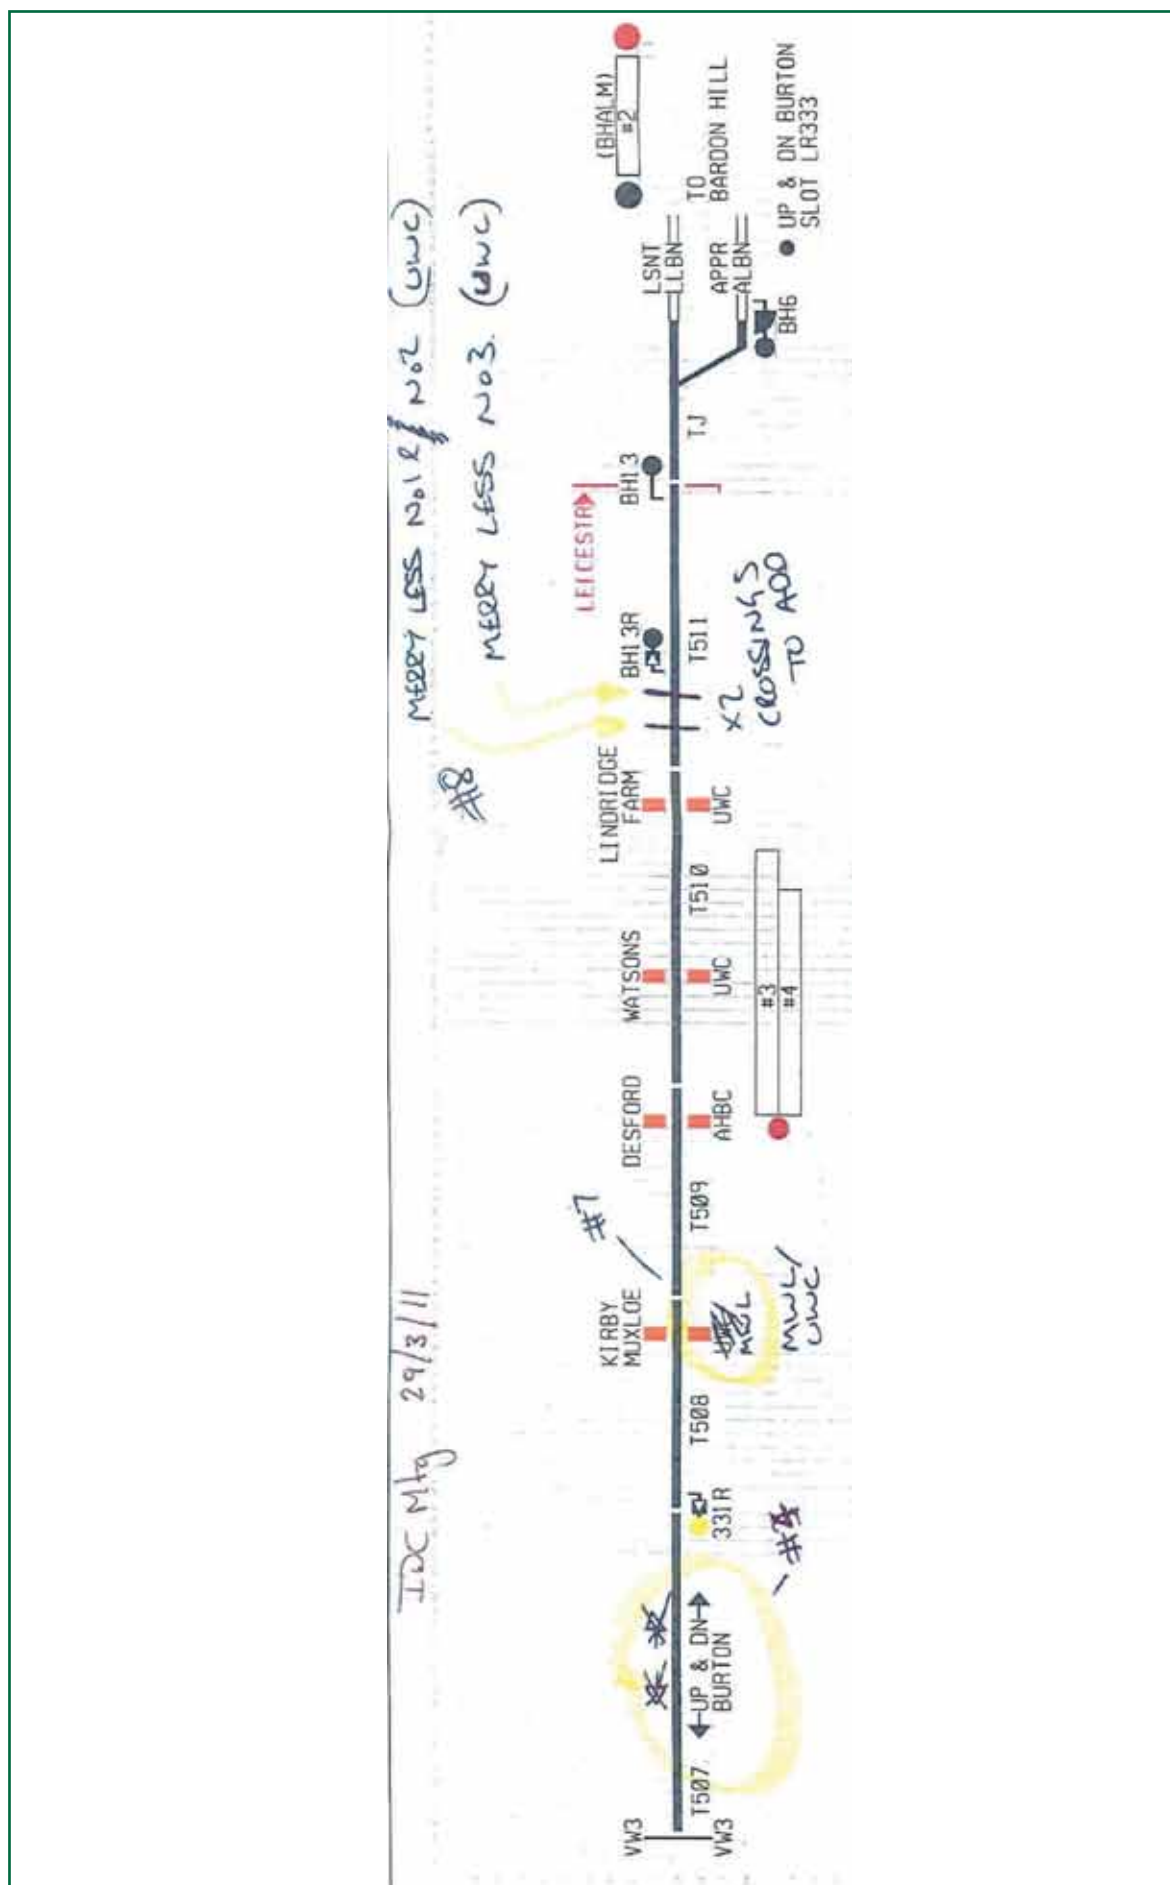
- 136 It is likely that the Network Rail attendee who proposed this change looked at the Leicester interlocking renewal signalling plan, which had the error on it which named track circuit T510C as T511C (paragraph 67), and concluded that the Merry Lees crossings were on track section T511. At this time, the scheme plans for the re-control work were not available as they were still being produced by Network Rail SDG.

- 137 Invensys Rail modified the workstation view in line with meeting comments and this change was marked as complete at the next design check meeting held on 3 May 2011. The incorrect placement of the Merry Lees crossings on track section T511 was not identified at the meeting held on 12 August to review the workstation views against the first versions of the new scheme plans (paragraphs 107 to 110) or found during the testing work (paragraphs 115 to 125). The workstation view was commissioned with the Merry Lees crossings shown on the wrong track section along with the Lindridge Farm crossing (figure 8). Network Rail discovered this error when the incident at Lindridge Farm crossing was investigated (paragraph 35).
