TEM analysis GaAs

12-02-2020

GaAs

Samples analyzed by STEM, STEM-EDX (and BF-TEM)

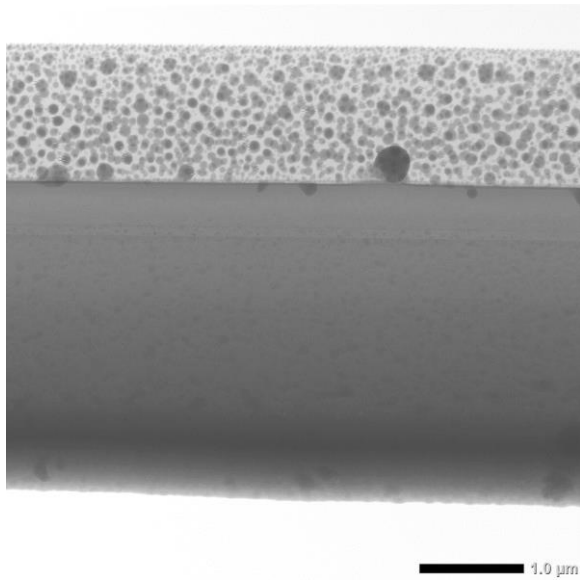
Up right (O4/L16)

- Note: due to technical issues we seem to have deposited a lot of Ga “droplets” on top of the carbon layer, they reside on the surface as confirmed by secondary electron imaging.
- Lamella taken from different regions of the wafer show somewhat different surface roughness – from left-most lamella being nearly flat to the right-most having about 100 nm deep surface ridges.
- In case of rough wafer surface, aluminum-oxide layer seems to vary in thickness from 30 nm up to even 150 nm patches, also it seems to be broken, and in some places lifted up from GaAs to form pores beneath (see next slide and EDX). In case of flat wafer, thin (~50nm) and continuous alumina layer is seen.

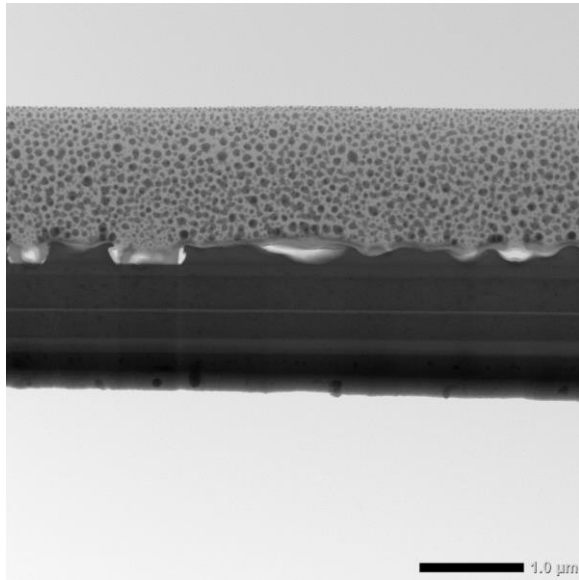
Center bellow (Q2/L20)

- Note: due to technical issues we seem to have deposited a lot of Ga “droplets” on top of the carbon layer, they reside on the surface as confirmed by secondary electron imaging.
- All lamella show similar surface roughness with depth of the ridges of ~30 to 150 nm.
- Aluminum-oxide layer seems to vary in thickness from 30 nm up to even 150 nm patches (filling up some ridges), also it seems to be broken, and in some places lifted up from GaAs to form pores beneath.

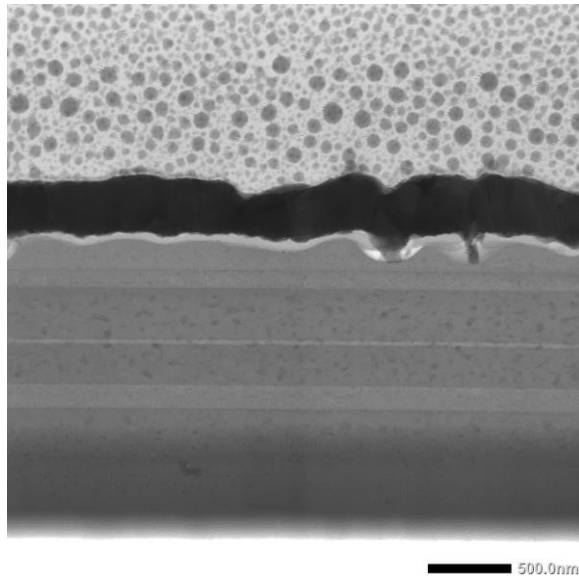
Center up (H1/L1)

- Note: due to technical issues we seem to have deposited a lot of Ga “droplets” on top of the carbon layer, they reside on the surface as confirmed by secondary electron imaging. Interestingly right-most lamella seem to be free of this artefact.
- All lamella show similar Ag and GaAs wafer surface roughness with depth of the ridges of ~30 to 150 nm.
- Aluminum-oxide layer seems to vary in thickness from 50 nm to 150 nm patches (filling up ridges), also it seems to more continuous and less broken that in previous 3 samples.
