General Summary

Customer
 Ministry of Transportation and Infrastructure

Property Address
 111 Old Hope Princeton Way
 Hope, BC V0X 1L4

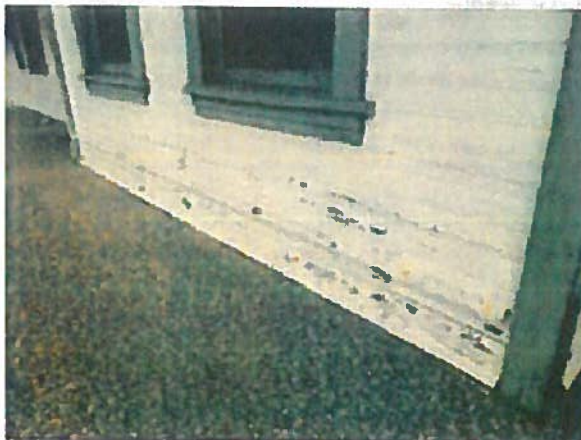
2.0 Picture 1

In general, the wood exterior of the entire building requires paint.

Cost Estimate to Paint: \$5,000 - \$8,000

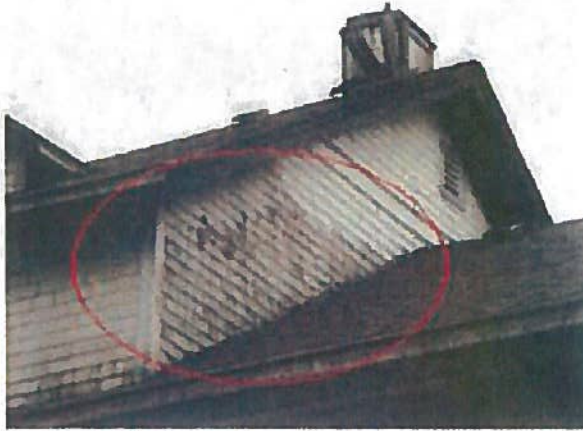
2.0 Picture 3

Water leaking damage was noted in locations around the exterior of the building. Upon further evaluation it was determined that the water source is the hydronic heating system from within the building.

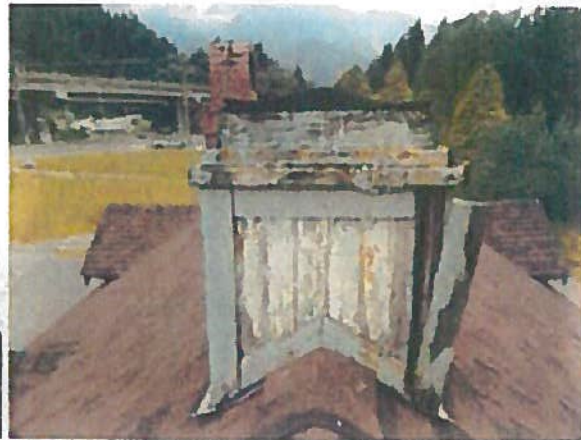
2.0 Picture 9

Where two brick chimneys once exited the roof for the old pot-bellied stoves, there are now two structures which are falling apart, requiring extensive repair. They are not large, and subsequent repair costs would probably be not much more than to have a Roofer remove them and sheet & shingle the void spaces they would leave behind. For the charm they add to the building, I would

recommend repairing and retaining them.

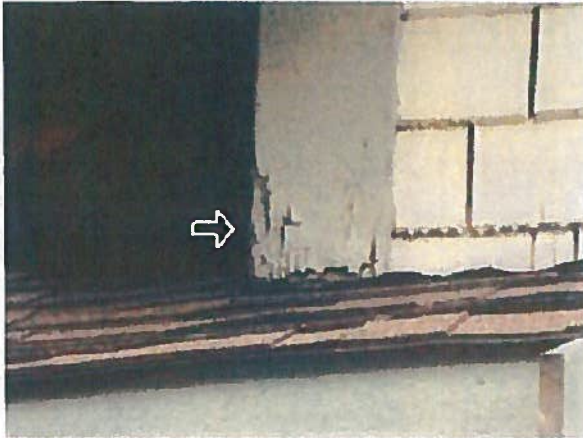
2.0 Picture 14

The lower course of exterior wood shingles at the front 2nd Storey (Picture 12) and West end of the building (Picture 13) requires repair/replacement due to exposure to the elements, and a few pieces of exterior trim require replacing (Picture 14).

Cost Estimate for Exterior Wood Siding/Trim repairs: \$2,000 - \$2,500.

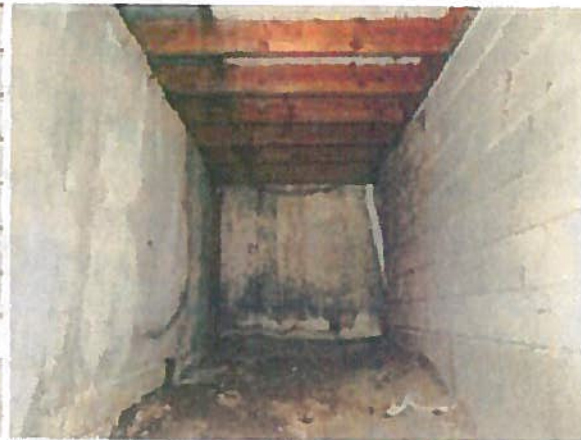
2.3 Picture 8

As a precautionary measure, I recommend enclosing the underside of the deck at the East end of the building to keep people out of this area.

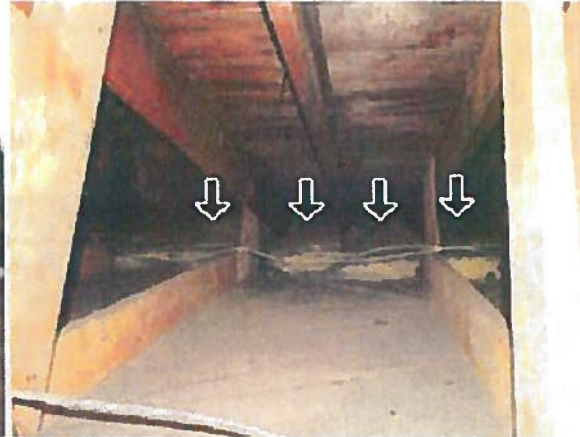
3.3 Picture 2

Roof vents (for exhaust) were installed along the back ridge of the roof (Picture 1), however the soffit/eaves are not vented to allow for air intake (Picture 2). As such, natural convection and air exchange can not happen. I recommend a Roofer install soffit venting and baffling.

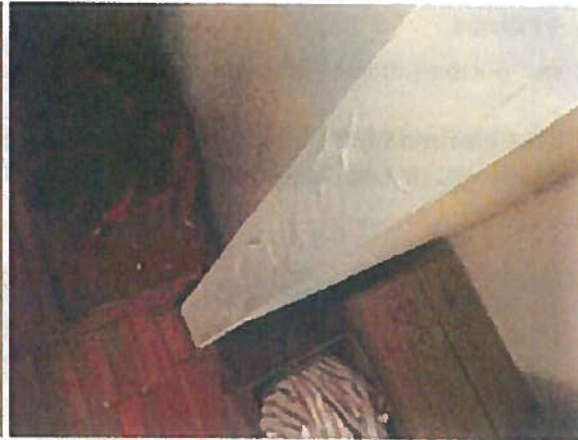
4.1 Picture 2

For the most part the walls are in fair condition, however there are a couple areas which require minor repairs and paint, particularly upstairs on the 2nd Storey where an old roof leak caused the paint to bubble and peel.

Cost Estimate for Wall Repair and Paint: \$500 - \$1,500

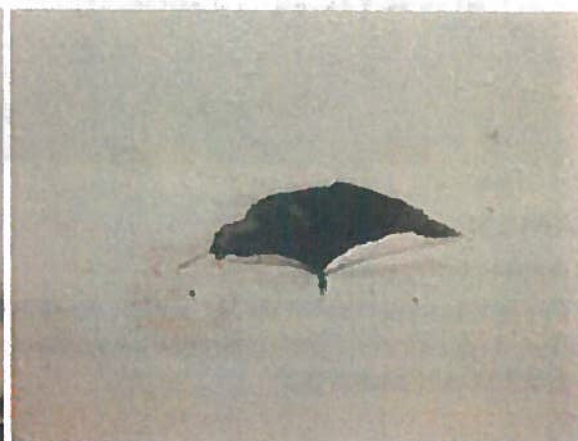
4.2 Picture 2

Water leaking prior to the Roof replacement has damaged the ceilings in a few locations, namely near the main floor entry (Pictures 1 & 2) and in the 2nd Storey apartment (Pictures 3, 4, 5, 6). Repairs are necessary.

I recommend repairs by a qualified Drywaller/Contractor.

Cost Estimate for Ceiling Repairs: \$1,200 - \$1,800

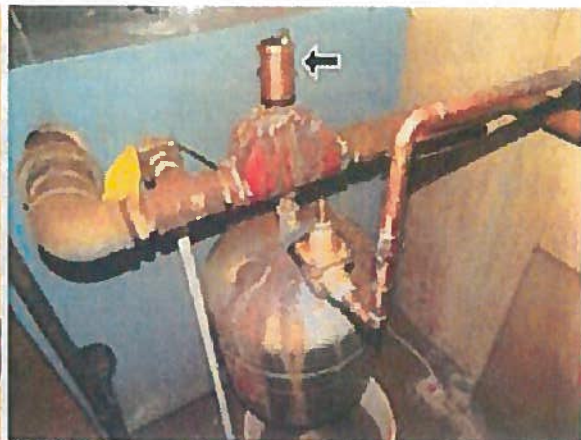
8.0 Picture 4

The main repair issue is that a few of the bleeder valves on the actual radiator units are leaking. A few have been replaced (Pictures 3 & 4) but many have gone unchecked, particularly at the East end of the building where long-time leaks (Pictures 5, 6, 7 & 8) have subsequently damaged exterior walls beneath them (Picture 9), as previously mentioned in the Exterior section of the report.

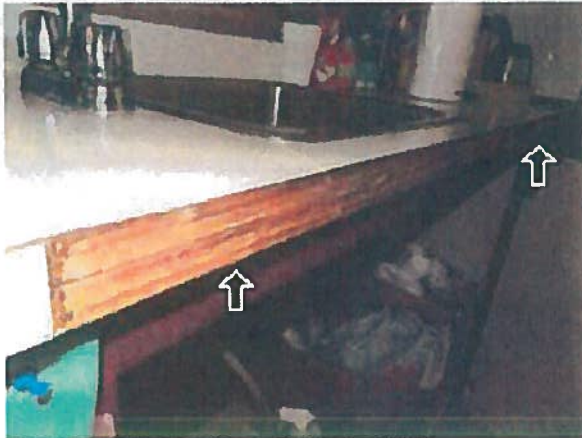
10.2 Picture 1

The laminate has peeled from the countertop.

Cost Estimate: \$100
