**20:20 House (Residential management)
Limited C/o Cardoe Martin –
20:20 Building, Skinner Lane, Leeds**

**Fire Safety Review of External Walls and
Attachments**

IFC Report FSA/21183/01

23th November 2021

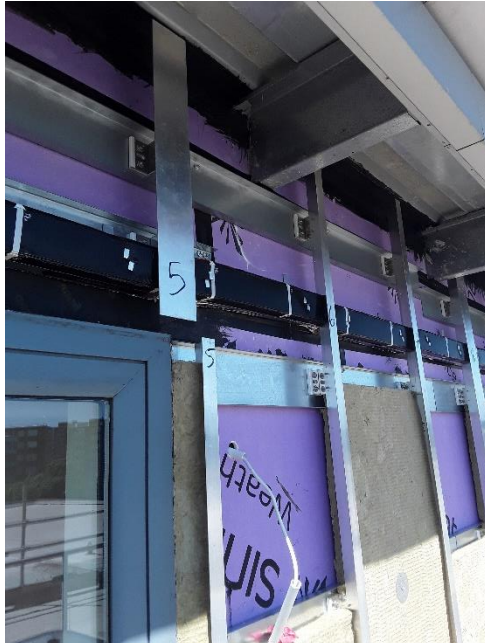
Figure 14 – Details from Façade Construction

- b) Vertically in line with party walls; AOCA and AJ Cladding have produced drawings for proposed cavity barrier locations.
- c) Around the perimeter of windows and doors; the survey completed by Wintech found cavity barriers placed in the cavity above the openings and sat on the soffit panel.
- d) Around any service penetrations; the survey completed by Wintech found cavity barriers placed in the cavity above the openings.
