20:20 HOUSE, LEEDS

Site Monitoring Report No. 22

Date of visit: 11th October 2021

Document reference: 05218/HB/LEK/53621/WL/01

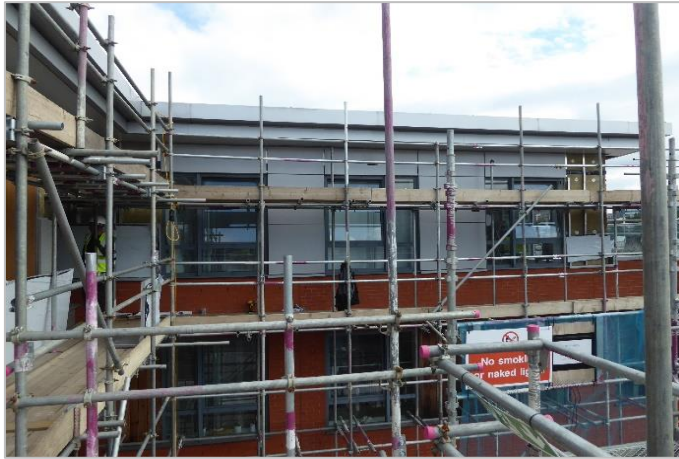
Photograph No. 3 – Elevation No. 3 (Update on this photograph could not be taken, latest photograph has been used as a reference)

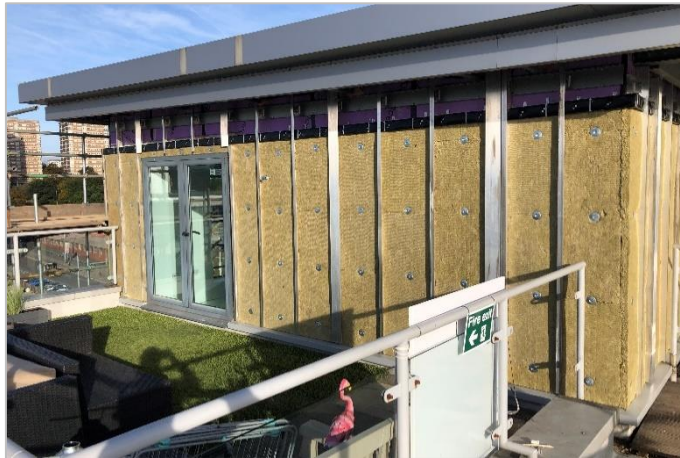
Photograph No. 11 – Elevation No. 11

The remaining elevations have helping hand brackets installed along with vertical rails, insulation slabs and cavity barriers. (Refer to Photographs No.'s 11 to 20).

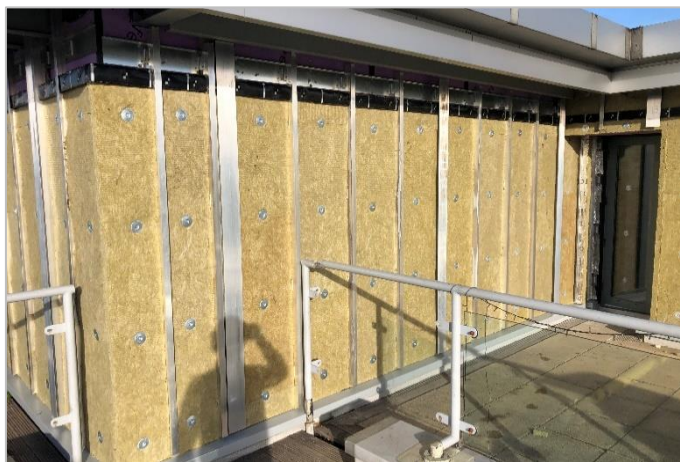
Photograph No. 12 – Elevation No. 12

An additional 'L' rail was observed on elevation 12. The additional rail was not illustrated on the updated subframe drawings. Therefore, a panel was temporarily installed to understand the rationale of the additional rail. It was concluded to be necessary in order to pick the fixing clips.

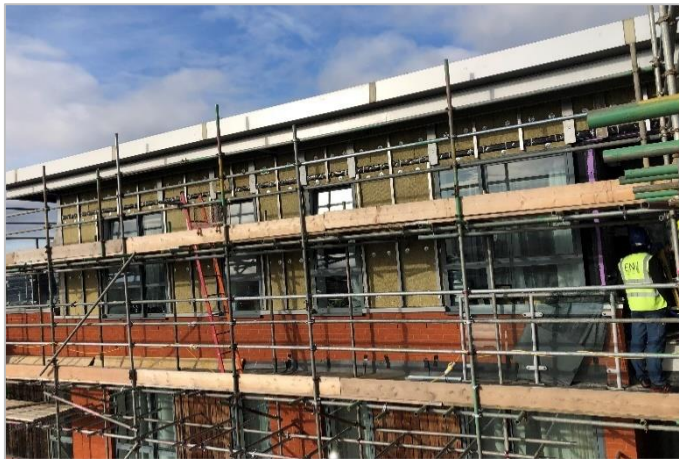
Photograph No. 14 – Elevation No. 14

A double bracket was observed to the external corner of elevation 14 leading into the recessed balcony area. Subframe drawings indicate that a single sliding bracket should be installed in this area.
