Oklahoma Murrah Federal Building Collapse

Sue Nopachinda

CE-GY 7823

December 16, 2015

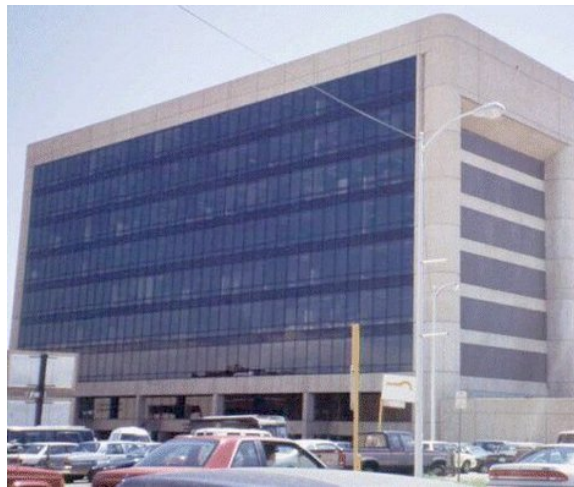
"tiers" between the first two floors and the rest of the building as shown in Figure 1. While the Murrah Building was designed as an ordinary office building, its structural systems could not withstand blast forces from potential terrorist attacks or threats.

Figure 1: Murrah Building in 1977 before the bombing. (Source: thirdworldparanormal.weebly.com)
