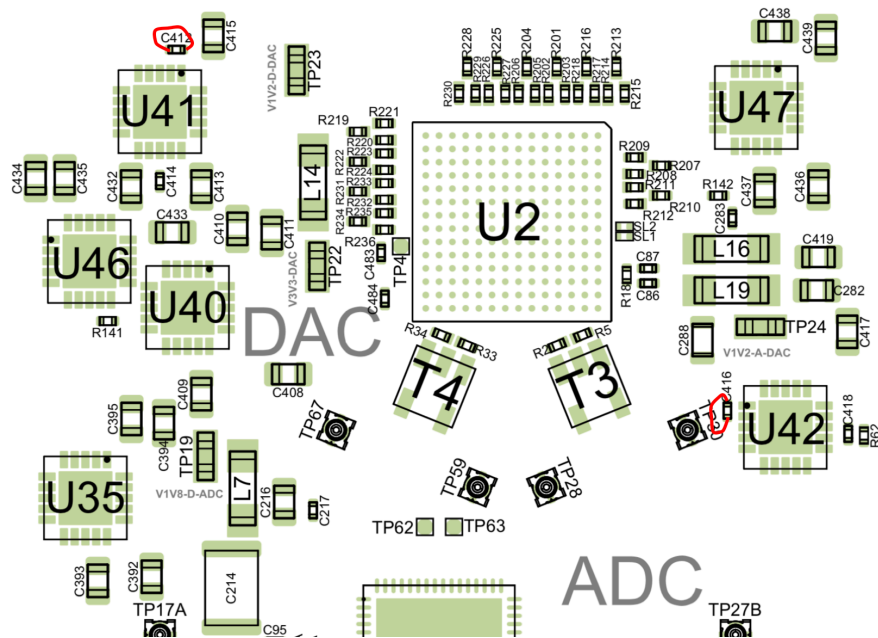
#2. "SPI bus being held low"

Solution: DAC, SYNTH, and CLOCK power supplies need to be jumpered ON (i.e. on by default).

Instructions: Jumper **R62 to C417** (as shown below). Jumper **R66 to C428** (as shown below). Jumper **R60 to C404** (as shown below).
