Home Inspection Report

1832 Astor Way NE, Salem, Oregon 97302

Date: 01 November 2021

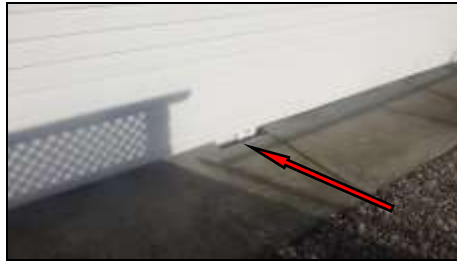
Photo 5

21. **Monitor:** The crawl space wall vents close to the ground (South) could have a well guard to prevent water blowing into the crawlspace. [Photo5INS](#)

- **Monitor:** Plumbing pipes within the crawl space should be insulated to protect them from freezing. [Photo4INS](#)
- **Monitor:** The crawl space wall vents close to the ground (South) could have a well guard to prevent water blowing into the crawlspace. [Photo5INS](#)
- **Repair:** Small section of ductwork within the crawl space (West) should be better insulated. [Photo6INS](#)
