# Solar AI Platform — Project Report (Starter)

Project: test (ID: 11)  
Address: ghjjh

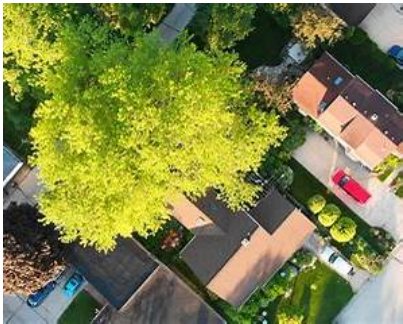
[photo]  
roof\_20260103\_161952\_414595\_two image.jp  
[View Full Size](#)

**Roof Risk: SAFE**

- Roof appears to be in good condition

From this aerial perspective, no visible cracks, sagging, holes, or major structural damage are apparent on the main visible roof sections.

No obvious signs of water leakage, prominent staining, or significant discoloration are discernible on the roof surfaces.  
The roof appears to be primarily an asphalt shingle type, common for residential structures.  
Due to the aerial view and image resolution, minor defects such as small hairline cracks, localized rust on flashing (which is not clearly visible), or subtle signs of wear cannot be definitively assessed.  
A very large, dense tree significantly shades a substantial portion of the roof, which would severely impact solar panel efficiency and would likely necessitate significant tree trimming or removal for optimal solar production.  
Roof type identified: Asphalt Shingle

- Action:** Proceed with solar installation
- Reason:** Roof is in good condition with no significant issues detected
- Next step:** Schedule installation at your convenience
