COMPLAINT

2-3 Overlap Valve Kit

68942-27K

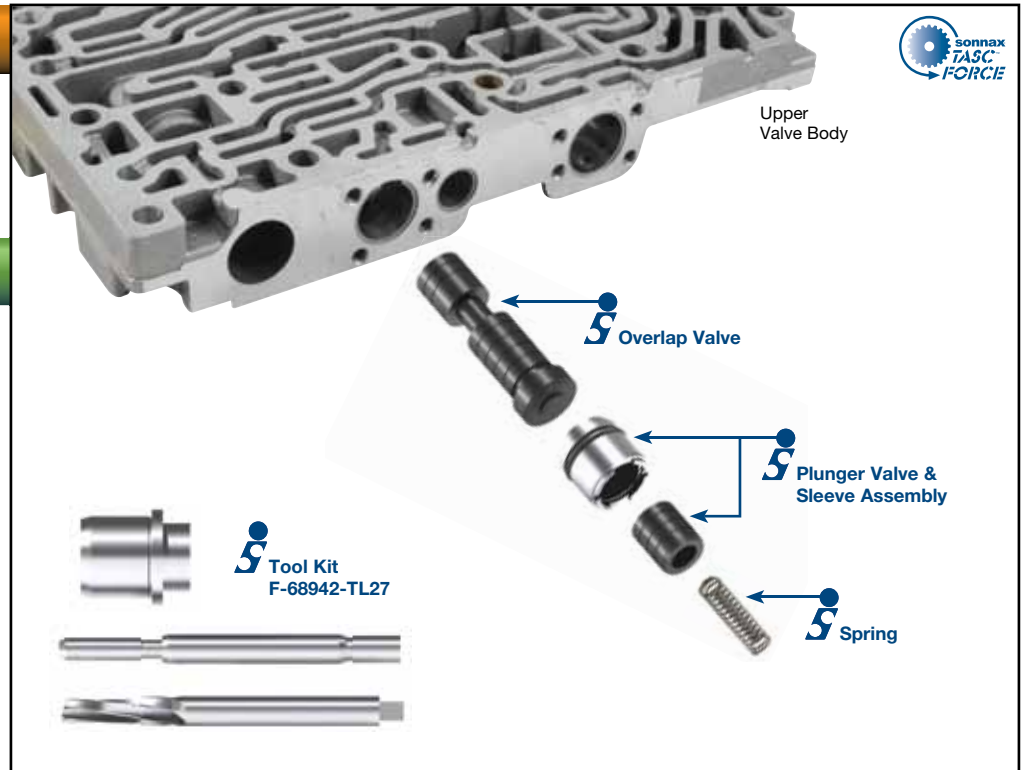
Wear at the overlap valve bore prevents proper exhaust of the disengaging clutch pressure, altering the precise timing required in the clutch-to-clutch shift transition.

A vacuum test at either port indicated fails to hold 18" of vacuum or higher, or if visual wear is detected at the inboard overlap valve bores.

The improved Sonnax overlap valve kit restores hydraulic sealing integrity and valve timing when installed in a refurbished bore.
