3-4 Overlap Valve Kit

68942-31K

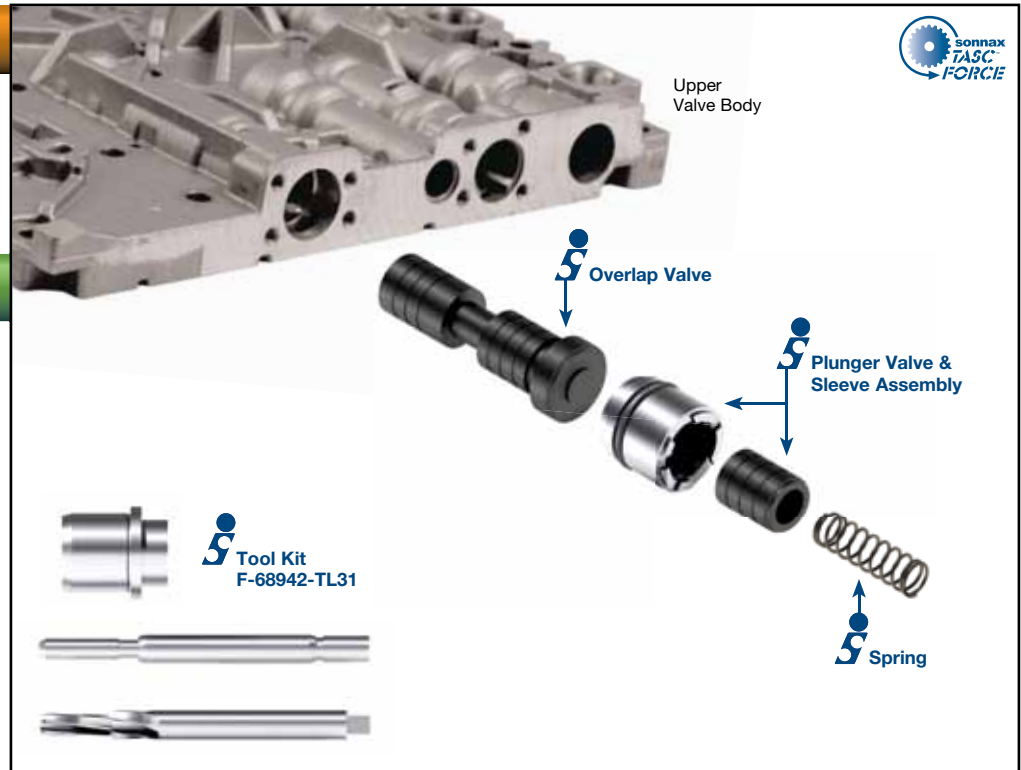
Wear at the overlap valve bore prevents proper exhaust of the disengaging clutch pressure, altering the precise timing required in the clutch-to-clutch shift transition.

The 722.6 transmission uses clutch-to-clutch transitioning during shifts, so timing is very critical to prevent shift complaints like flares or bind-ups. The overlap valves, controlled by EPC (modulated pressure) and shift valve pressure, are used to gradually reduce the pressure to the disengaging clutch.

A vacuum test at either port indicated fails to hold 18" of vacuum or higher or if visual wear is detected at the inboard overlap valve bores.

The improved Sonnax overlap valve kit restores hydraulic sealing integrity and valve timing when installed in a refurbished bore.
