Lockup Clutch Control Valve Kit

15741-29K

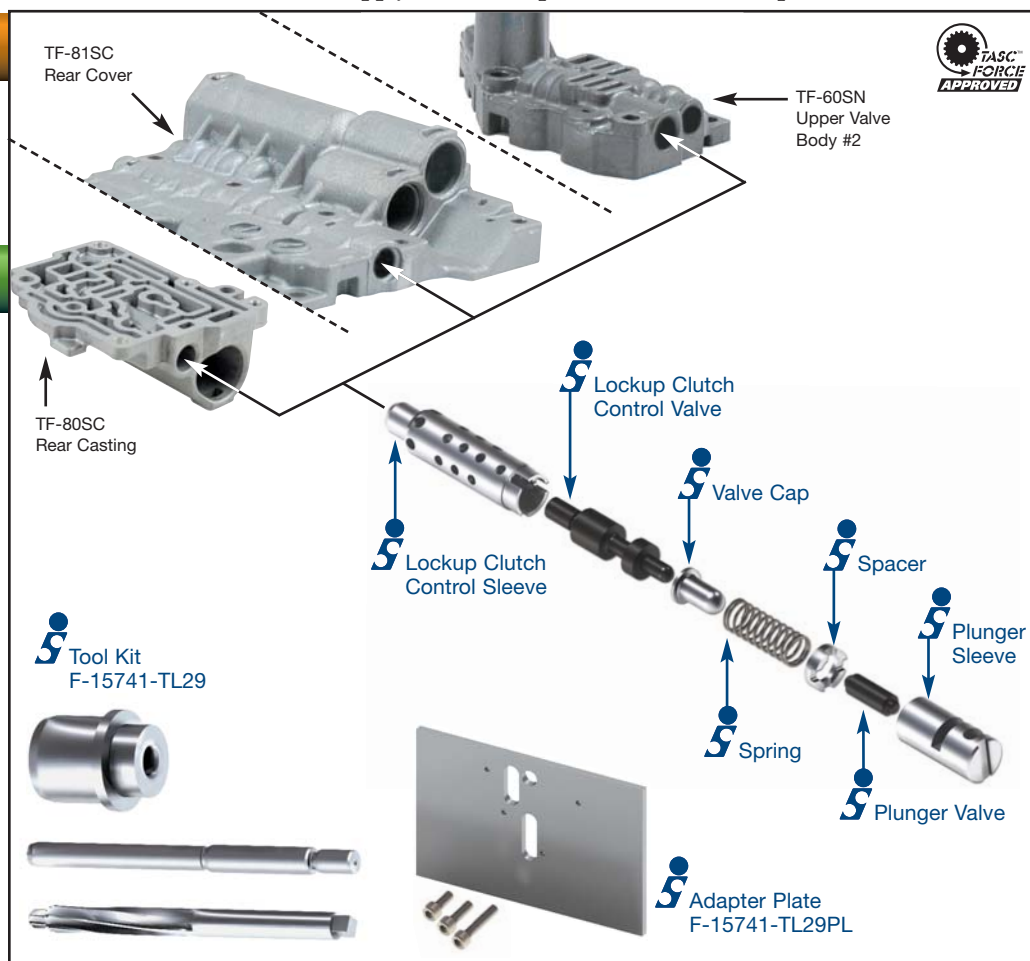
Either a Wet Air Test or a Vacuum Test in the locations shown, result in leakage. A vacuum test must hold a minimum of 18".
