Main Pressure Regulator & Boost Assembly

15741-01K

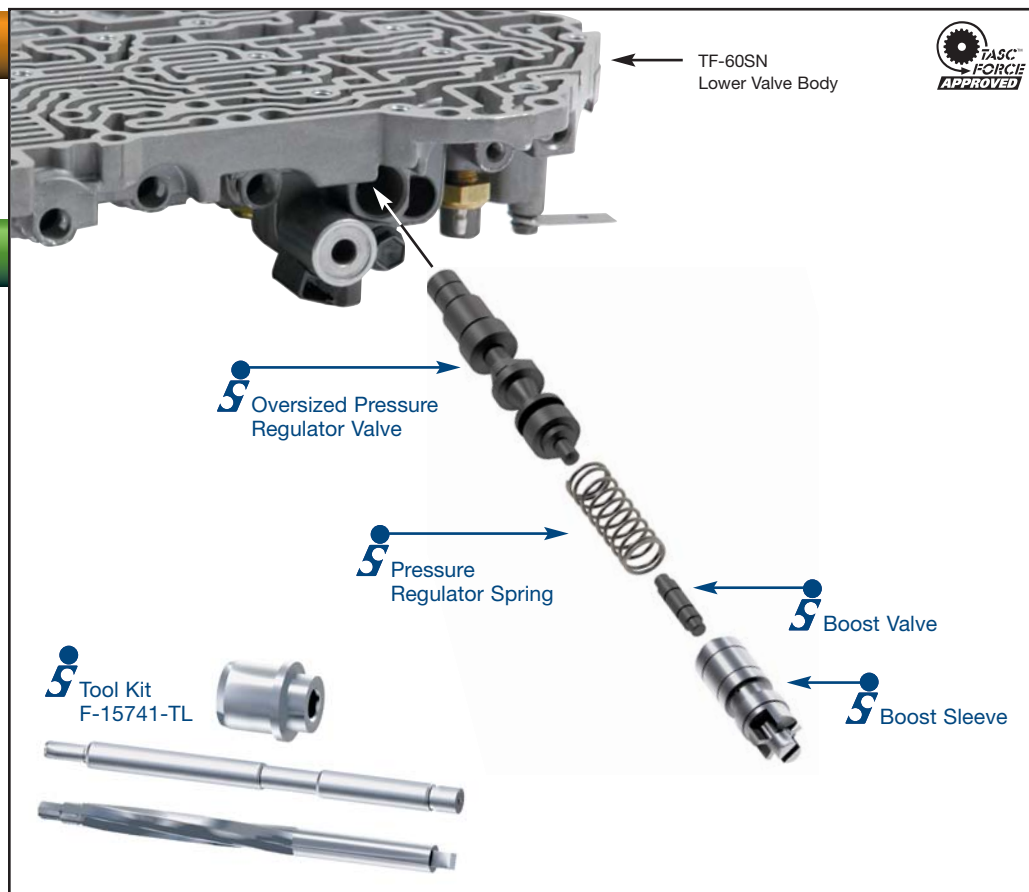
You need this if...

Either a Wet Air Test or a Vacuum Test in the two locations shown, result in leakage. A vacuum test must hold a minimum of 18".

This oversized pressure regulator valve and boost assembly allows the valve body bore to be restored to normal operating condition.
