Oversized 1-2 Accumulator Valve

84754-57K

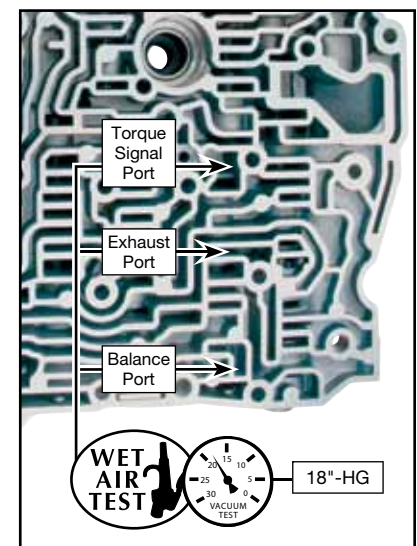
A vacuum test at torque signal, exhaust or balance port fails to hold 18" of vacuum or higher, or if visual wear is detected.
