K3 Clutch Control Valve Kit

25741-08K

Flare upshifts or downshift bind-ups in vehicles with the Aisin AW TR-60SN, VW/Audi 09D transmission can be caused by a worn K3 clutch control valve. Wear at this valve causes incorrect shift timing, which can also cause clutch distress. The Sonnax K3 clutch control valve kit 25741-08K helps restore shift timing.

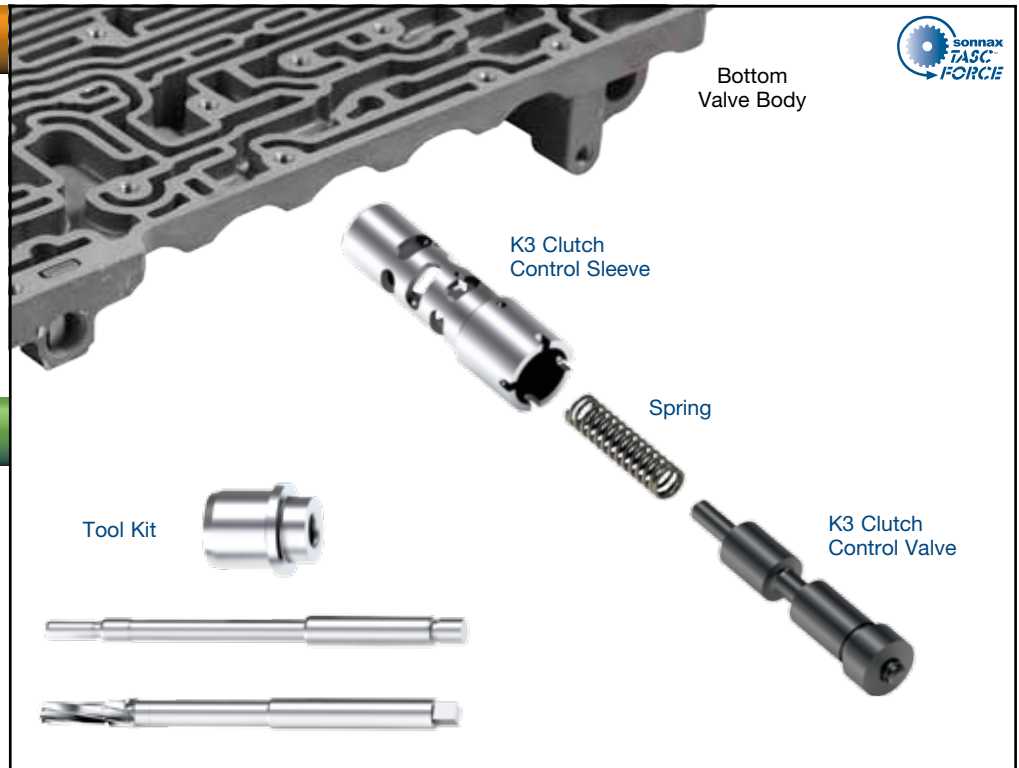
A vacuum test at indicated ports fails to yield 18 in-hg or greater, or if visual wear is detected.

The Sonnax wear resistant sleeve and valve corrects circuit pressure loss and restores control timing of the K3 clutch.
