COMPLAINT

2-3 Shift Complaints

2-3 Accumulator Valve Kit

84754-53K

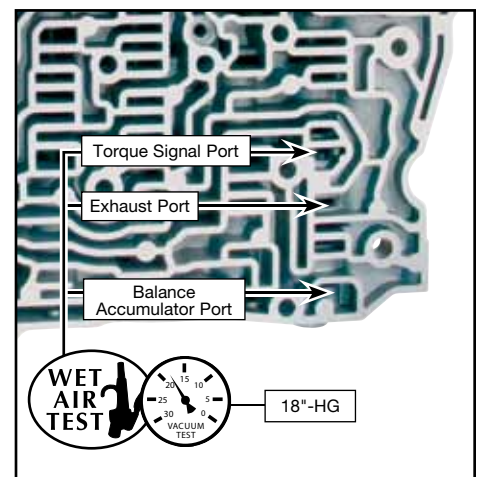
Wear of the 2-3 accumulator valve and/or sleeve allow loss of torque signal, 2-3 accumulator and/or line pressure.

A vacuum test at either port indicated fails to hold 18" of vacuum or higher, or if visual wear is detected at the inboard overlap valve bores.

Install the Sonnax valve and sleeve kit that has upgraded materials, restores correct hydraulic clearances and is designed to prevent wear.
