# 1870 DTC, TCC, AFL, PWM, EC<sup>3</sup>, etc.

By Maura Stafford

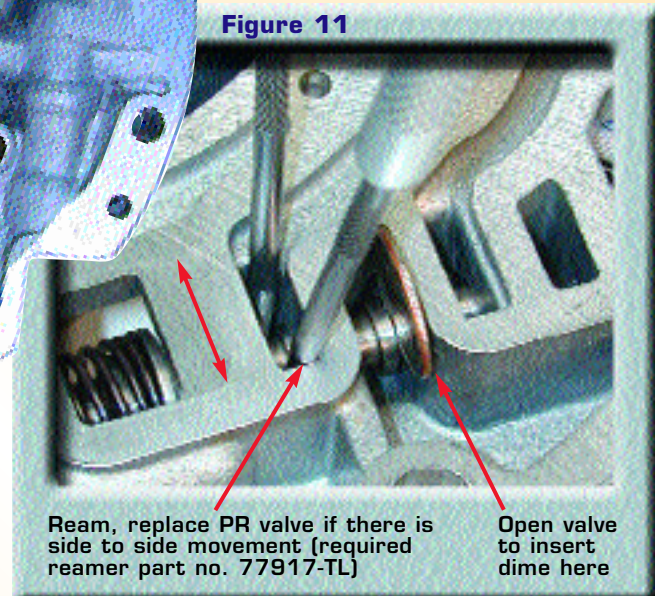
**Figure 12**

So our best advice in resolving any pump or valve body related code 1870 problems is to check each of these locations for bore wear or valve malfunctions. A reference chart for quick valve checks has been compiled (*Figure 12*). The 4T60-E TCC circuitry is very similar to that of the 4L60-E, so valves to check to correct an 1870 code in that application are given as well. The time invested in performing wear tests will prevent comebacks and save time, headaches, and money in the future.
