A Clutch Call

What 740/1740 codes can reveal about Chrysler converter flow

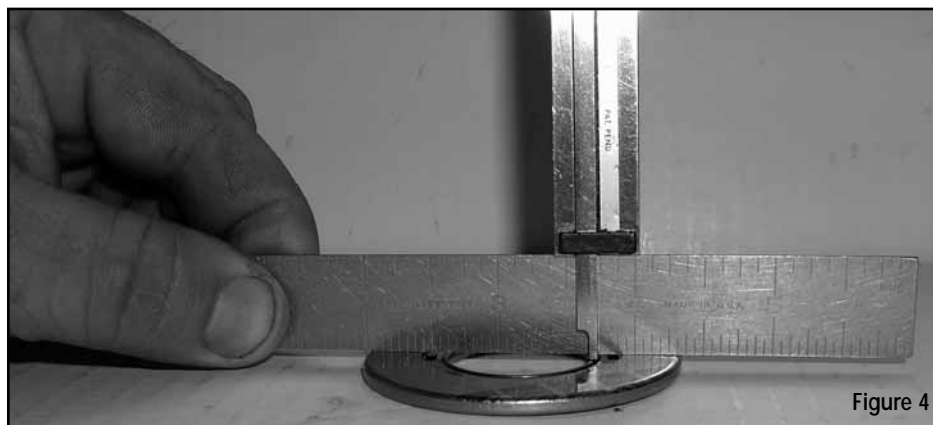
phenolic), the only flow you will have is the oil that squeezes past the internal clearances that you have built into your converter. This will also usually set a 740 code. If your thrust washer only has grooves on one side, you also need to pay attention to this. When you place the thrust washer on your turbine hub with the grooves facing up (toward the cover) you can see that there are passages for oil flow, but if you can place the thrust washer on the turbine hub with the flat side up, you will see that when the oil exits

inner race of the bearing to the bushing may cause the race to flex and eventually fail. Either of these two concerns may help to explain the failure rate of the bearing.

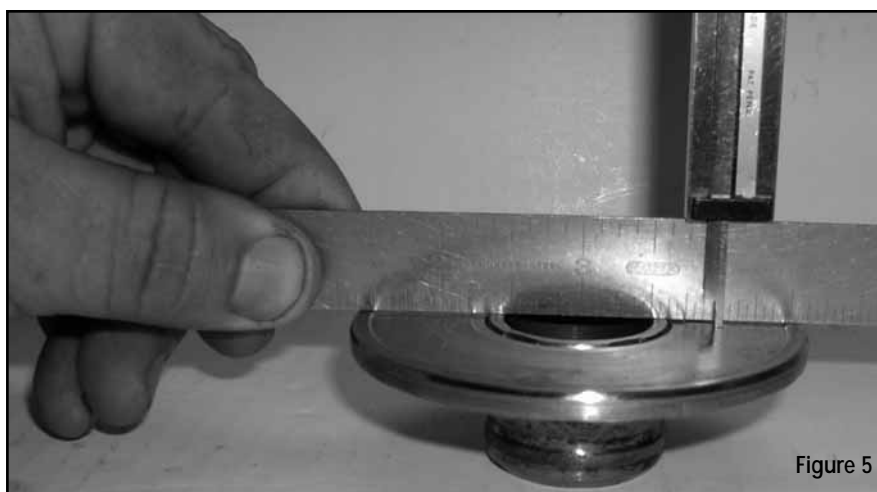
The input shaft of the 604 has more clearance at the cover, but clearance would probably not be an issue anyway, because of the stronger flex plate. The turbine hub bushing on the 604 looks like a smaller version of the 518 bushing with one less groove on the outside. When the bushing is installed to its proper depth, it is flush to .020" up from the thrust surface of the cover. This is well above the .012" flow relief step at the top of the bore. The machined angle at the bottom of the bore for clearance is greater than its sister angle on the 518 converter and is more flow-friendly. Special attention should be paid to the position of the bushing. Since the inner race of the OEM bearing is only .015" below the thrust surface of the outer race (see *Figure 4*), it may come into contact with the bushing if the bushing is up .020" above flush as shown in *Figure 5*. The .005" of wear shown in *Figure 6* is the result of that contact. This is a bad thing for two reasons: First, the material from the bushing that was worn away by the bearing race has to pass through the bearing, and secondly, the pinpoint contact of the

TCC piston and turbine increases, the chances of a spring walking out of place also increases. A small amount of extra clutch release clearance will only allow the spring to walk up the turbine enough to push the clutch forward, making it drag on the cover. A larger amount of clearance will allow the spring to come completely out of the piston's spring retainer, causing catastrophic results.

Checking Chrysler's clutch release clearance is time-consuming at best, and some rebuilders are relying on the "use thicker friction material and hope" method. Making sure that the turbine hub bushing is not creating extra clearance may help to eliminate some problems.
