TORQUE CONVERTER PARTS

GM-WA-40 STATOR REPAIR PLATE

INSTALLATION INSTRUCTIONS

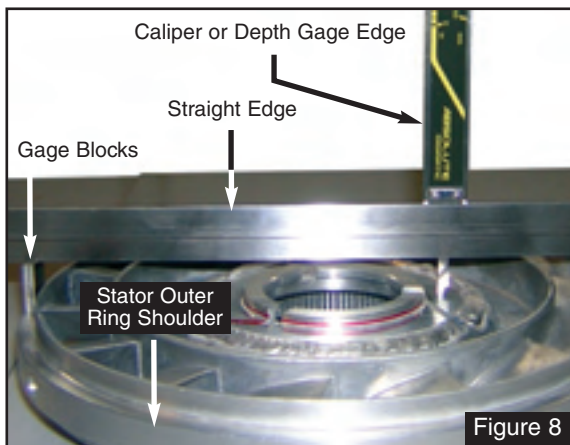
Figure 8

Note: It is likely the surface that the needle bearing rests on has distorted, so additional material, approximately .015", is left to true this surface with a lathe. This surface must be held flat to .003" so as not to damage the bearing. This surface must be located .085" to .095" above the outer ring shoulder (see Figure 7) to allow the correct stack up for the thicker GM-N-20 bearing. This can be measured using a height gage or with a straight edge and gage blocks (see Figure 8). In addition, the bearing surface area must be held parallel within .004" to the stator outer ring shoulder. Maintaining parallelism will prevent stator wobble and interference with impeller and turbine. The best way to assure the bearing surface is machined parallel to the outer ring shoulder is to chuck the stator on the ID and check outer ring shoulder runout with a dial indicator.
