4T65E All Wheel Drive Problems

Noise and Gear Failures

By Ed Lee

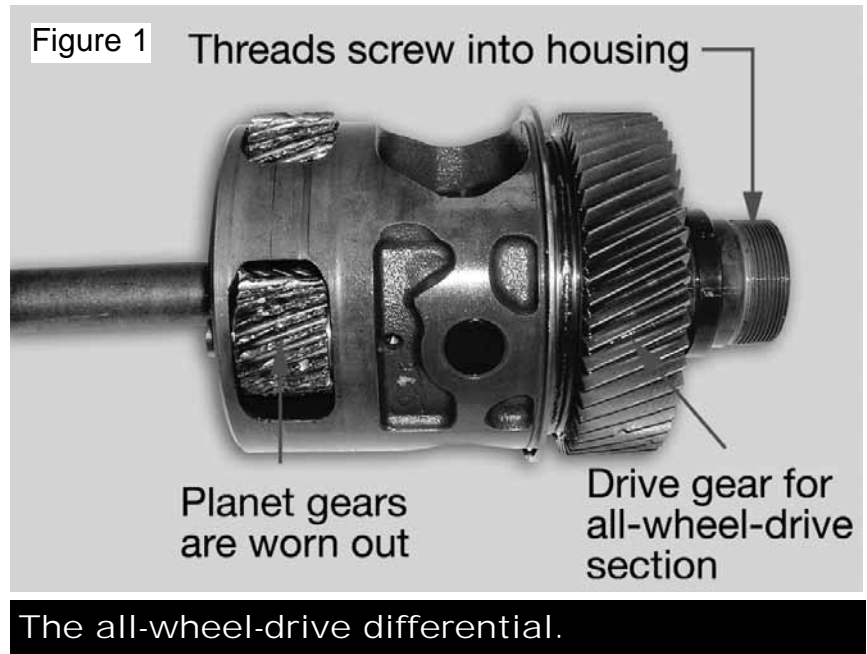
The differential for the front-wheel-drive 4T65-E rests between the final drive ring gear and the final drive housing. Since the differential is free to move between these two members, its end play must be regulated. The parameters for the end play are a minimum of .005" and a maximum of .025", and final drive selective thrust washers are used to adjust this measurement. There are 10 different selective thrust washers ranging from .055" to .095" thick, and they are installed just as they have been since the introduction of GM's first front-wheel transaxle, the 125. In 1999 an all-wheel-drive version of the 4T65-E was offered in the 3.4L Montana.

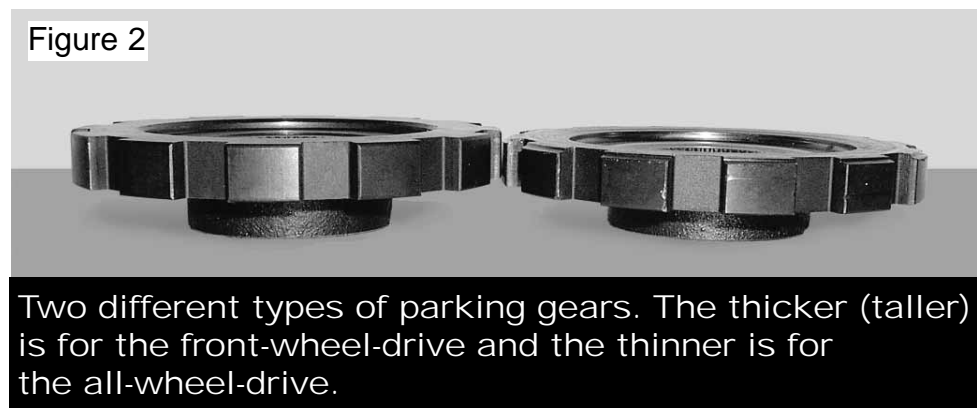
When power is transmitted through gear-to-gear contact, the end play of the gears must be as close to zero as possible. For this reason, the differential of the all-wheel-drive 4T65-E is attached to the transfer case housing. The end of the differential is threaded, and a large nut is used to secure the differential to a bearing in the housing. Since the differential is affixed to the housing, the end play of the mating parts must be adjusted inboard of the differential. This is done by moving the selective thrust washer to a new position, at the drive end of the differential. Material is removed from the parking gear and the selective washer is sandwiched between the parking gear and the final drive sun gear.
