Sonnax Technical Bulletin

TAKE COMPLETE CONTROL

OF YOUR SLIPS, BUMPS, &
SHUDDERS WITH THESE
UNIQUE TCC CONTROL FIXES

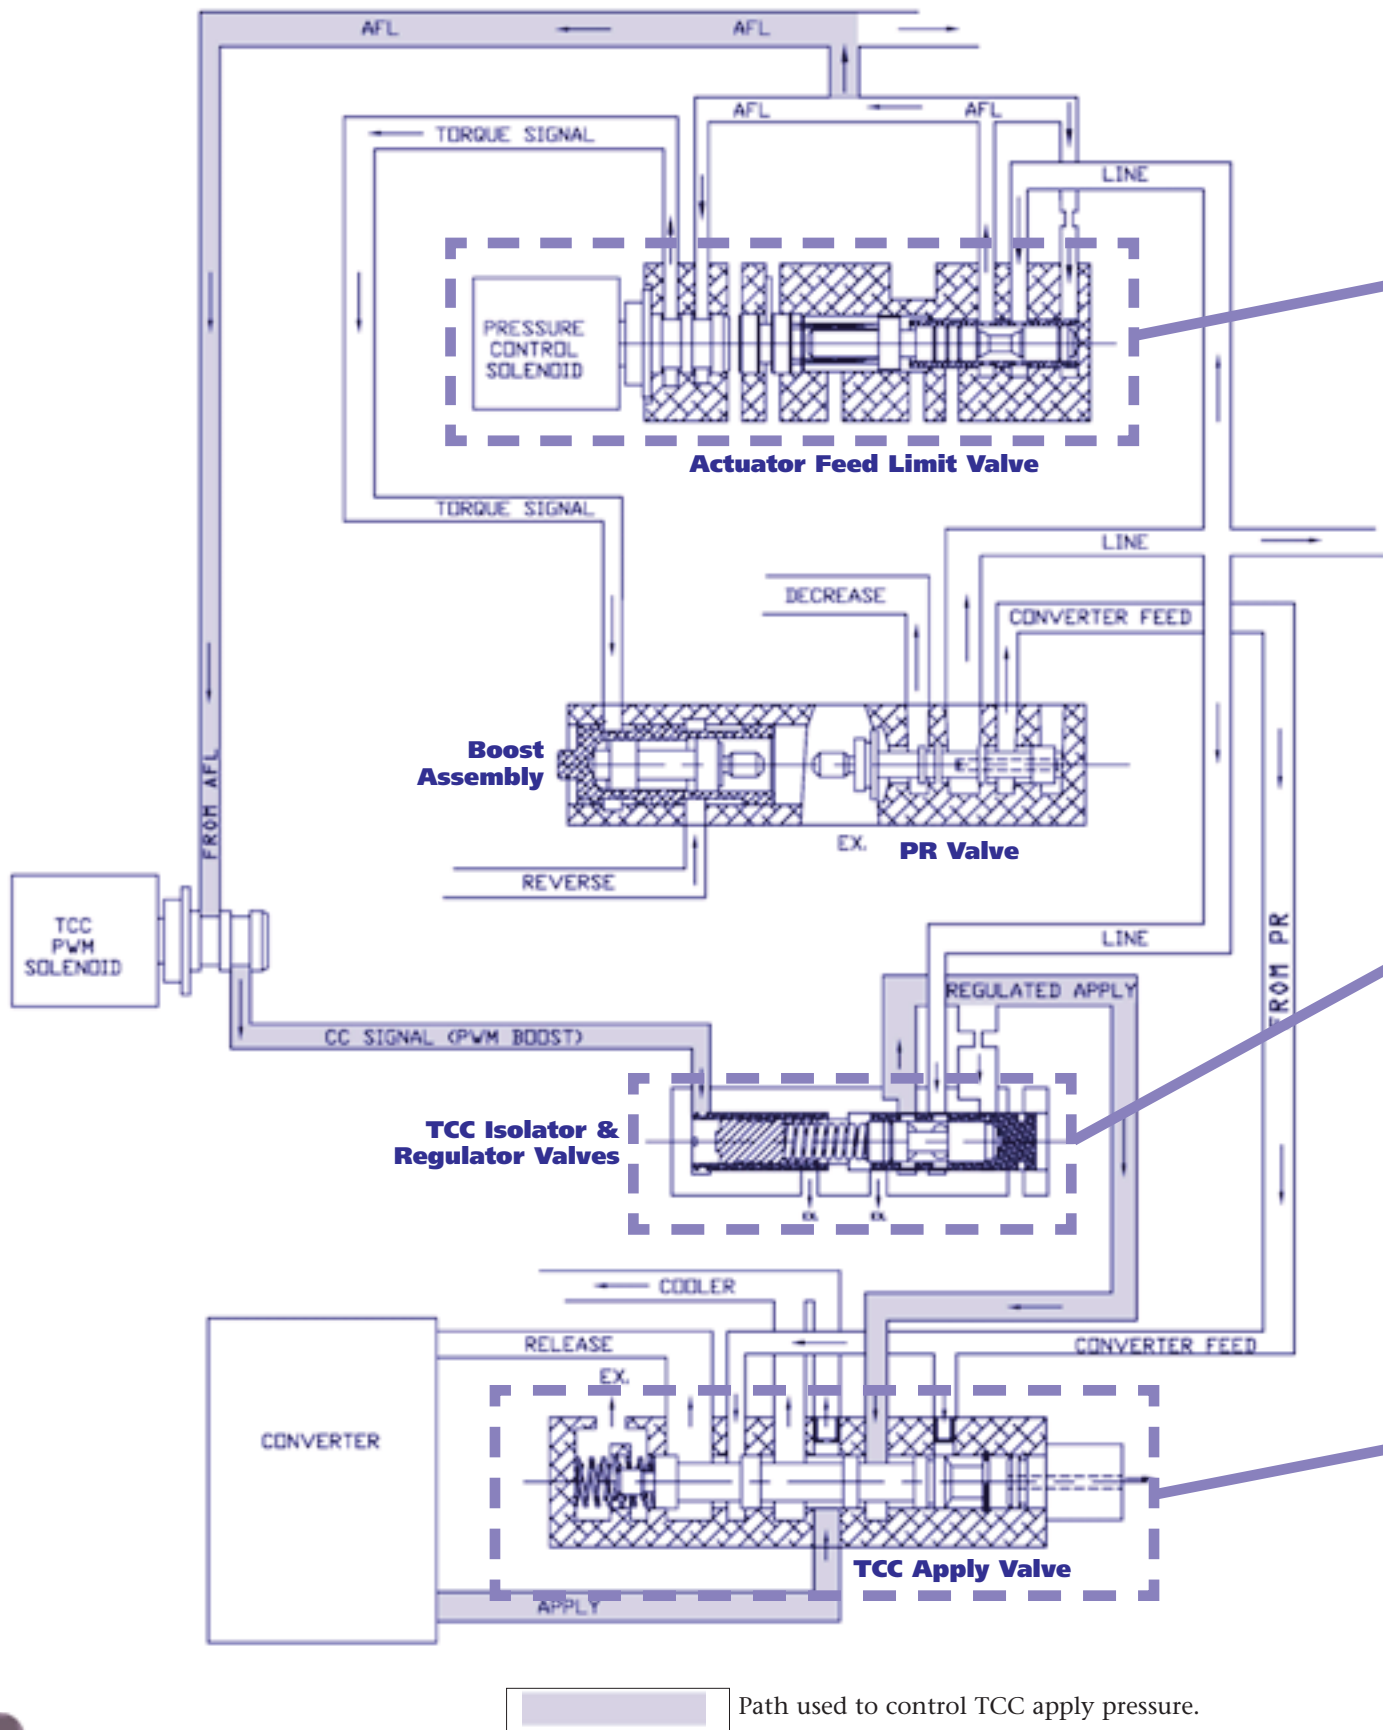
Figure 1

In the system shown, the first component involved is the Actuator Feed Limit Valve. This valve determines the signal pressure available to the TCC PWM Solenoid. The PWM Solenoid CC signal then strokes the Isolator and Regulator Valves, establishing a regulated apply pressure which is made available to the TCC Apply Valve. Changes in duty cycle at the PWM Solenoid are used to increase or decrease this regulated apply pressure. The TCC Apply Valve must then deliver the regulated apply pressure to the Torque Converter Clutch Piston.

4L60-E PWM CONTROLLED SYSTEM
