# New options for rebuilding the E4OD/4R100/5R110W Converters

by Mike Morin

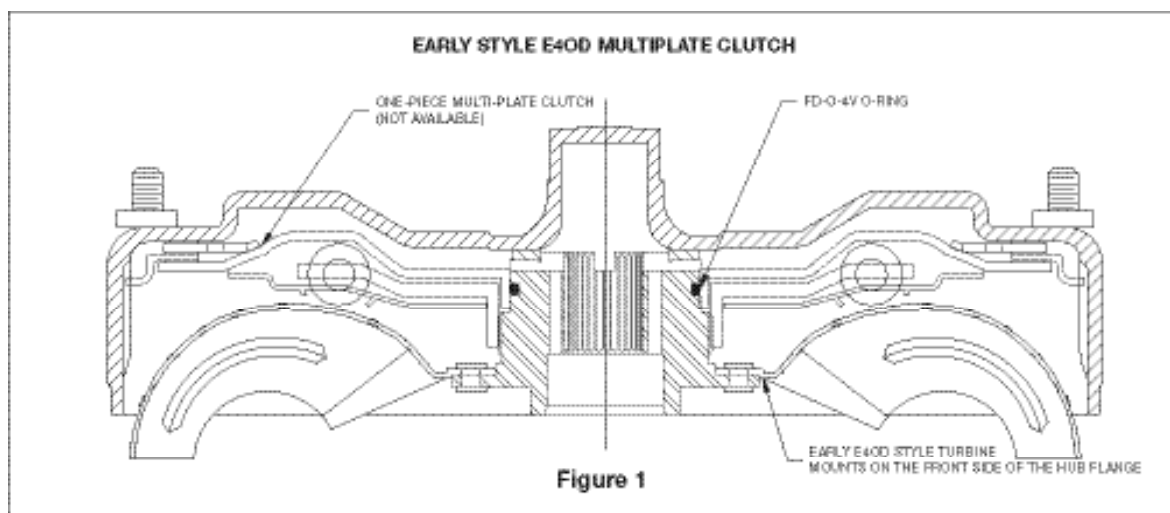
**W**e often talk about E4OD and 4R100 converters as if they're the same thing. When our article on E4OD converters appeared in our last catalog, the options were limited in rebuilding the E4OD multi-plate or grob converter. Ford redesigned the E4OD converter piston, damper clutch, turbine and turbine hub when it switched to the 4R100 transmission design, but left the rest of the parts in the converter the same. The old E4OD multi-plate clutch is difficult to repair because it is a one-piece design that must be disassembled to replace the friction rings (*see Figure 1*).

the original E4OD turbine and turbine hub design with the o-ring seal (see Figure 1). As noted earlier, it is difficult to replace the friction rings on this design because the damper assembly must be disassembled. Many rebuilders still convert this design to the heavy-duty single clutch by using a Sonnax forged cover (see Figure 2).

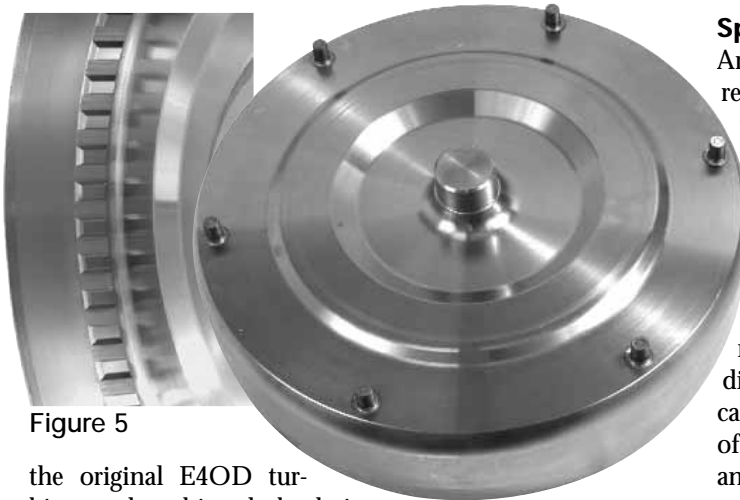
Figure 5

Sonnax has offered heavy-duty forged billet front covers since 1999. These covers were designed for the single friction clutch only and could not be used with the multi-plate clutch. Since the high torque diesel and gas engines use the OEM multi-plate clutch, a splined version of this converter cover was needed. The new Sonnax billet cover FD-CC-17S offers both the spline feature for the multi-plate clutch and thicker walls for extra strength. The shaped spline on this cover is taller and provides more engagement than the OEM cover grob spline, and that extra spline engagement reduces wear on the cover spline and splined ring. The Sonnax cover is designed to take the abuse from the extra torque produced in a chipped or modified engine. A billet cover should also be considered for vehicles towing heavy loads (*see Figure 5*). Sonnax also offers a four-long-stud spline cover, FD-CC-17L4.

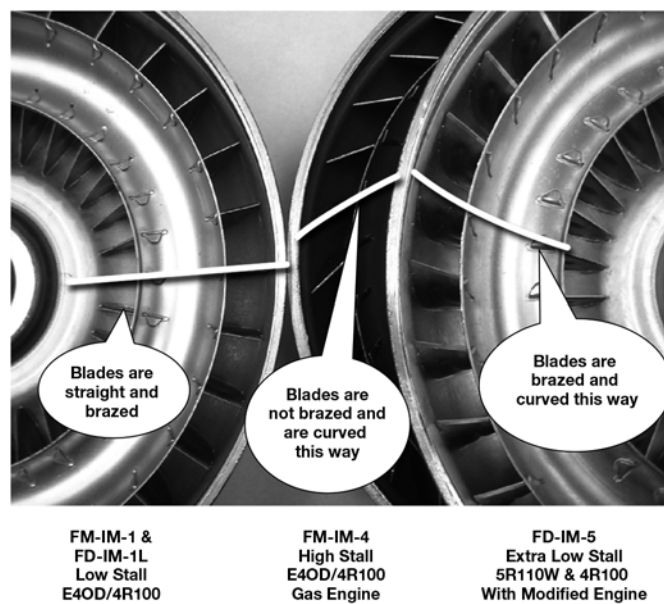
### E4OD/4R100/5R110W IMPELLER IDENTIFICATION

tic stator cap; and FD-IM-1L low stall (105K) without hub base slots for use with a bearing and steel stator cap. If you are building a converter for a modified engine that produces at least 560 ft.-lbs., you should consider using the Sonnax FD-IM-5 extra low stall (95K). This is the same impeller used in the 5R110W converter (see Figure 6). These impellers come complete with impeller hubs.
