TECHNICALLY *Speaking*

Article No.: TCTIP-03-2009

Internal Clearance

Sometimes misunderstood, and often overlooked, but very important!

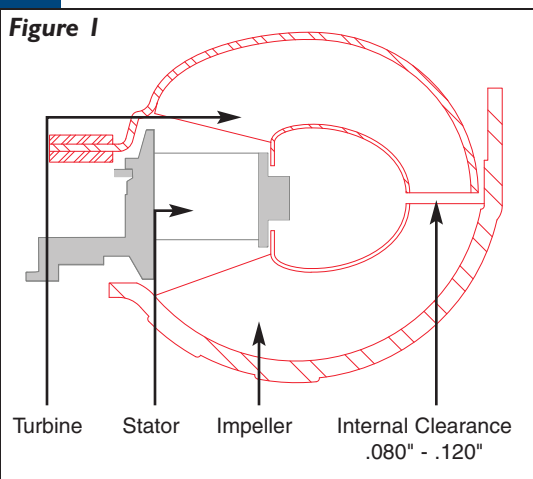
Figure 1

"Internal clearance" is the space between the impeller and the turbine in an assembled torque converter.

Hydraulically, it is the distance that the oil travels from where it exits the vanes of the impeller to where it enters the vanes of the turbine. Some rebuilders use the term

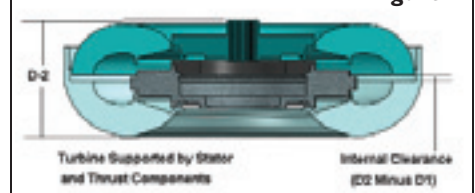
Figure 4

Now, take the turbine out of the impeller and place the stator and all thrust components into the impeller, followed by the turbine. The impeller and turbine are now separated by the stator and thrust washer. Once again, measure from the top of the turbine hub down to the flat surface. The difference between the two measurements is the internal clearance.
