Converter Conundrums

The top 3 converter vs. transmission issues of 2010

TCRA 2010

Presented by:
Bob Warnke

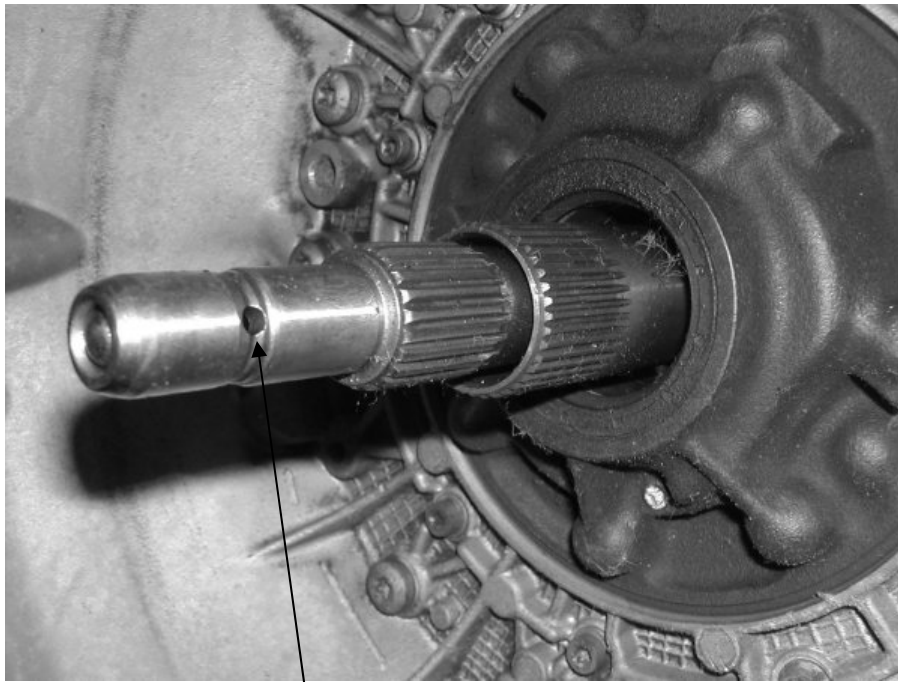
TCC Piston Apply

5: The TCC piston must return to release the converter clutch. A problem arises when centrifugal force reacts on fluid trapped behind the clutch piston. The residual pressure plus the force walks the piston toward the clutch. Within the 722.6 converter, oil trapped behind the TCC piston cannot be vented. This problem is increased by charge pressure of 50-100 psi. working its way into the low pressure TCC circuit.

The TCC apply circuit can be air tested, (30-60 psi.) with the unit in the vehicle and the valve body in place. Charge the exhaust hole. The air supplied will push remaining fluid into the converter TCC piston. Minimal leakage should come out cooler lines or other valve body locations.

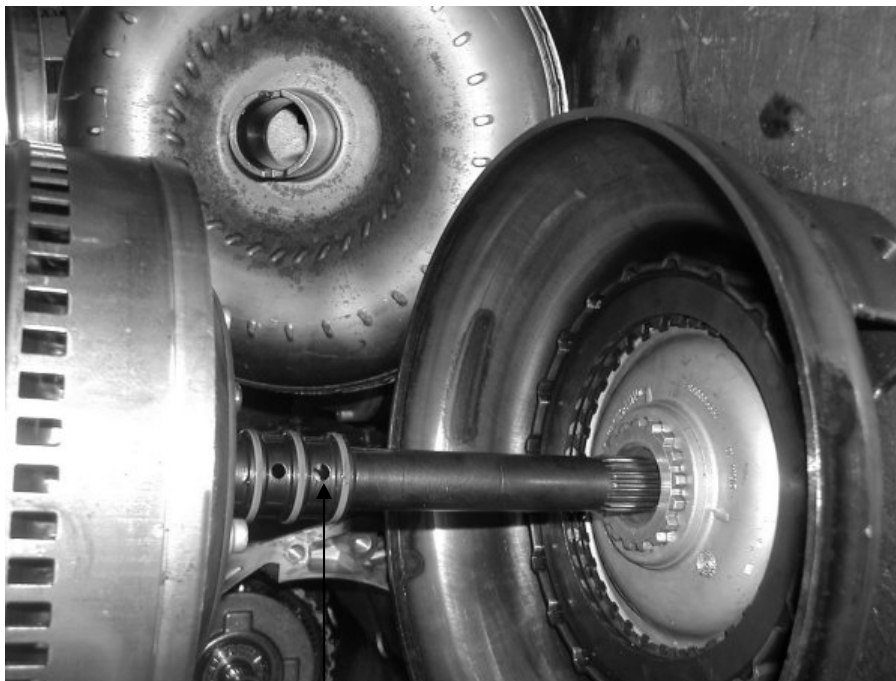
TCC Piston Apply

If the valve body is removed, the three converter circuits can be isolated. Any leakage from converter charge or converter out, is from cross leak at the pump or within the converter.

Note: Teflon type of sealing rings require fluid to lift. If air testing with a dry circuit, they will cross leak. Turbine shaft sealing rings should be the OE overlap design. Valve body must be flat and the pump stator or converter cross leaks should be eliminated. Internal transmission bushings insure the turbine shaft runs true, a requirement for the rings to seal.
