Delay in reverse or slipping causing burnt clutches and bands

Reverse Boost Valve Kits

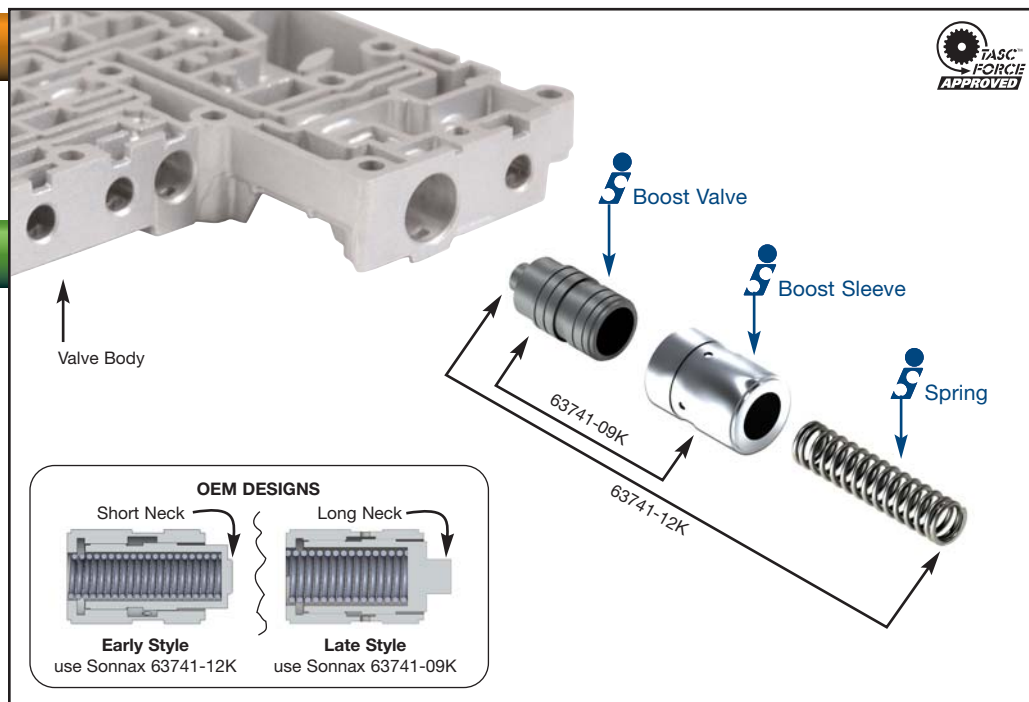
Either a Wet Air Test or a Vacuum Test in the location shown, results in leakage. A vacuum test must hold a minimum of 18".
