Article No.: TASC Tip_07-07

Déjà vu all over again

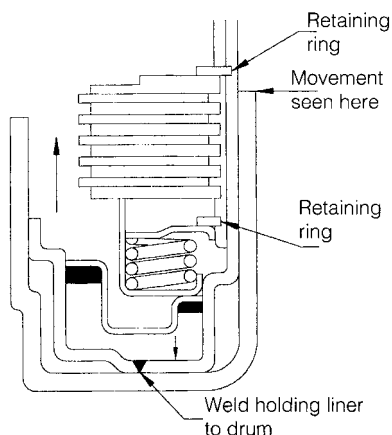
Figure 1

When GM introduced the stamped steel drum for the THM 200 transmission, it presented technicians with some new challenges. The 200 direct drums would crack where the inner liner (where the piston lives) was joined to the outer shell. The weld that holds the two members of the drum together is subject to pivotal flexing each time the clutch is applied. Over time, this flexing action will cause a crack at the weld.

The challenge to the technicians was in finding the crack (leak). Since the crack was under the piston and not visible from the outside of the drum, it wasn't detectable with a normal air check. Some ingenious technicians learned that adding a small amount of mineral spirits between the mating parts of the drum before the air check helped to find the crack. A mist would rise from the cavity between the mating parts at the point of the crack when air was applied.
