Manual Valve

96201-05

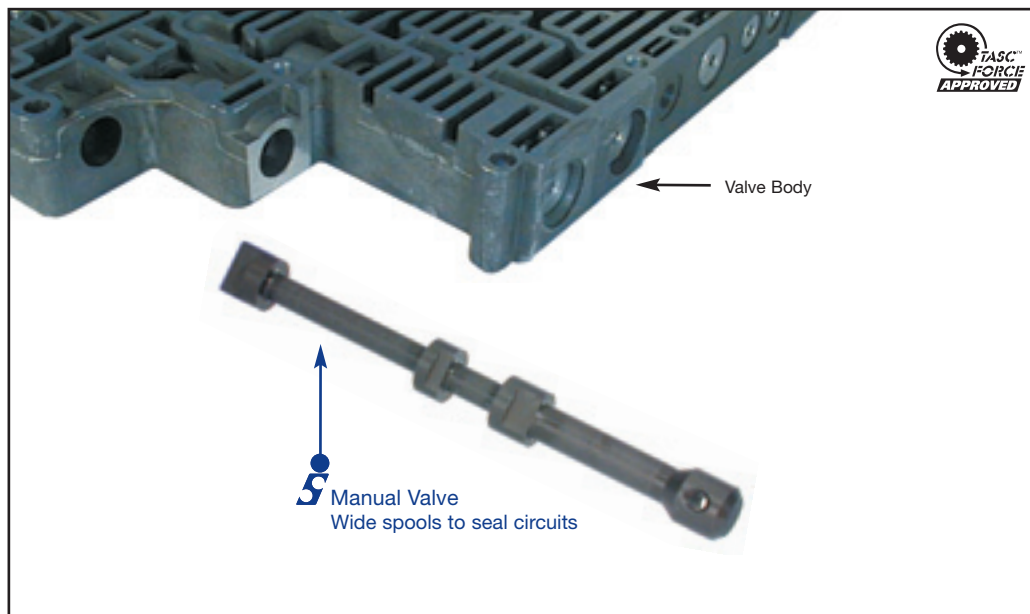
1 Manual Valve

This manual valve was designed to reduce loss at the manual valve bore. In some conditions the bore will become severely polished or have step wear from frequent linkage movement. This can be seen visually in badly worn valve bodies. To verify if the bore is worn, a “wiggle test” can be performed as illustrated below. On an assembled unit, or dyno test, the pressure will be erratic and may drop below 50 psi in O.D. range as the unit reaches operating temperature. In order to perform a Wet Air Test of the forward circuit and manual valve, the unit must be completely assembled with fluid filling the valve body, in order to seat the checkballs. With side cover removed, place the selector lever in O.D., and blow air into the forward tap. Fluid leaking out the end of the manual valve bore is leakage past the end spool.
