## TCC Modulator Sleeve & Plunger Valve Kit

**56947J-32K**

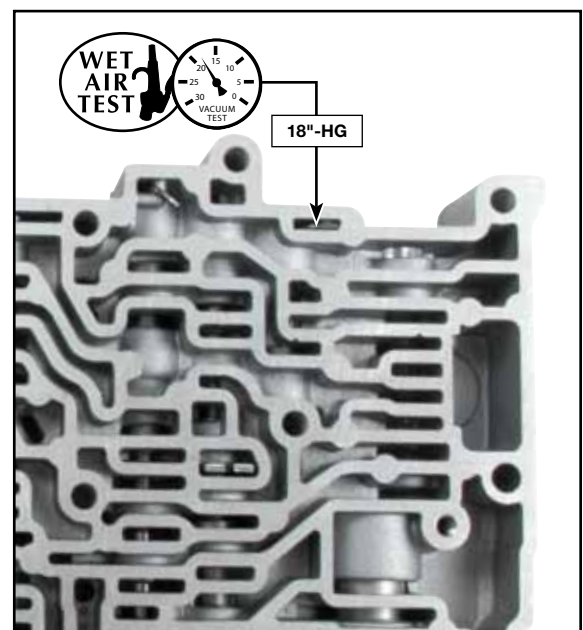
Common complaints with a 5R55N are high TCC slip RPM at increasing load, slip codes, and converter apply or release concerns. These complaints can be caused by wear of the TCC plunger valve and sleeve assembly due to constant oscillation by the pulse width modulated TCC solenoid.

A vacuum test fails to yield 18 in.-hg or greater, or if visual wear is detected.

The wear-resistant Sonnax kit prevents future wear and restores proper hydraulic clearances so fluid pressure can position the TCC modulator valve to fully apply lockup.
