## Building Inspection Report

Inspection Date: Tue, 18 Feb 2025

Property Address: 62 Hutt St, NORTHAM, WA, 6401, Australia

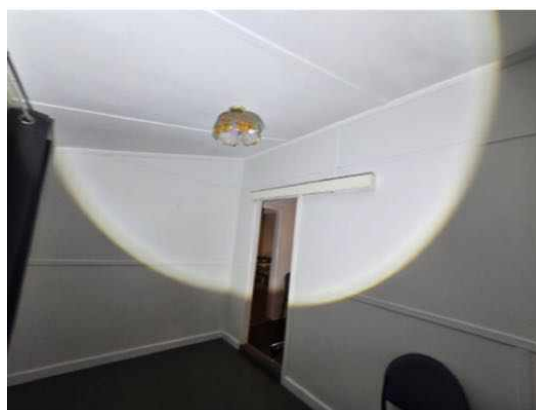
Defects 1.03

| Information: | Reporting on Asbestos is outside the Scope of this Report. This suspected defect is highlighted as a caution only. We suspect, based on our experience in the building industry, that there is a higher risk of the identified building element containing asbestos. |

As Asbestos Reporting is outside the scope of this report, we advise that you consider a separate Asbestos Inspection and Condition Audit, which can include the taking of samples for definitive confirmation of the presence of Asbestos.

In the interim, the client is advised to act with caution, especially when considering any damage to building materials general wear and tear renovations extensions demolition and general maintenance activities due to the suspected presence of Asbestos.

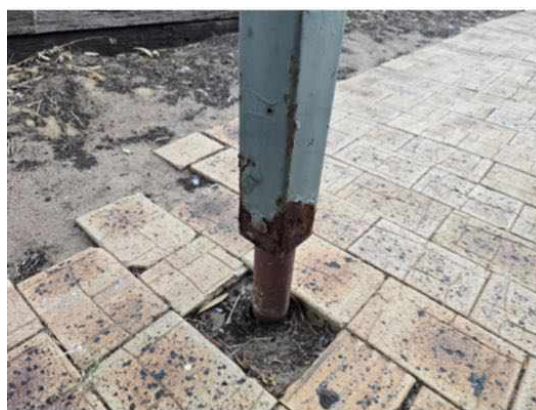
## Defects 2.02

| Finding: | Post/Column - Severely Rusted or corroded at base (rear patio area) |
| Information: | Post/Column of the rear Patio shows evidence of severe rusting and corrosion, which is likely to have developed as a result of excessive exposure to moisture and or inadequate coatings. |

As surface rust provides no protection to the underlying iron, the deteriorating condition is likely to worsen structural integrity if not addressed in the short-term future.

Base of the column/post fully corroded away which requires replacement on urgent basis to restore the structural integrity.

Where possible, the use of galvanized (treated) metals or aluminium coated metals aid in rust prevention, as does regular general maintenance. Rust formation can be controlled with coatings, such as paint, that isolate the iron from the environment.

Rusting and corrosion should be managed by ideally removing or limiting the affected surface from exposure to moisture. A registered builder may be appointed to replace any building elements that have been severely affected by rust or water damage.

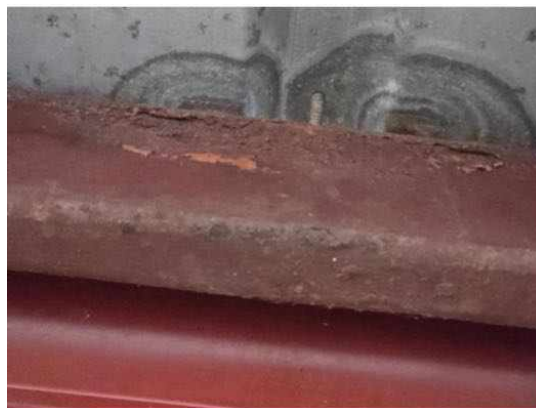
### Defects 3.01

| Finding: | Carport Roof Steel Rafter - Rusted or corroded (non-severe) |

Rusting and corrosion should be managed by ideally removing or limiting the affected surface from exposure to moisture. A registered builder may be appointed to replace any building elements that have been severely affected by rust or water damage.

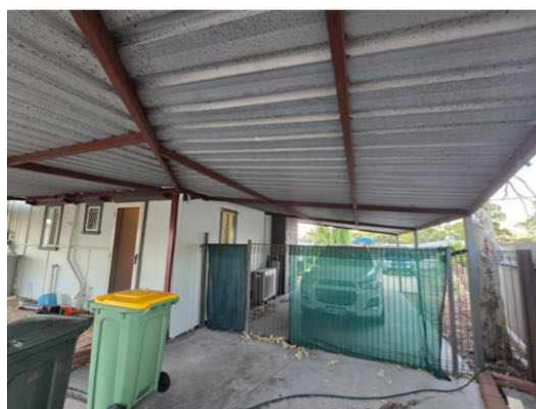
### Defects 3.02

| Finding: | Patio Roof Truss - Rusted or corroded (non-severe) |

Where possible, the use of galvanized (treated) metals or aluminium coated metals aid in rust prevention, as does regular general maintenance. Rust formation can be controlled with coatings, such as paint, that isolate the iron from the environment.

Rusting and corrosion should be managed by ideally removing or limiting the affected surface from exposure to moisture. A registered builder may be appointed to replace any building elements that have been severely affected by rust or water damage.

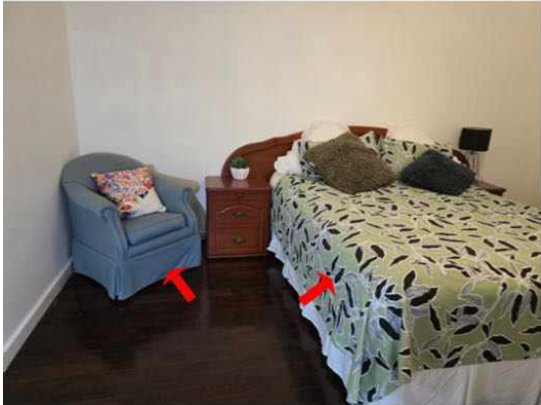
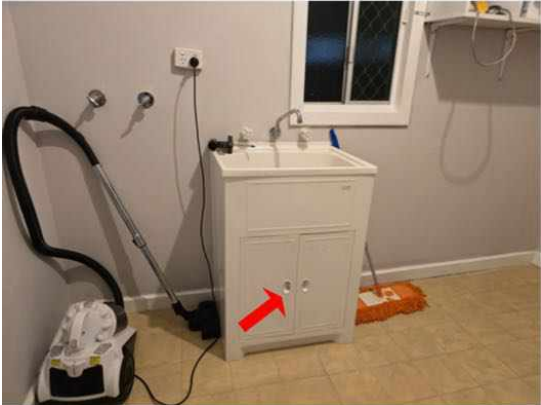
Building: Main Building  
Location: All Areas > All Areas  
Finding: Additional Photos - Obstructions and Limitations  
Information: These photographs are an indication of the obstructions and limitations which impeded full inspection of the property at the time of inspection. These obstructions can hide an array of defects and should be removed to allow full inspection to be carried out. A re-inspection is recommended once the areas are made accessible.
