Inspection Report

Property Address:
10101 Older Dallas Property
Dallas TX 75218

PROPERTY INSPECTION REPORT

By: Kevin R. Weiss 7108 / Absolute Inspections, LLC 2/10/2016

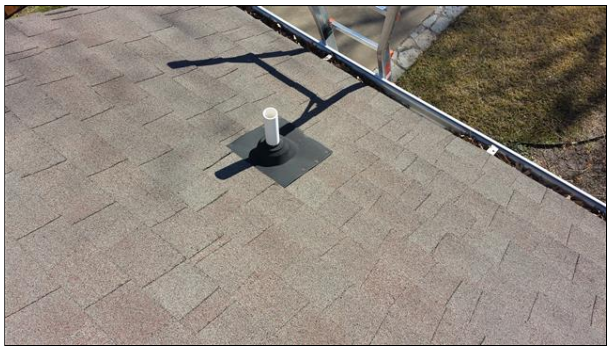
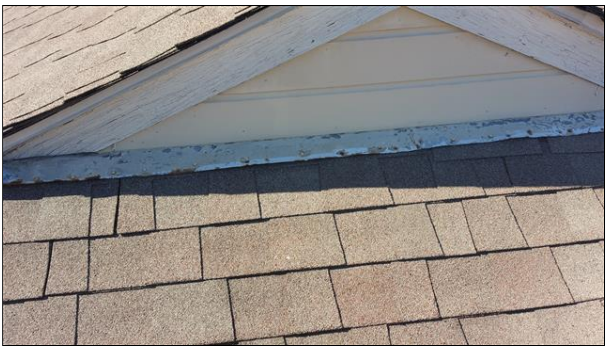
(2) Roof was walked for inspection. "Walking" the roof does not indicate that every area of the roof surface was walked. A representative area was mounted and the entire surface, or as much as safely possible, was viewed from above as well as from the ground. Some slopes may not have been walked due to safety concerns or due to possible damage to the shingles.

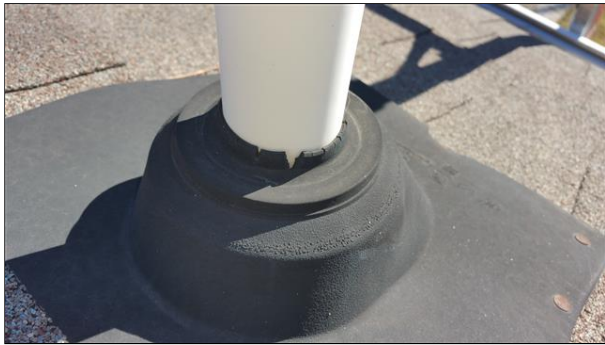
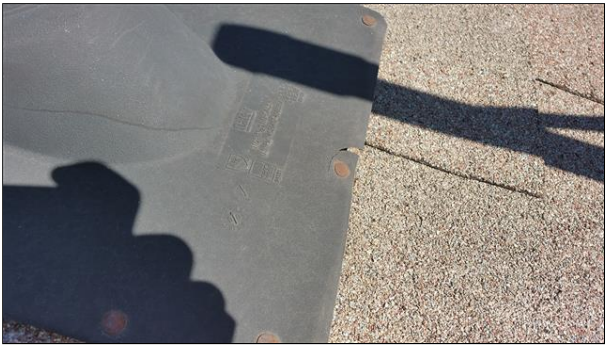
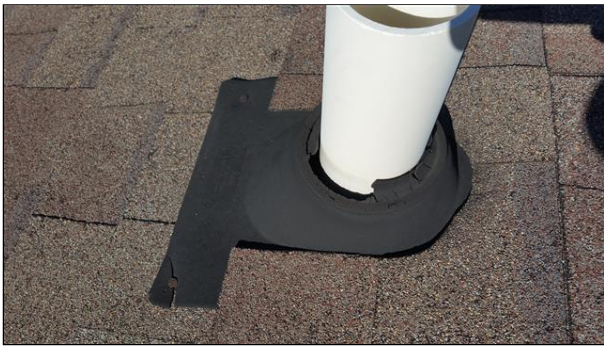
(3) Exposed staples / nail heads / fasteners observed on roof, all exposed fasteners should be sealed with appropriate roofing sealant to prevent water entry. The entire roof surface should be checked and repaired as needed at time of repair.

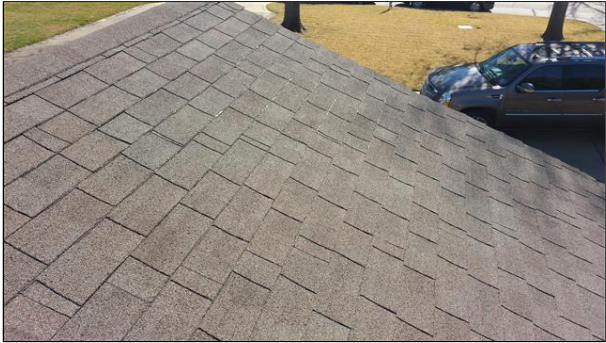
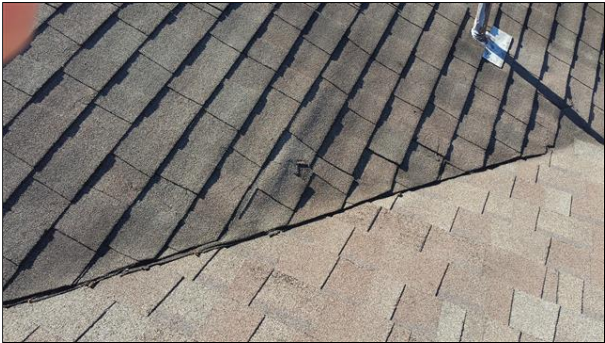
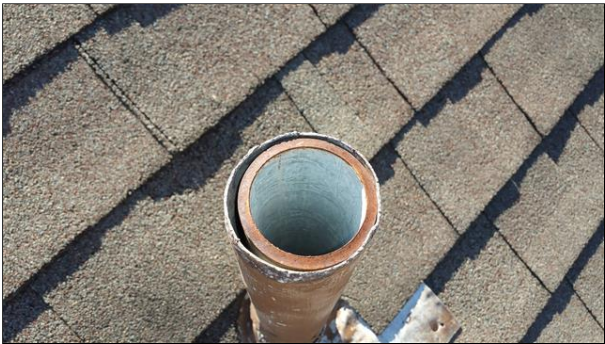
(5) Observed asphalt composition shingle "blister rash" or "mumps" in some areas of the roof. This defect is controversial as to whether or not it is a functional or cosmetic defect. In our experience it is not normal and is not cosmetic. When found it appears to cause accelerated granule loose at the mumps over time. This case shows significant granule loss in multiple locations that is not consistent with the age of the roof. These shingles need to be replaced. Recommend review and repair as needed by a professional roofing contractor.

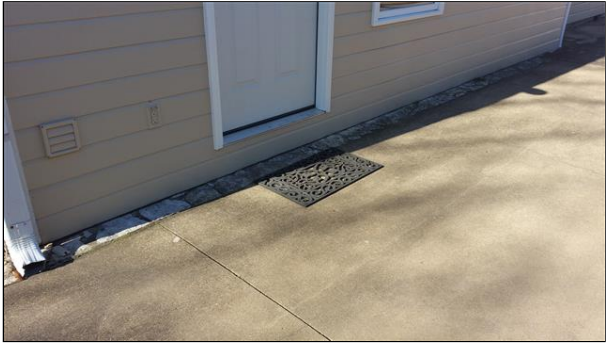
E. Item 1(Picture)

- (2) Observed that the cladding materials do not have the manufacturer required 2 inch gap between the bottom edge of the cladding/siding and the concrete flatwork. Failure to follow the manufacturers installation requirements can limit or void the manufacturer warranty on the product and could lead to premature product failure.
- (3) Rotted trim over garage over head door. Recommend review and repair as needed by a qualified contractor.

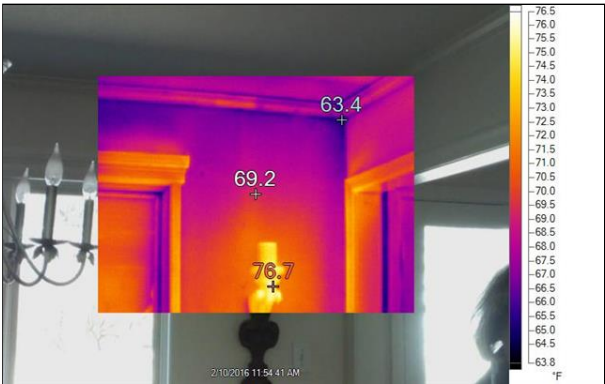
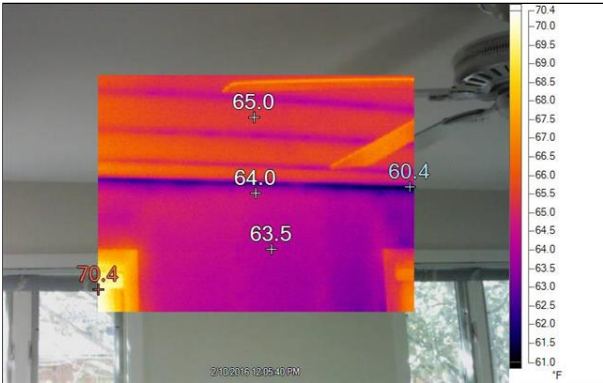
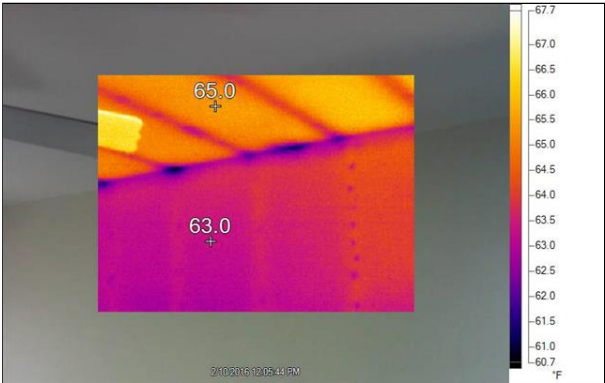
- (4) Exterior walls in the original construction areas do not have insulation. Efficiency concern. Upgrades may be desired. Typical for the age.

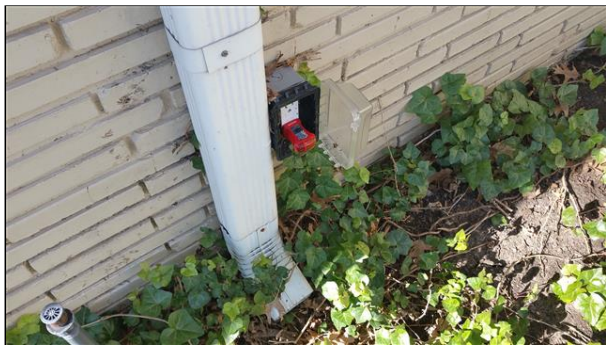
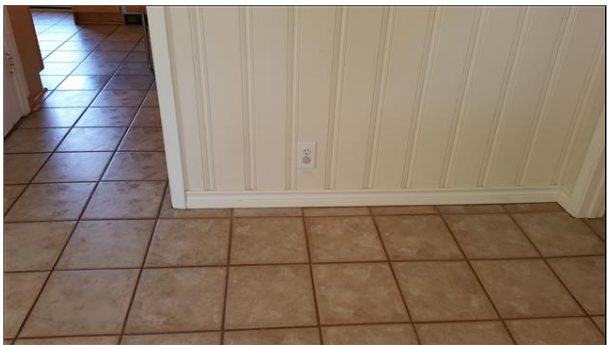
🏠 (2) Outlets observed that tested to have open grounds throughout the home. This condition is typical for an older house that originally did not have grounding. Some grounded outlets were found. Many non grounded outlets' original two-prong receptacles have been replaced with three-prong versions but are still missing grounding. This practice is typical but not proper. Recommend consultation with a licensed electrical contractor to discuss potential concerns with the current situation and possible repair/upgrade options.

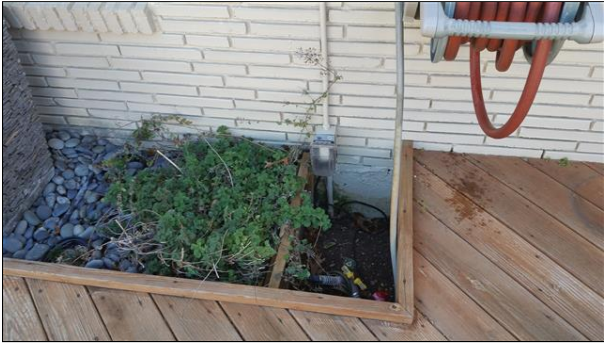
B. Item 4(Picture)

- 🏠 (3) Noted GFCI (ground fault circuit interrupter) outlets that did not trip when tested. Recommend review and repair as needed by a licensed electrical contractor. Locations include but are not limited to : exterior
- 🏠 (4) Exterior outlet cover damaged. Recommend review and repair as needed by a qualified contractor. Locations include but are not limited to : north side

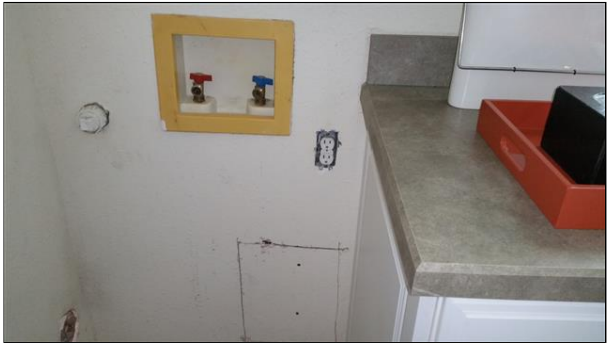
B. Item 7(Picture)

(7) Observed Covers missing at outlets. Recommend review and repair as needed by a qualified contractor. Locations include but are not limited to : under kitchen sink, laundry room

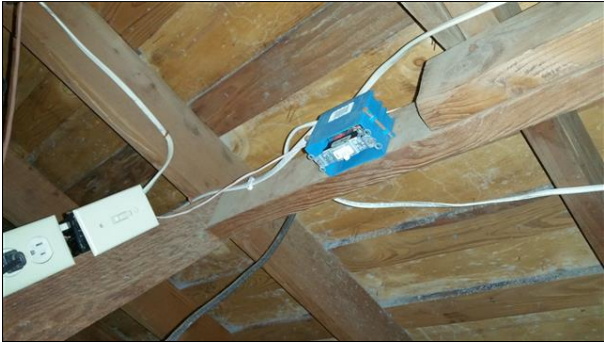
B. Item 8(Picture)

(8) Loose duplex outlets were observed. All outlets should be repaired so that they are securely mounted to the wall box and do not move when used. Locations include but are not limited to: pictured

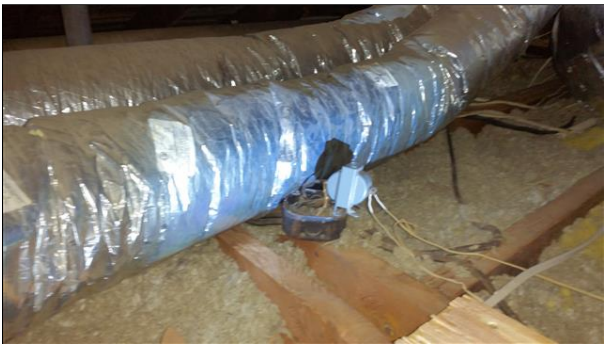
B. Item 13(Picture)

(13) Wires observed terminated outside of an appropriate Junction box in attic. Recommend review and repair as needed by a qualified contractor.

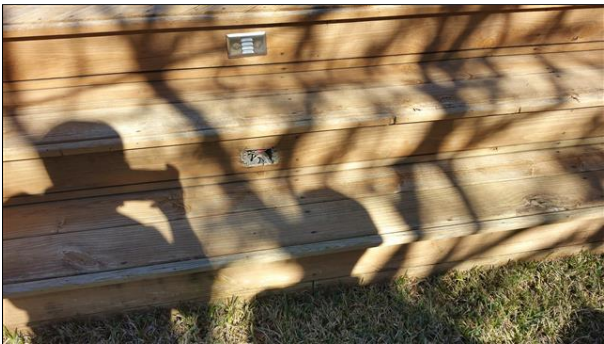
B. Item 14(Picture)

(14) Missing step light observed at rear deck. Recommend review and repair as needed by a licensed electrical contractor.

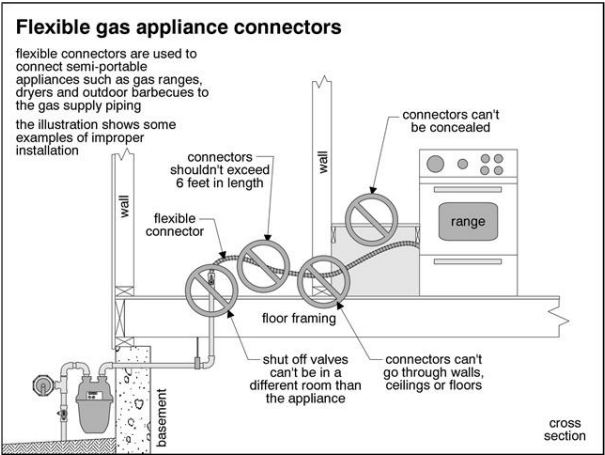
A. Item 3(Picture)

(4) Gas supply flex line(s) was/were routed into the cabinet(s). Current standards require that this connection be made outside of the furnace cabinet. Recommend repair by a licensed HVAC contractor. Locations include but are not limited to : main attic

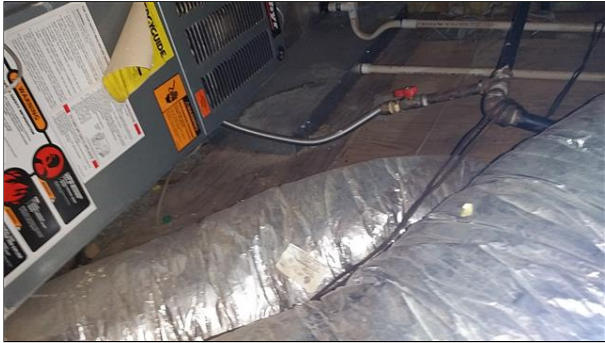
A. Item 5(Picture)

(5) Master furnace not fully accessible without disturbing ductwork and gas line. Inspected visually, without removing covers from 6 feet away.

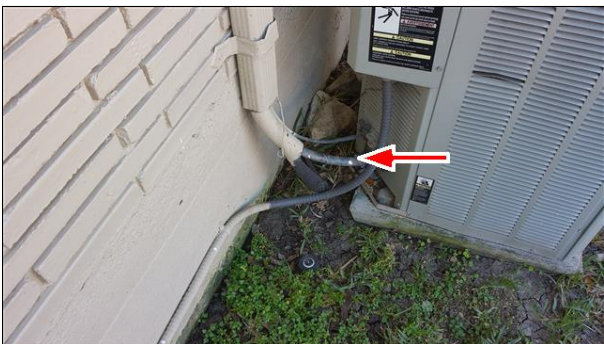
B. Item 3(Picture)

(3) Refrigerant line insulation is damaged/missing. Recommend review and repair as needed by a qualified contractor.
-

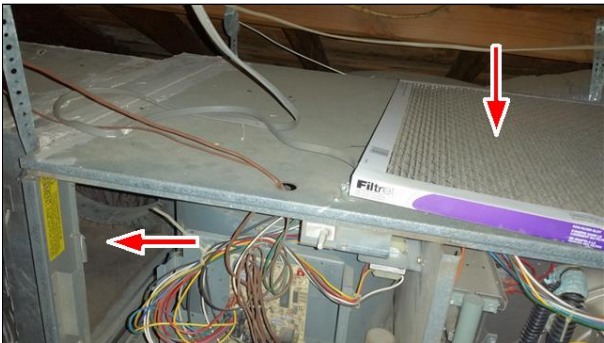
C. Item 1(Picture)

(2) No filter installed at main attic unit. Dirty filter laying on the top of the unit. Operating system without proper filtration can cause excessive dirt buildup on the evaporator coils. Recommend review of the system by a licensed HVAC contractor to include system cleaning if deemed necessary by contractor.

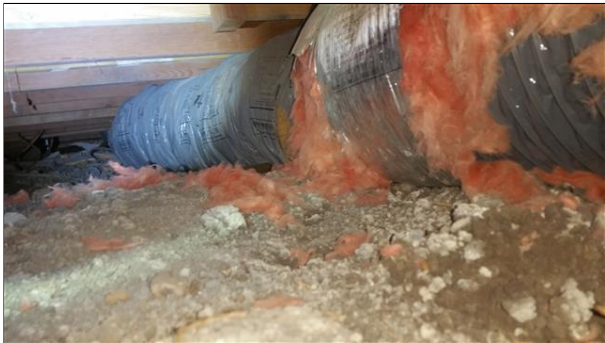
C. Item 3(Picture)

(4) Observed flexible ductwork in the crawlspace. Vapor barrier and insulation has deteriorated. Integrity of the duct was not tested. Leaks could be present which could draw in crawlspace. Recommend review and replacement by a licensed HVAC contractor.

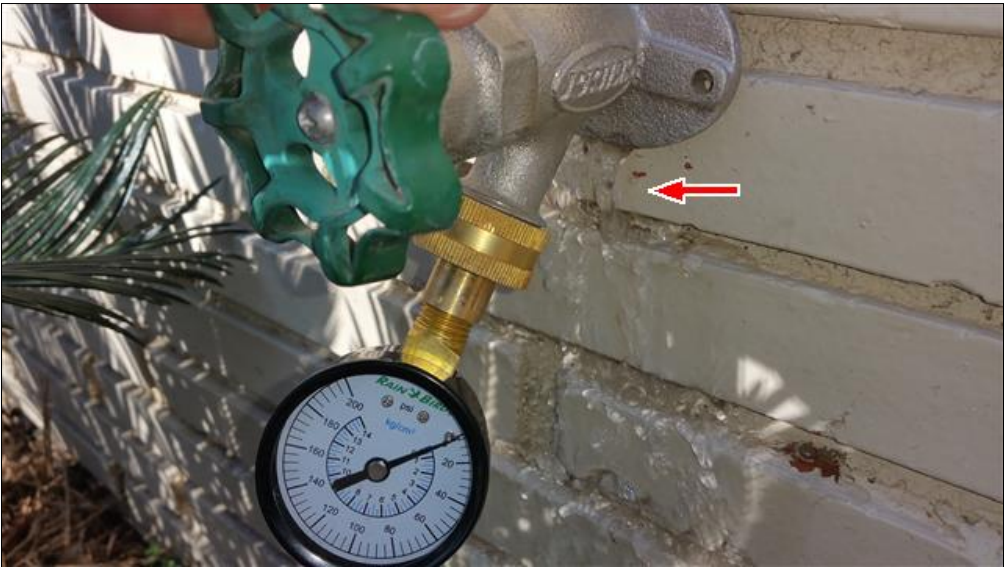
A. Item 2(Picture)

- 🏠 (2) Front North exterior faucet leaks in wall. Suspect freeze damage. Recommend review and replacement as needed by a licensed plumbing contractor.

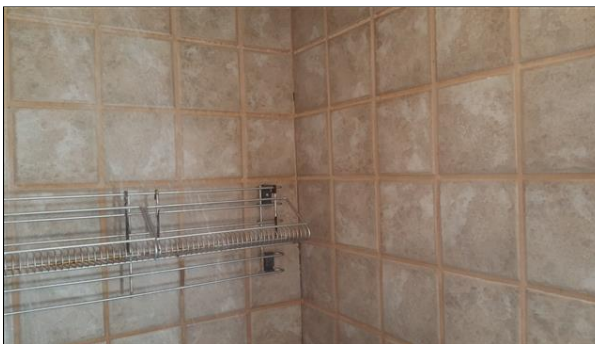
A. Item 4(Picture)

- 🏠 (6) Caulking repair or replacement is needed at shower / bath tub tile surround corners and seams. Caulking will remain somewhat flexible and will resist cracking. Caulking will be a normal maintenance item and will require periodic upkeep or replacement. Locations include but are not limited to: master shower
- 🏠 (7) Toilet bowl loose at the floor. Recommend resetting with a new wax ring and properly securing the bowl to the floor. Recommend checking for possible water damage if toilet is lifted. Locations include but are not limited to : master bathroom

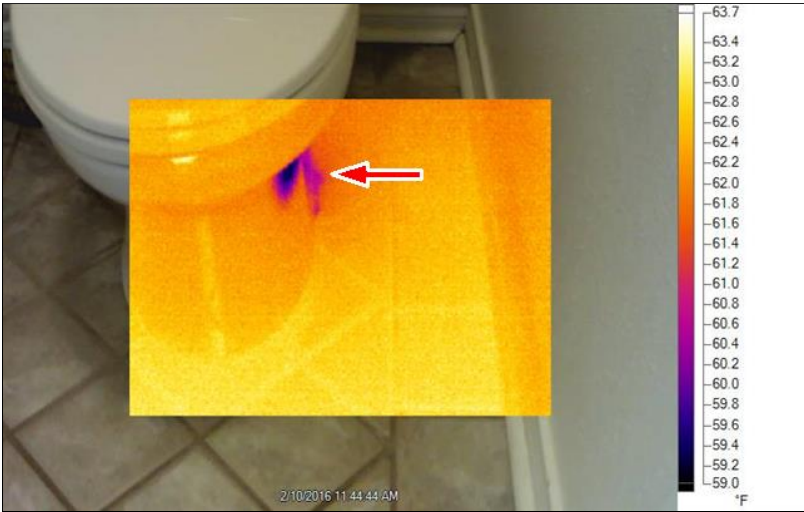
A. Item 5(Picture)

(8) Active leakage observed at loose toilet base at floor. Recommend review and repair as needed by a qualified contractor. Locations include but are not limited to : master bathroom
-

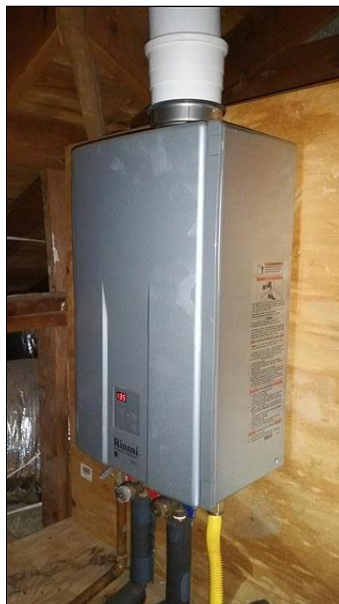
C. Item 1(Picture)

(2) Water heater did not have a safety/drain pan. The TREC recommends that all water heaters be installed with a safety/drain pan which is plumbed to the exterior to prevent water damage in the event of a tank leak. Even in garage locations the unit is generally next to at least two interior walls where water will leak to in the event of failure.
