# Inspection Report

11111 Newer Slab Foundation Existing Home Sample Inspection Report  
Plano TX

# PROPERTY INSPECTION REPORT

**By:** Kevin R. Weiss 7108 / Absolute Inspections, LLC 1/8/2016

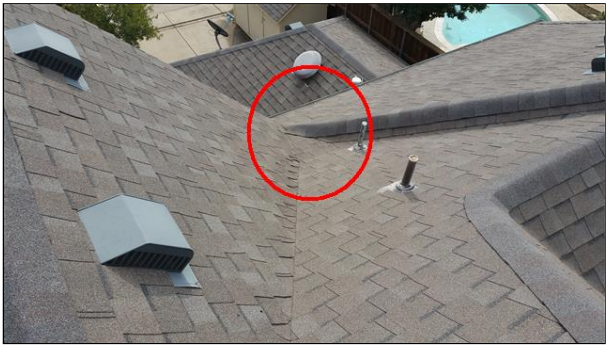
C. Item 5(Picture)

- (3) One or more areas of the roof had a low slope design with composition shingles installed. Most manufacturers recommend special underlayment installation when typical composition shingles are used on low slope areas. It is beyond the scope of this inspection to inspect the underlayment. Recommend acquiring written confirmation that manufacturer recommendations were followed.
-

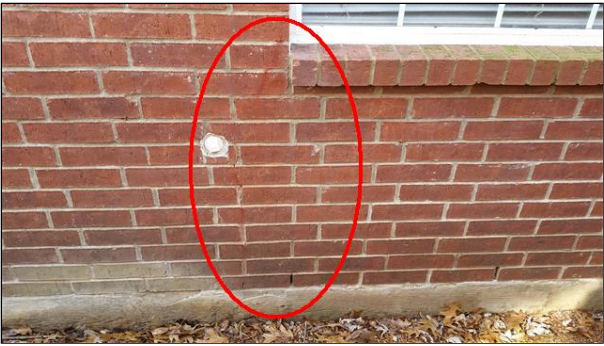
E. Item 6(Picture)

(4) Expansion joint not sealed / completely sealed. Should be sealed with a appropriate elastomer sealant. Locations include but are not limited to : North side

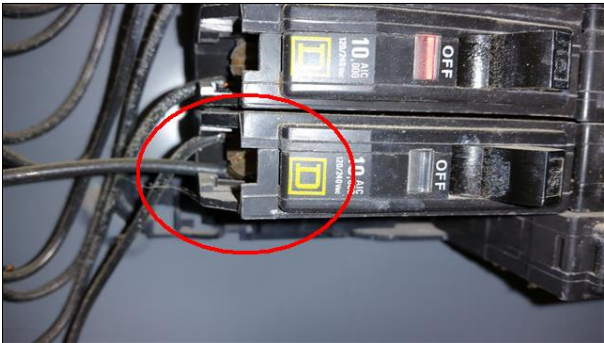
A. Item 4(Picture)

this wiring method, others don't. This can be a safety or equipment hazard under certain conditions and I recommend a licensed electrician further inspect and repair if deemed necessary.

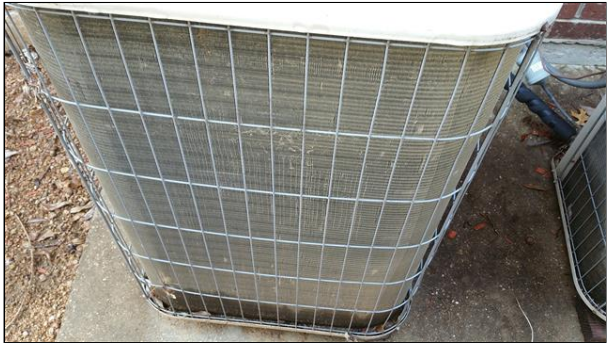
B. Item 3(Picture)

(4) Refrigerant line insulation is damaged/missing. Recommend review and repair as needed by a qualified contractor.

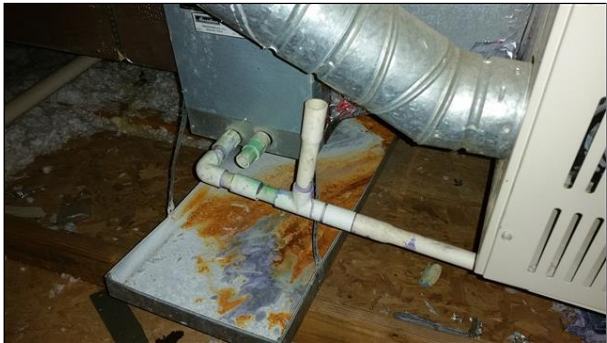
B. Item 6(Picture)

(7) Observed moisture or signs of past water presence (rust and/or mineral build up) in the secondary condensate pan(s). This is a possible indication that the primary drain line is clogged or obstructed or has been. Recommend review by a licensed HVAC contractor should be performed as soon as these units are actively used.

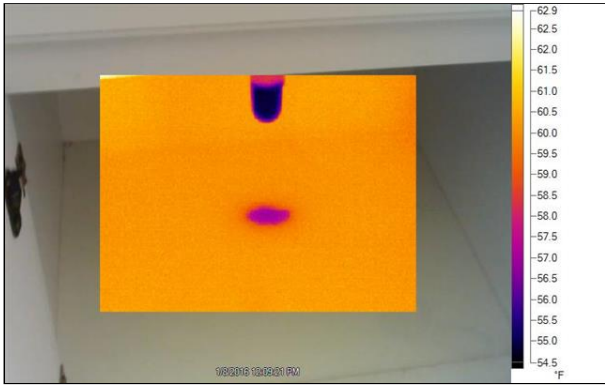
B. Item 1(Picture) right sink

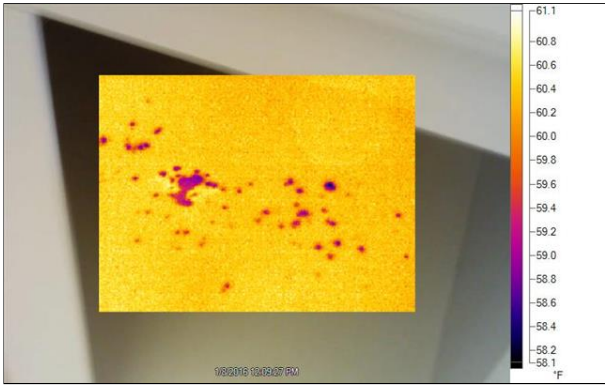
B. Item 2(Picture) left sink

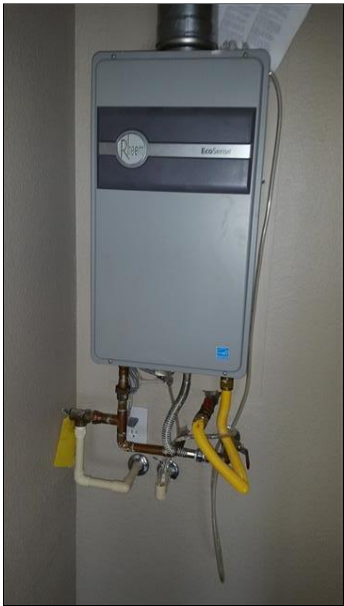
C. Item 1(Picture)

(1) Did not check operation of T&P valve due to possible damage of resident's property, or the valve mechanism. Because these valves are not normally used, operation during the inspection can cause the valve to leak. Manufacturers generally recommend testing this valve monthly. If further inspection of this device is desired a licensed plumbing contractor should be contacted.

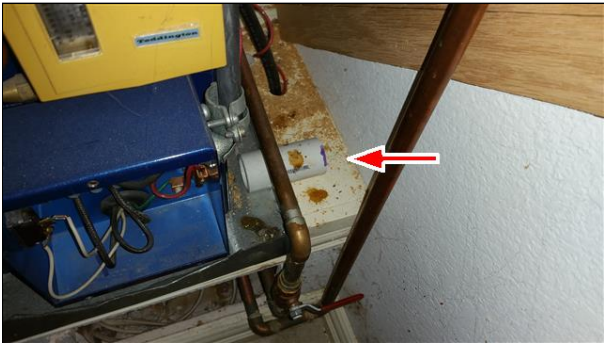
E. Item 2(Picture)

(2) Safety pan for steam generator is not properly plumbed to the exterior. Recommend review and repair as needed by a qualified contractor.

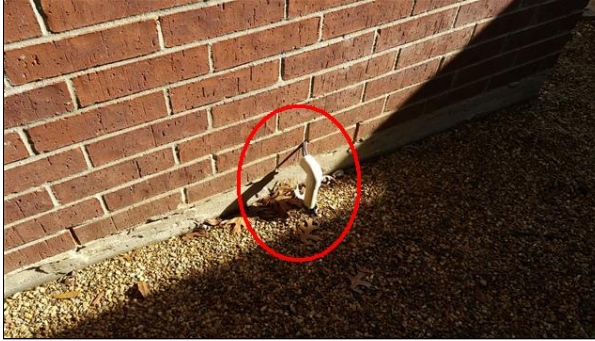
A. Item 1(Picture)

(2) PVC piping that protects the sprinkler wires as they enter the home is broken. Recommend repair of sealing.
- (3) Rain / Freeze sensor observed to be present. Operation of the sensor was not tested.
-

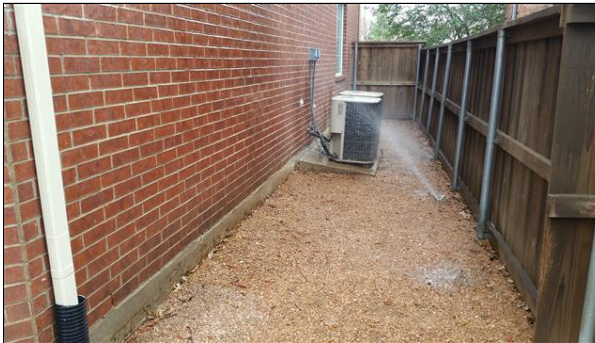
A. Item 2(Picture)

(6) Head(s) observed to spray excessively on structure in Zone 3, adjustment of head alignment needed.
