# Inspection Report

**Property Address:**  
54321 Older Slab Foundation Home  
Plano TX 75025

# PROPERTY INSPECTION REPORT

**By:** Kevin R. Weiss 7108 / Absolute Inspections, LLC 1/12/2016

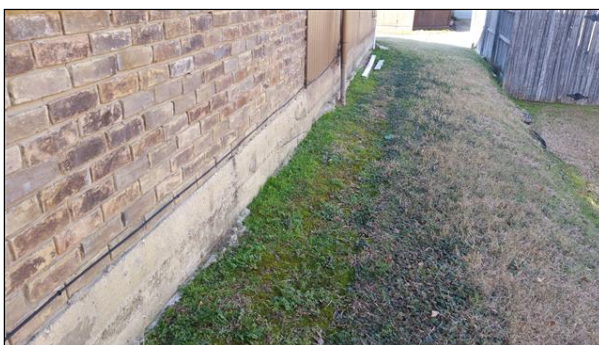
B. Item 10(Picture)

(5) Major shifting and deterioration observed in retaining wall(s). It is virtually impossible for a home inspector to determine whether cracks are caused by structural failure or by some other cause, or, if caused by structural failure, whether the cause is active and ongoing. Recommend further evaluation by a licensed professional engineer or retaining wall specialist licensed by the state of Texas.

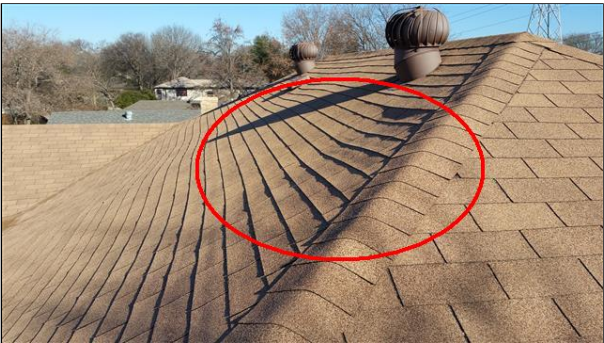
C. Item 8(Picture)

(4) Observed multiple areas of loose shingles on the roof. Pictures and caulk marking show examples. These areas had shingles that were slightly out of line and that were not properly adhering to the layer below. This condition leaves the shingles vulnerable to being blown off in high winds. Entire roof surface should be checked by a qualified roofing contractor and repair or replacement conducted as needed.

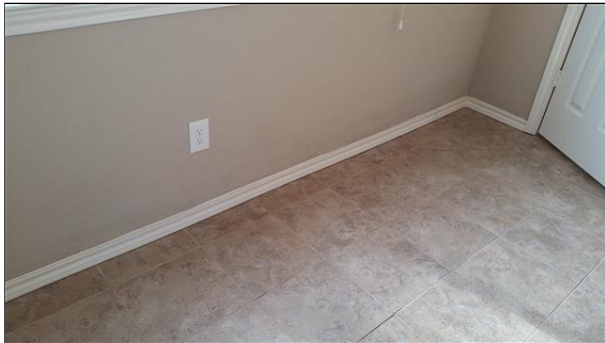
E. Item 8(Picture)

(5) Structural movement type interior cracking observed in multiple self evident location throughout the home. These sheetrock cracks are indications of structural movement that will generally exceed allowed tolerances. Recommend review by a licensed structural engineer. Locations include but are not limited to : master closet

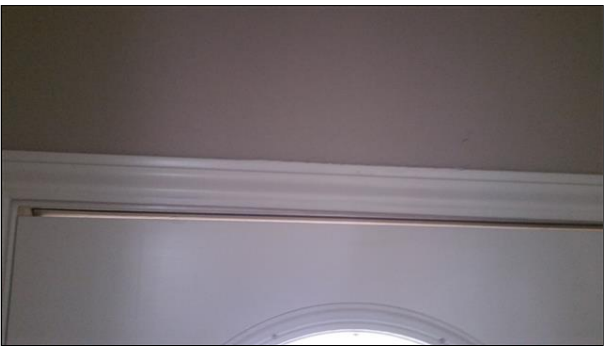
G. Item 1(Picture)

(2) Front and patio doors observed to fit poorly in opening /frame. Large gap observed at top. Recommend review and repair as needed by a qualified contractor.

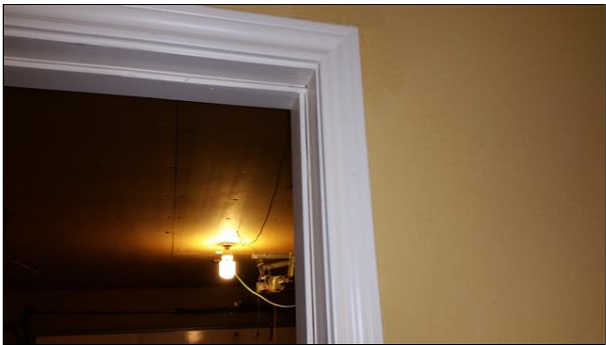
G. Item 3(Picture)

(3) Overhead garage door was not opened due to seller's motorcycle having rolled back against door. Inspector does not move seller possessions like this.

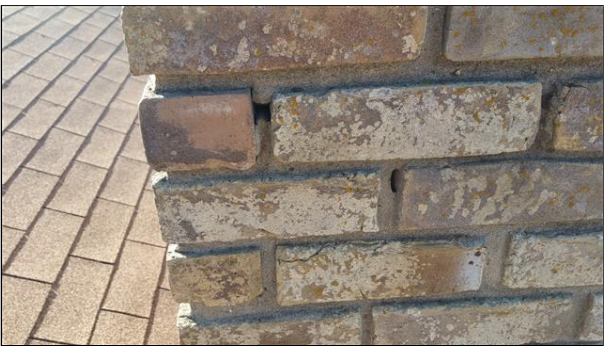
J. Item 3(Picture)

(2) Chimney concrete cap cracking and in disrepair. Repair needed by qualified contractor.

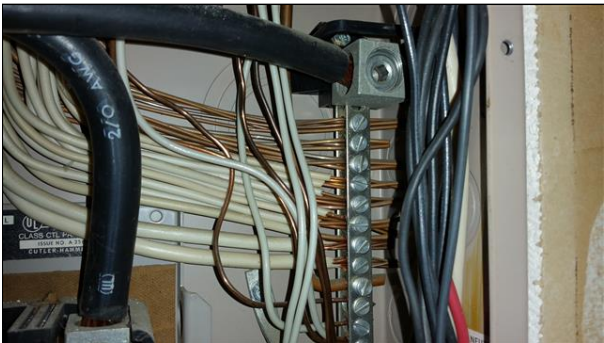
A. Item 5(Picture)

(3) Two circuits improperly joined together and protected with one circuit breaker. Commonly known as "double-lugged." This is not allowed by most breaker manufacturers, although there are a few exceptions. Recommend review and repair by a licensed electrician.

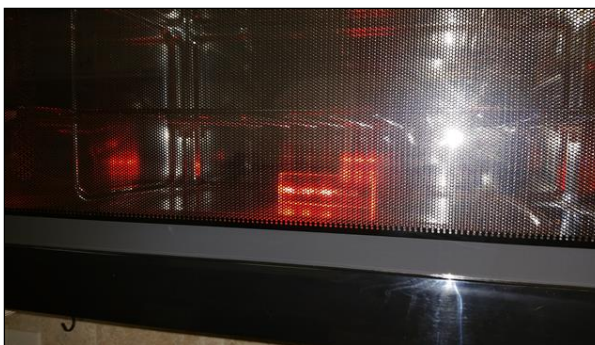
E. Item 1(Picture)

The microwave unit was inspected and appeared to be functioning as intended at the time of the inspection. Inspection of the microwave is for heating ability only. No radiation leak testing was completed.
