Inspection Report

Property Address:
9999 New Construction
Allen TX 75013

PROPERTY INSPECTION REPORT

By: Kevin R. Weiss 7108 / Absolute Inspections, LLC 8/2/2015

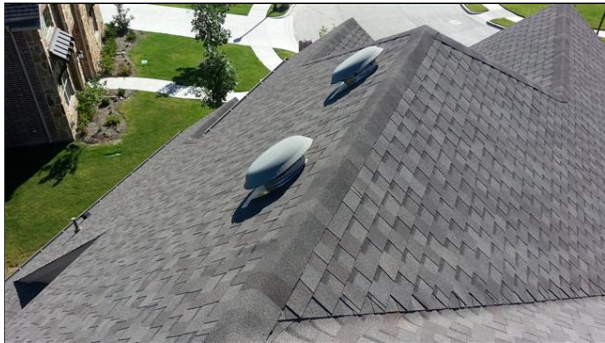
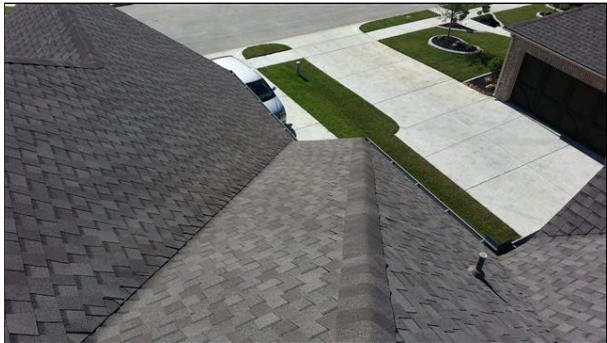
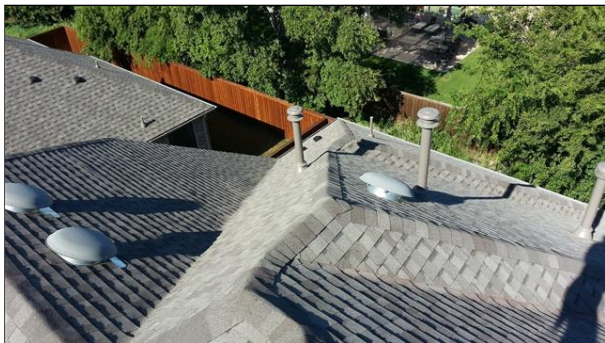
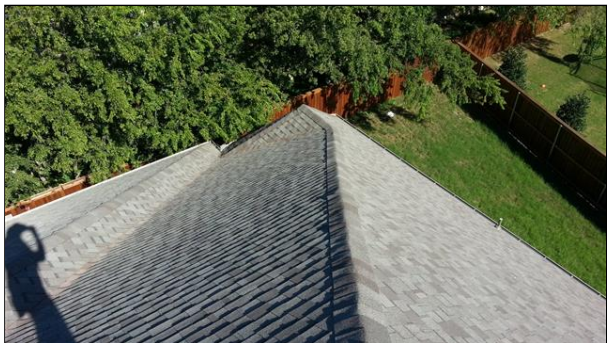
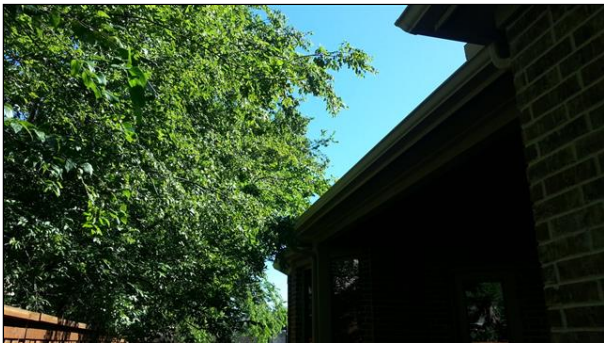
C. Item 1(Picture)

(2) Roof was mounted and walked in a limited fashion due to the steep slope of some portions of the roof. Inspector typically walks the valleys and ridges and/or lower slopes to view the roof from above but did not walk on fields of the roof unless specifically noted. Parts of roof may be observed from ground due to the height and/or pitch of the roof making it unsafe for the inspector to walk. Some areas may not be visible and are not inspected.

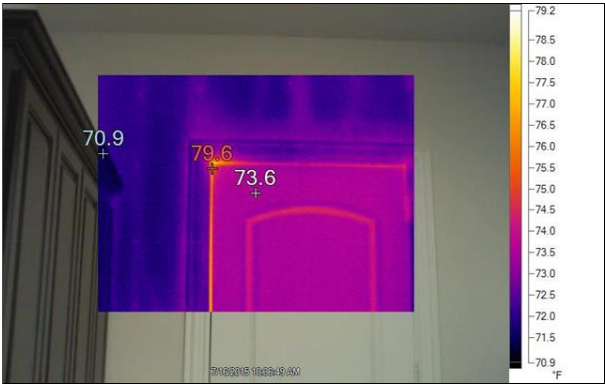
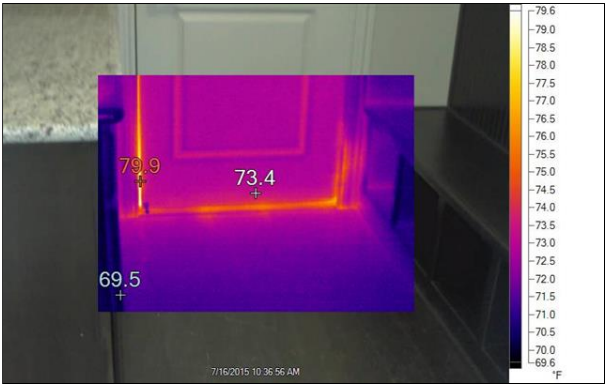
G. Item 1(Picture)

(2) Door to Single car garage latch needs adjustment. Hard to close. Recommend review and repair as needed by a qualified contractor.

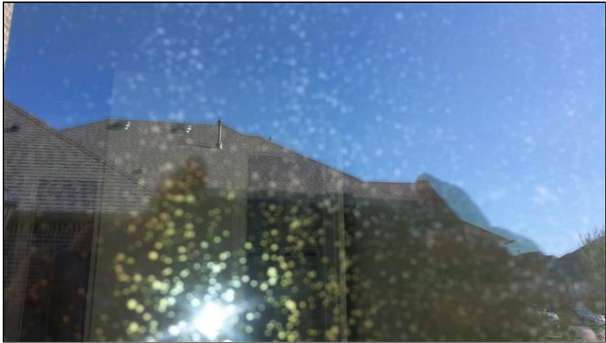
H. Item 1(Picture)

(2) Window seal appears damaged/defective due to marks inside glass at downstairs southeast bedroom. Recommend review and repair as needed by a qualified contractor.

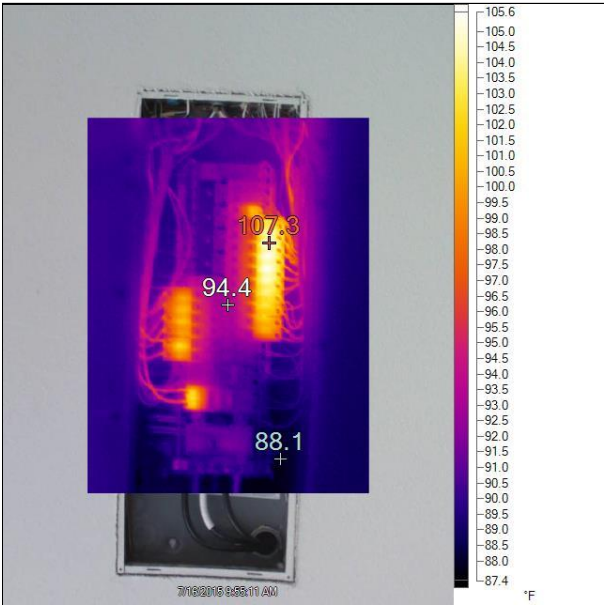
A. Item 3(Picture)

- (1) Circuit breaker panel was labeled. Inspector does not verify the accuracy of this labeling. You are recommended to verify all circuits yourself to confirm that labeling is accurate.
- (2) AFCI circuits were randomly tested at corresponding plugs to confirm protection. AFCI circuits were tested by using "test" button at panel (this is the manufacturer approved method for testing these units.) You should test them monthly.
- (3) Service entrance and panel were inspected and appeared to be properly installed and functioning at the time of the inspection.

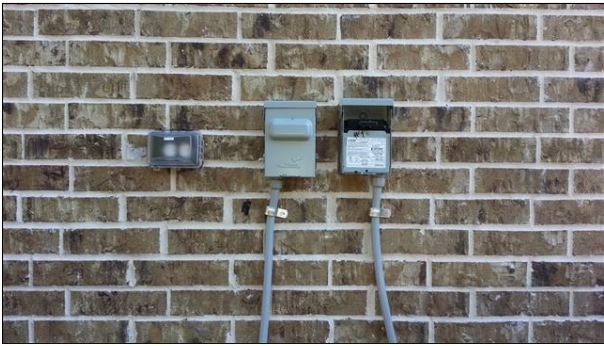
B. Item 1(Picture)

(2) AC condenser electrical cutoff box missing cover. Recommend review and repair as needed by a qualified contractor.
-

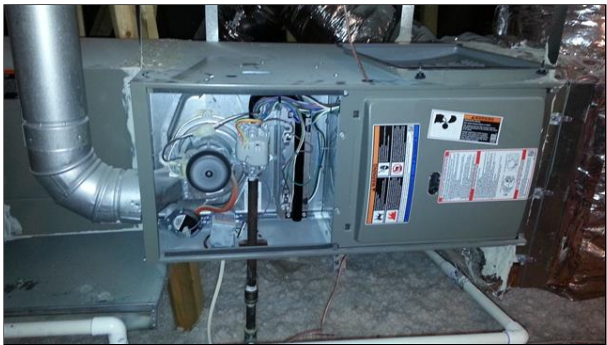
A. Item 2(Picture)

(3) The system(s) were operated using normal controls. The gas flame was a desirably blue color and no noticeable distortion of flames occurred when blower engaged.

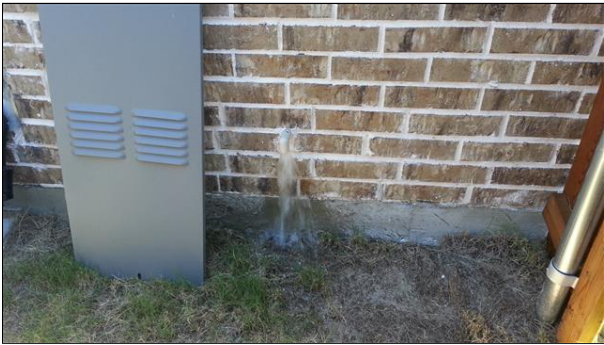
C. Item 3(Picture)

(4) T & P Drain line is improperly routed. End of pipe should be approximately 6" from ground, pointed down, and unobstructed. Repairs are required for safety.
