Inspection Report

Property Address:
999 New Construction Home
Frisco TX 75034

PROPERTY INSPECTION REPORT

By: Kevin R. Weiss 7108 / Absolute Inspections, LLC 2/19/2016

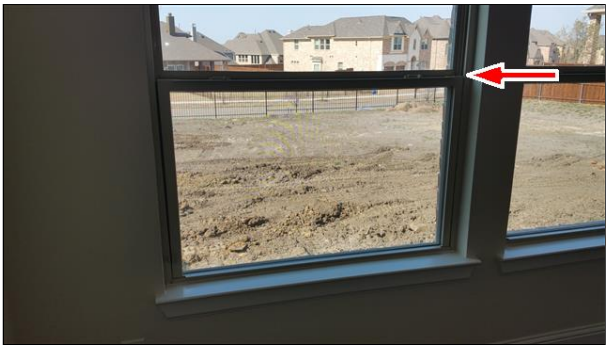
H. Item 2(Picture)

(2) Window frame separated at bottom corner. Does not appear to be separated at the interior. Recommend review and repair as needed by a qualified contractor.

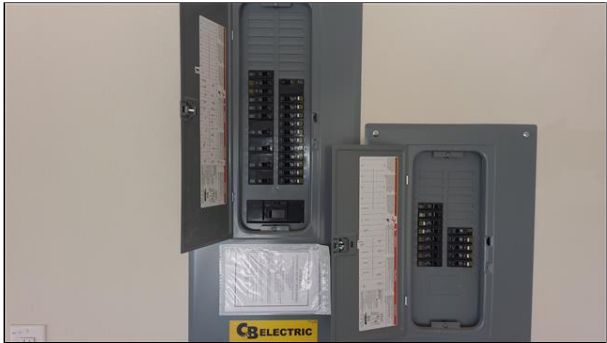
A. Item 1(Picture)

(1) Circuit breaker panel was labeled. Inspector does not verify the accuracy of this labeling. You are recommended to verify all circuits yourself to confirm that labeling is accurate.
(2) AFCI circuits were randomly tested at corresponding plugs to confirm protection. AFCI circuits were tested by using "test" button at panel (this is the manufacturer approved method for testing these units.) You should test them monthly.

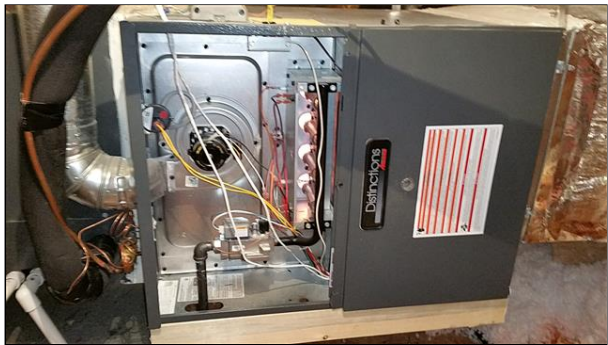
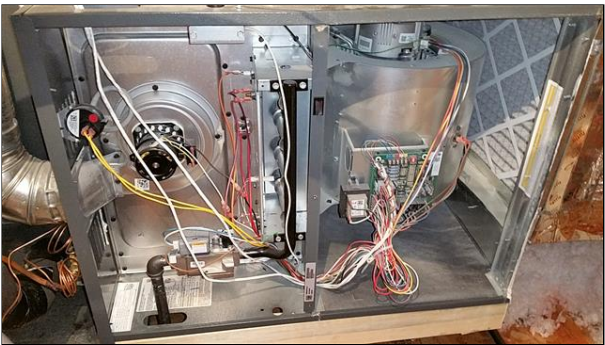
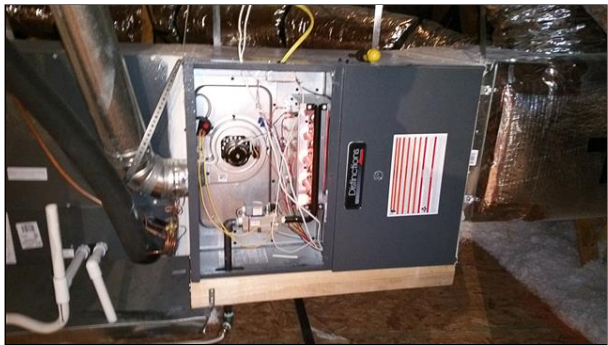
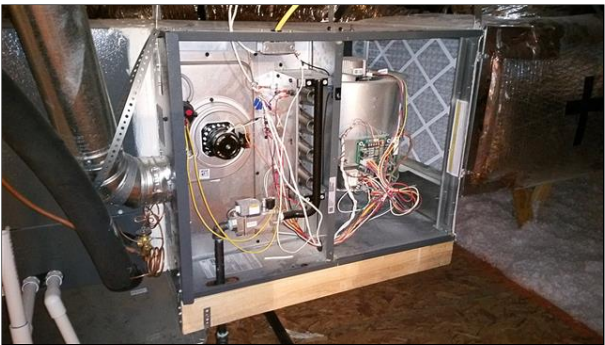
(3) The system(s) were operated using normal controls. The gas flame was a desirably blue color and no noticeable distortion of flames occurred when blower engaged.

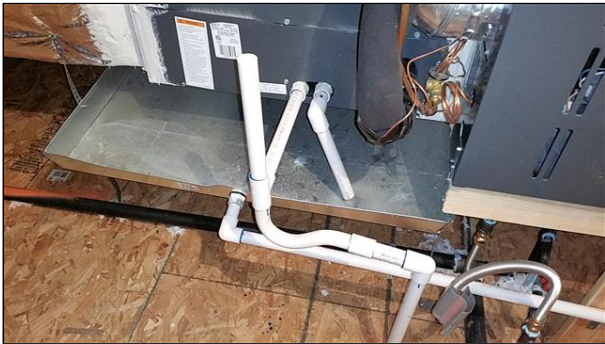
B. Item 2(Picture)

(2) Downstairs / Upstairs air conditioning unit does not appear to be functioning properly. No noticeable cooling was achieved when operated. Multiple possible causes exist. Review and repair by licensed HVAC contractor, including but not limited to compressor amp check, contact check, refrigerant check (look for leaks if refrigerant is added). Inspect and clean all coils as needed and acquire certification of proper function of complete AC system.

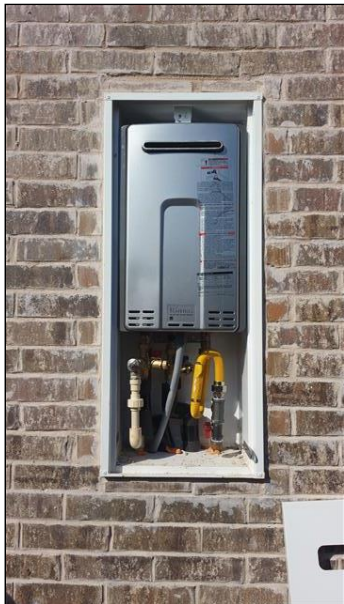
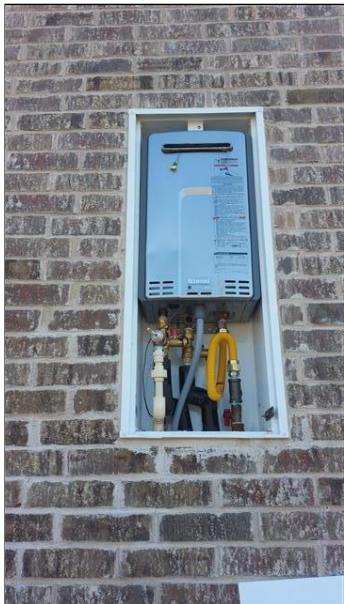
(1) T&P valve was operated and appeared to function properly. If leakage is observed outside, at any time, it is an indication of a defective valve mechanism which needs replacement. This T&P valve is an important safety feature of water heater tanks and must be properly maintained. Most manufacturers recommend that this valve be operated on a monthly basis to help keep its parts lubricated and functioning.

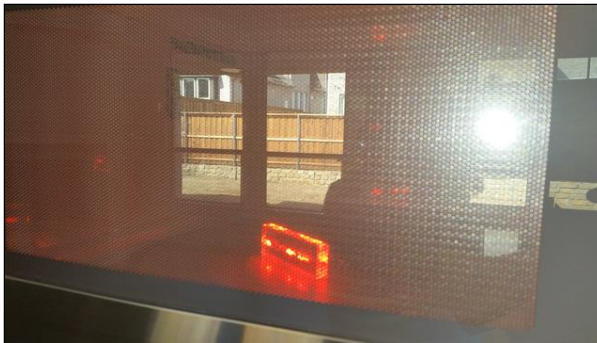
E. Item 1(Picture)

The microwave unit was inspected and appeared to be functioning as intended at the time of the inspection. Inspection of the microwave is for heating ability only. No radiation leak testing was completed.
