Vincent & Bryte Bellotti
Inspection Address: 1018 Carolyn Ave
San Jose, CA

Inspection Date: 2/1/2021

INSPECTOR: CRAIG MOORHEAD

Craig Moorhead
WellHouse Corporation - Building Inspections

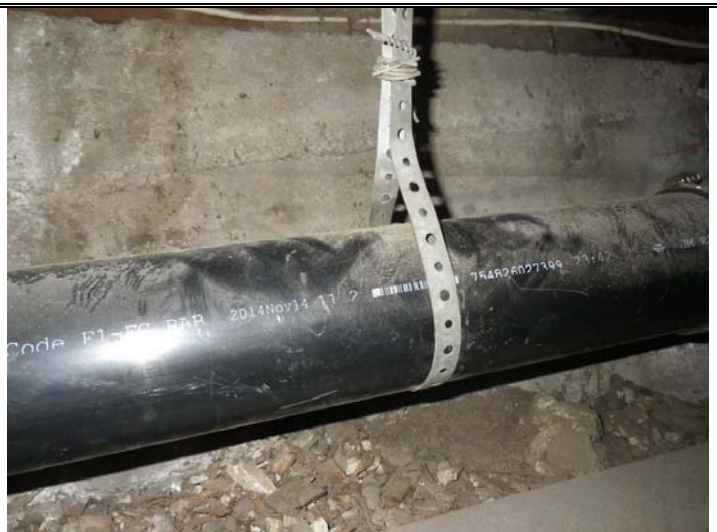
Figure 18(# 1670)

12.2. Crawlspace: The ABS drain-waste piping had metal support/hanger(s) that was in direct contact. A buffer material is generally used to prevent direct contact and resulting abrasion. Modification is suggested. (See figure # 18)

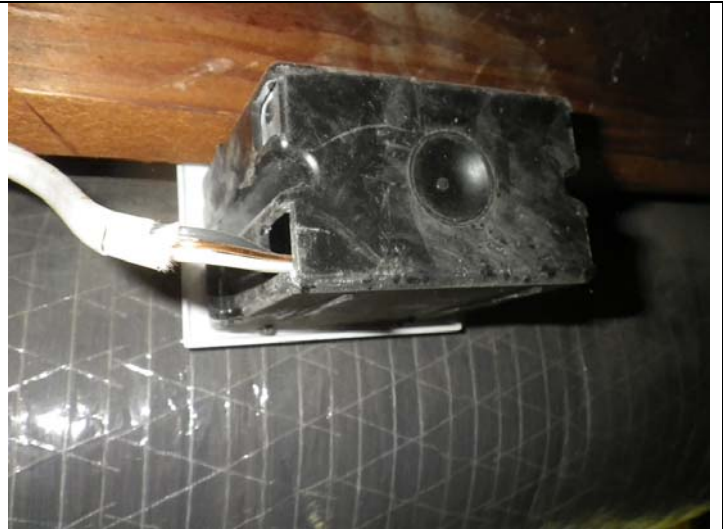
Figure 20(# 1698)

13.2. Basement: Improper wiring methods including unprotected wiring and bare / exposed conductors were noted and visible at the back basement area junction box location(s). This presents a current safety concern and it is recommended to have a licensed electrical contractor provide repairs as needed. (See figure # 20)

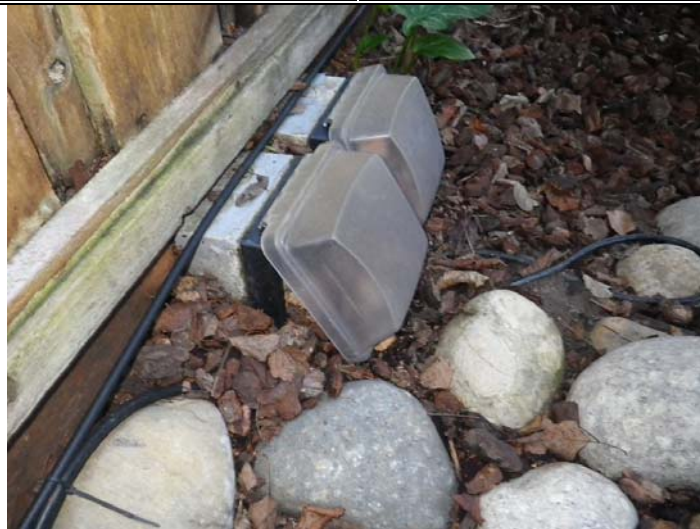
Figure 21(# 1651)

13.4. Right Yard Exterior: Electrical junction boxes /receptacles were visible and located at the right side fence location(s) which had soil too high. This is generally considered as a minor condition, however, it should be modified to prevent possible moisture intrusion into the J-box and maintain a safe installation. (See figure # 21)
